Profile/Photo Observation Report

Street:	AZALEA DR	Flow Control:	Not Controlled
City:	Hobart, IN	Year Renewed:	
Location:	Sidewalk	Tape/Media #:	
Purpose:	Maintenance Related	Dia/Height:	8"
Use:	Sanitary	Material:	PVC
Drain Area:	NA	Lining:	Cured in Place
Category:	NA		
Comment:	Flow direction wrong.

Location Details:		Direction of Survey:	Upstream
US MH:	M-708-134	DS MH:	M-708-169
		Total Length Surveyed (ft):	295.1

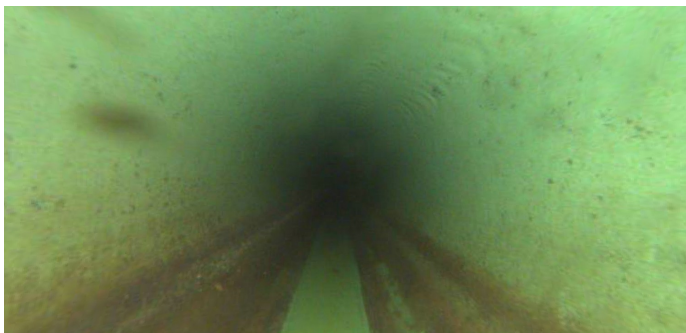
Code: **AMH**
Description: **Manhole**

Distance (ft): **.0**
Structural Grade: **0**
O&M Grade: **0**
Clock Start/From:
Clock To:
1st Value:
2nd Value:
Value Percent:
Continuous Index:
Within 8" of Joint: **NO**
Remarks: **M-708-169**

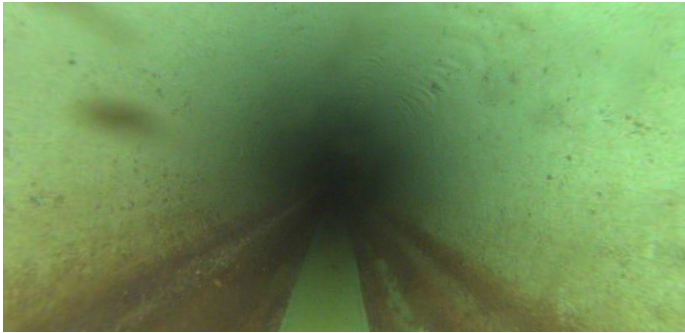
Code:	MWL
Description:	Water Level

Distance (ft):	.0
Structural Grade:	0
O&M Grade:	0
Clock Start/From:	
Clock To:	
1st Value:	
2nd Value:	
Value Percent:	5.000
Continuous Index:	
Within 8" of Joint:	NO
Remarks:

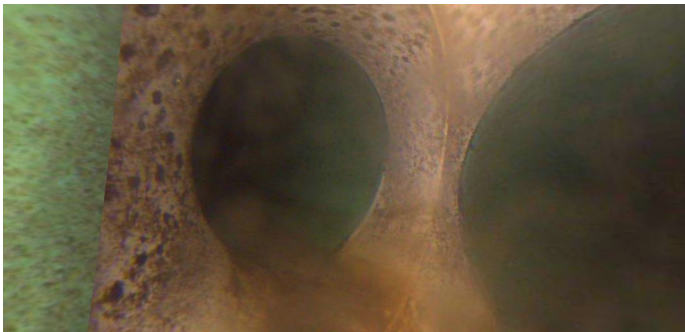
Code:	TFA
Description:	Tap Factory Active

Distance (ft):	10.8
Structural Grade:	0
O&M Grade:	0
Clock Start/From:	3
Clock To:	
1st Value:	4.000
2nd Value:	
Value Percent:	
Continuous Index:	
Within 8" of Joint:	
Remarks:

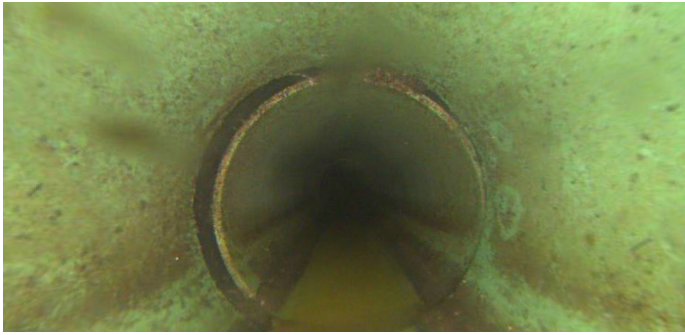
Code: **JSM**
Description: **Joint Separated Medium**

Distance (ft): **21.9**
Structural Grade: **1**
O&M Grade: **0**
Clock Start/From:
Clock To:
1st Value:
2nd Value:
Value Percent:
Continuous Index:
Within 8" of Joint: **NO**
Remarks:

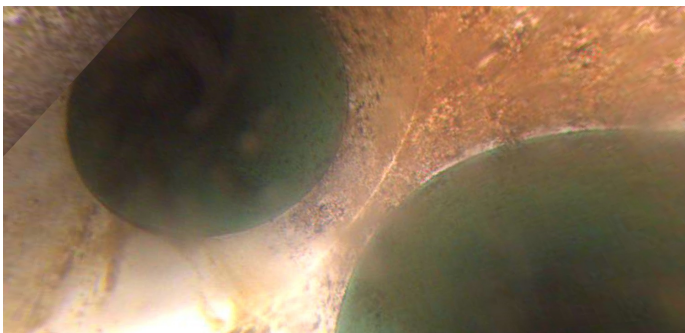
Code: **TF**
Description: **Tap Factory**

Distance (ft): **35.6**
Structural Grade: **0**
O&M Grade: **0**
Clock Start/From: **2**
Clock To:
1st Value: **4.000**
2nd Value:
Value Percent:
Continuous Index:
Within 8" of Joint:
Remarks:

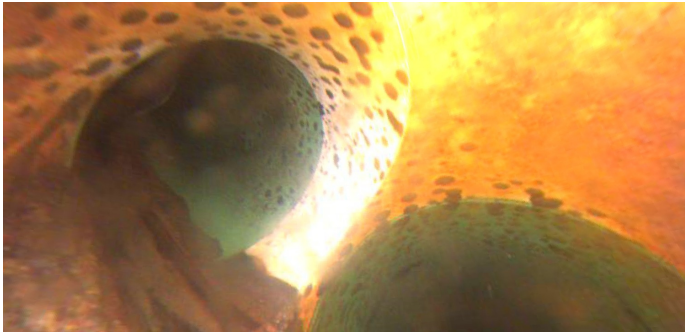
Code: **TFD**
Description: **Tap Factory Defective**

Distance (ft): **102.9**
Structural Grade: **0**
O&M Grade: **2**
Clock Start/From: **2**
Clock To:
1st Value: **4.000**
2nd Value:
Value Percent:
Continuous Index:
Within 8" of Joint:
Remarks: **DAE**

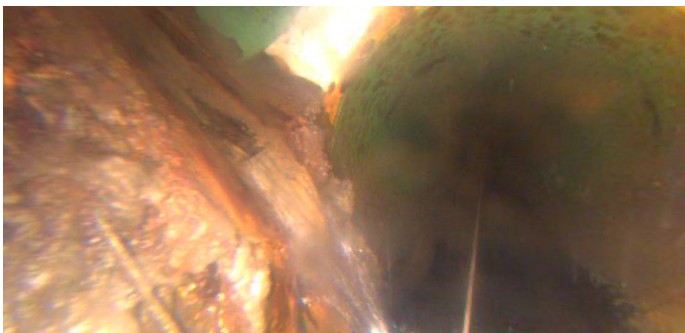
Code: **DAE**
Description: **Deposits Attached Encrustation**

Distance (ft): **102.9**
Structural Grade: **0**
O&M Grade: **2**
Clock Start/From: **3**
Clock To: **5**
1st Value:
2nd Value:
Value Percent: **10.000**
Continuous Index:
Within 8" of Joint: **NO**
Remarks:

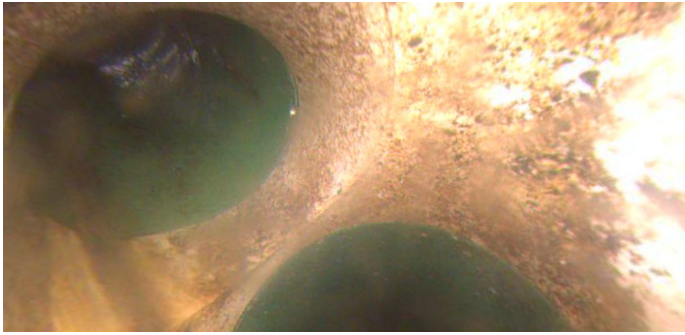
Code: **TF**
Description: **Tap Factory**

Distance (ft): **159.5**
Structural Grade: **0**
O&M Grade: **0**
Clock Start/From: **1**
Clock To:
1st Value: **4.000**
2nd Value:
Value Percent:
Continuous Index:
Within 8" of Joint:
Remarks:

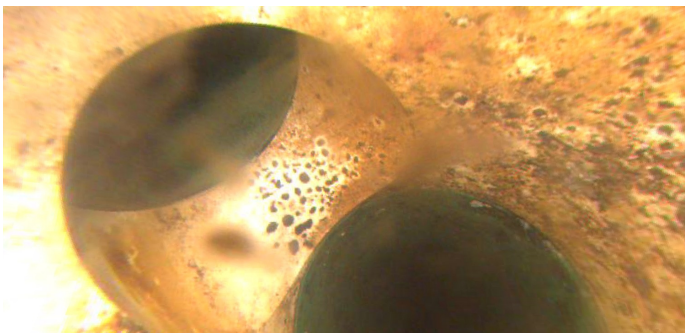
Code: **TF**
Description: **Tap Factory**

Distance (ft): **227.6**
Structural Grade: **0**
O&M Grade: **0**
Clock Start/From: **10**
Clock To:
1st Value: **4.000**
2nd Value:
Value Percent:
Continuous Index:
Within 8" of Joint:
Remarks:

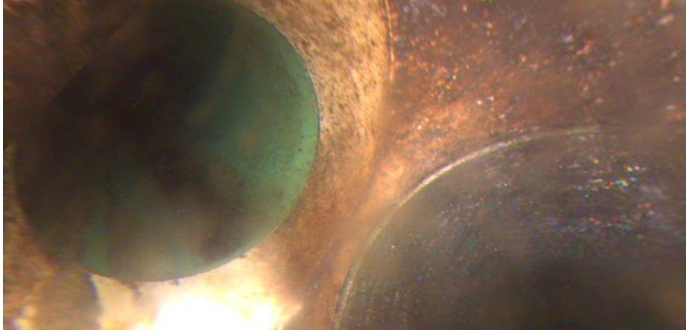
Code: **TF**
Description: **Tap Factory**

Distance (ft): **244.3**
Structural Grade: **0**
O&M Grade: **0**
Clock Start/From: **2**
Clock To:
1st Value: **4.000**
2nd Value:
Value Percent:
Continuous Index:
Within 8" of Joint:
Remarks:

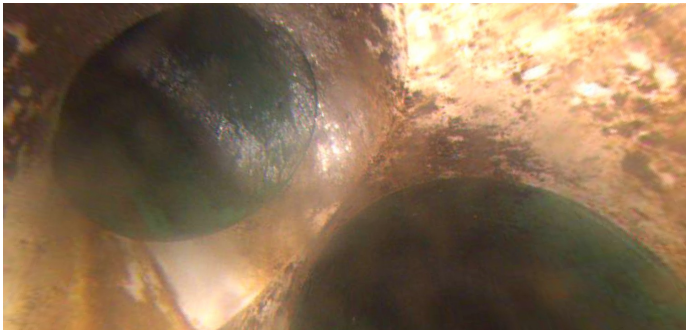
Code: **TF**
Description: **Tap Factory**

Distance (ft): **271.9**
Structural Grade: **0**
O&M Grade: **0**
Clock Start/From: **1**
Clock To:
1st Value: **4.000**
2nd Value:
Value Percent:
Continuous Index:
Within 8" of Joint:
Remarks:
