Profile/Photo Observation Report

Street:	Magnolia	Flow Control:	Not Controlled
City:	Hobart, IN	Year Renewed:	
Location:	Sidewalk	Tape/Media #:	
Purpose:	Maintenance Related	Dia/Height:	8"
Use:	Sanitary	Material:	PVC
Drain Area:	NA	Lining:	Cured in Place
Category:	NA		
Comment:	Flow direction wrong.

Location Details:		Direction of Survey:	Upstream
US MH:	M-708-134	DS MH:	M-708-169
		Total Length Surveyed (ft):	295.1

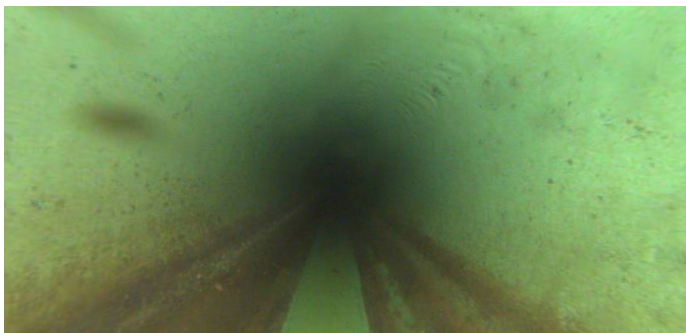
Code: **AMH**
Description: **Manhole**

Distance (ft): **.0**
Structural Grade: **0**
O&M Grade: **0**
Clock Start/From:
Clock To:
1st Value:
2nd Value:
Value Percent:
Continuous Index:
Within 8" of Joint: **NO**
Remarks: **M-708-169**

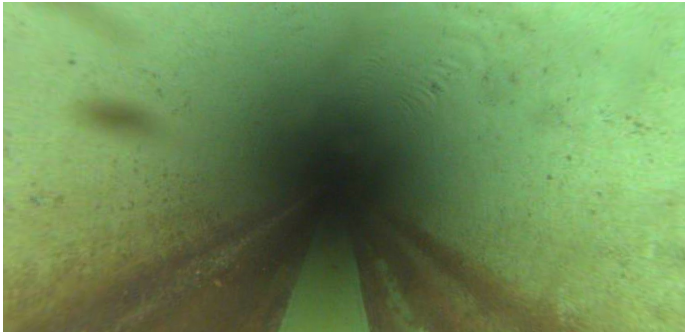
Code:	MWL
Description:	Water Level

Distance (ft):	.0
Structural Grade:	0
O&M Grade:	0
Clock Start/From:	
Clock To:	
1st Value:	
2nd Value:	
Value Percent:	5.000
Continuous Index:	
Within 8" of Joint:	NO
Remarks:

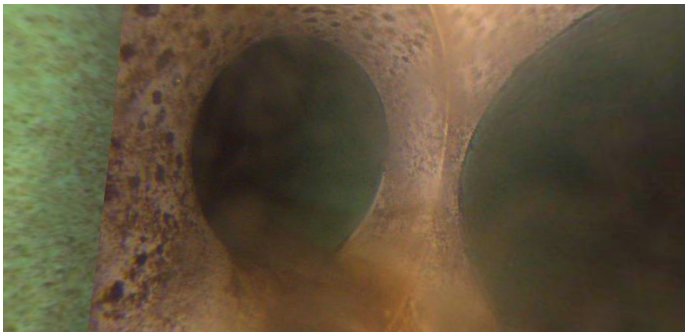
Code:	TFA
Description:	Tap Factory Active

Distance (ft):	10.8
Structural Grade:	0
O&M Grade:	0
Clock Start/From:	3
Clock To:	
1st Value:	4.000
2nd Value:	
Value Percent:	
Continuous Index:	
Within 8" of Joint:	
Remarks:

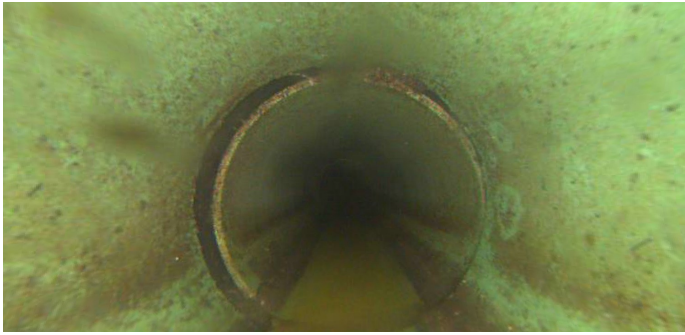
Code: **JSM**
Description: **Joint Separated Medium**

Distance (ft): **21.9**
Structural Grade: **1**
O&M Grade: **0**
Clock Start/From:
Clock To:
1st Value:
2nd Value:
Value Percent:
Continuous Index:
Within 8" of Joint: **NO**
Remarks:

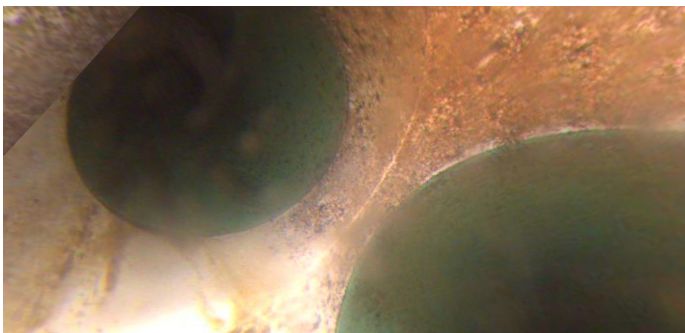
Code: **TF**
Description: **Tap Factory**

Distance (ft): **35.6**
Structural Grade: **0**
O&M Grade: **0**
Clock Start/From: **2**
Clock To:
1st Value: **4.000**
2nd Value:
Value Percent:
Continuous Index:
Within 8" of Joint:
Remarks:

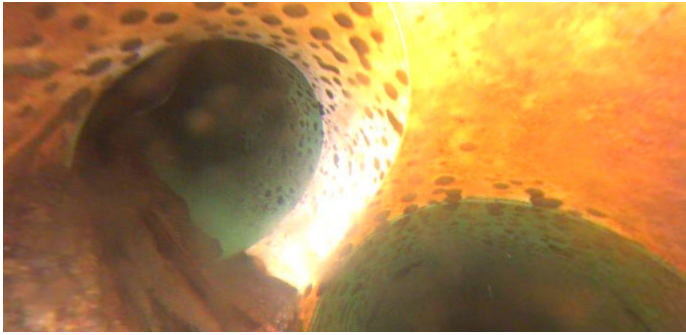
Code: **TFD**
Description: **Tap Factory Defective**

Distance (ft): **102.9**
Structural Grade: **0**
O&M Grade: **2**
Clock Start/From: **2**
Clock To:
1st Value: **4.000**
2nd Value:
Value Percent:
Continuous Index:
Within 8" of Joint:
Remarks: **DAE**

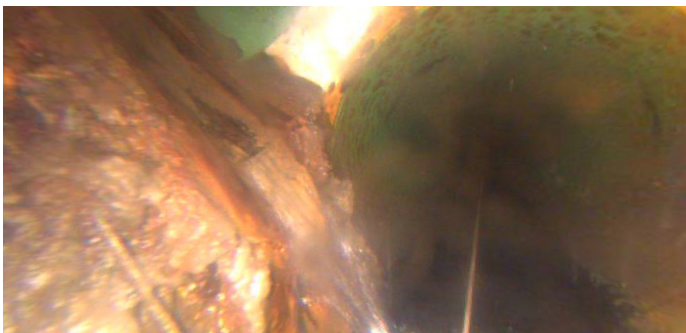
Code: **DAE**
Description: **Deposits Attached Encrustation**

Distance (ft): **102.9**
Structural Grade: **0**
O&M Grade: **2**
Clock Start/From: **3**
Clock To: **5**
1st Value:
2nd Value:
Value Percent: **10.000**
Continuous Index:
Within 8" of Joint: **NO**
Remarks:

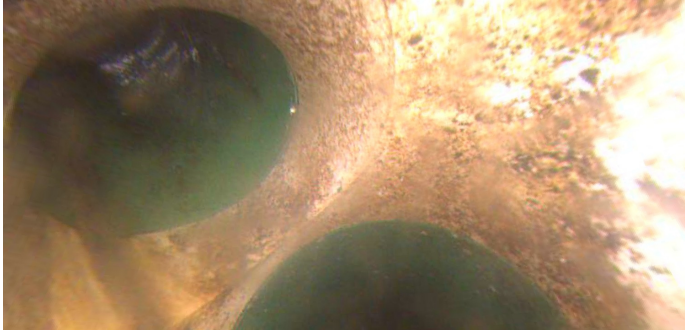
Code: **TF**
Description: **Tap Factory**

Distance (ft): **159.5**
Structural Grade: **0**
O&M Grade: **0**
Clock Start/From: **1**
Clock To:
1st Value: **4.000**
2nd Value:
Value Percent:
Continuous Index:
Within 8" of Joint:
Remarks:

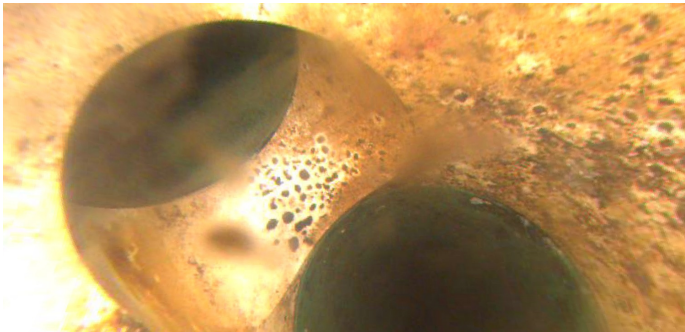
Code: **TF**
Description: **Tap Factory**

Distance (ft): **227.6**
Structural Grade: **0**
O&M Grade: **0**
Clock Start/From: **10**
Clock To:
1st Value: **4.000**
2nd Value:
Value Percent:
Continuous Index:
Within 8" of Joint:
Remarks:

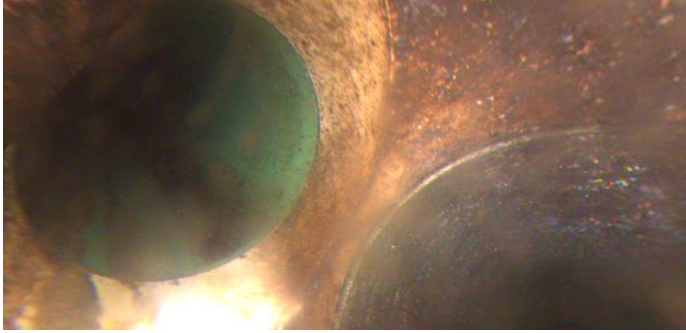
Code: **TF**
Description: **Tap Factory**

Distance (ft): **244.3**
Structural Grade: **0**
O&M Grade: **0**
Clock Start/From: **2**
Clock To:
1st Value: **4.000**
2nd Value:
Value Percent:
Continuous Index:
Within 8" of Joint:
Remarks:

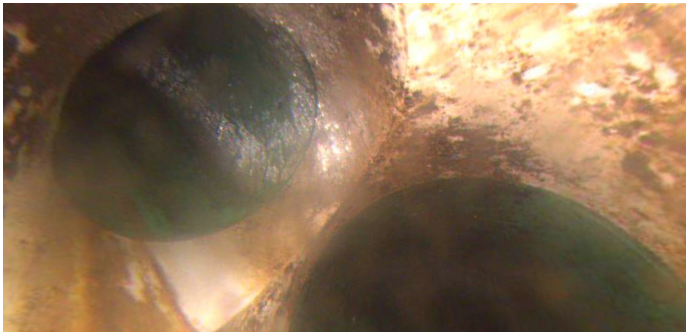
Code: **TF**
Description: **Tap Factory**

Distance (ft): **271.9**
Structural Grade: **0**
O&M Grade: **0**
Clock Start/From: **1**
Clock To:
1st Value: **4.000**
2nd Value:
Value Percent:
Continuous Index:
Within 8" of Joint:
Remarks:
