Profile/Photo Observation Report

Date:	03/31/2018	Weather:		Coding:	PACP 6.0
Pipe Length (ft):	100.0	Owner:	NA	Pre Clean:	Not Known
P.O.#:		Surveyor:	Jen Costello	PSR:	P-708-141-140
Customer:		Clean Date:	01/01/1900	Shape:	C

Street:	LAKE ST	Flow Control:	Not Controlled
City:	Hobart, IN	Year Renewed:	
Location:	Light Highway	Tape/Media #:	
Purpose:	Maintenance Related	Dia/Height:	8"
Use:	Sanitary	Material:	PVC
Drain Area:	NA	Lining:	Cured in Place
Category:	NA		
Comment:	Flow direction wrong. Redeployment.		
Location Details:		Direction of Survey:	Upstream
US MH:	M-708-140	DS MH:	M-708-141
		Total Length Surveyed (ft):	18.6

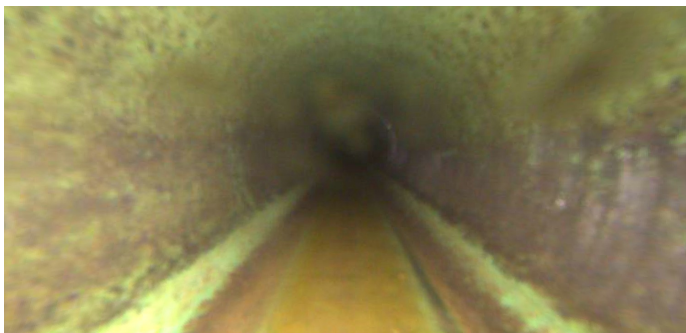
Code: **AMH**
Description: **Manhole**

Distance (ft): **.0**
Structural Grade: **0**
O&M Grade: **0**
Clock Start/From:
Clock To:
1st Value:
2nd Value:
Value Percent:
Continuous Index:
Within 8" of Joint: **NO**
Remarks: **M-708-141**

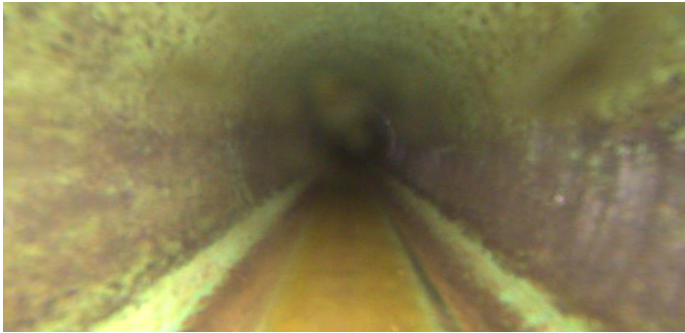
Code:	MWL
Description:	Water Level

Distance (ft):	.0
Structural Grade:	0
O&M Grade:	0
Clock Start/From:	
Clock To:	
1st Value:	
2nd Value:	
Value Percent:	5.000
Continuous Index:	
Within 8" of Joint:	NO
Remarks:

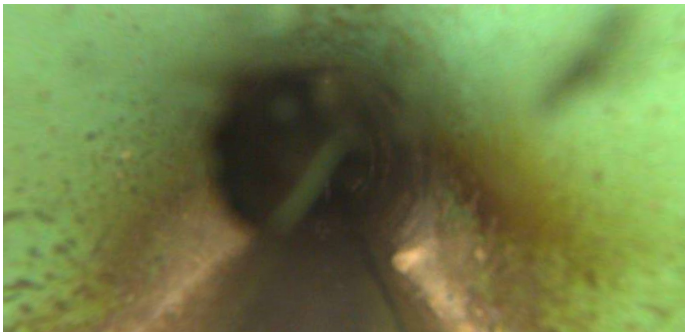
Code:	DAGS
Description:	Deposits Attached Grease

Distance (ft):	16.0
Structural Grade:	0
O&M Grade:	2
Clock Start/From:	7
Clock To:	5
1st Value:	
2nd Value:	
Value Percent:	5.000
Continuous Index:	
Within 8" of Joint:	NO
Remarks:

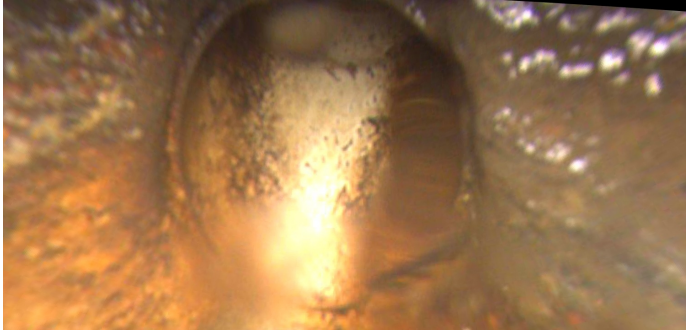
Code: **TFA**
Description: **Tap Factory Active**

Distance (ft): **17.4**
Structural Grade: **0**
O&M Grade: **0**
Clock Start/From: **12**
Clock To:
1st Value: **4.000**
2nd Value:
Value Percent:
Continuous Index:
Within 8" of Joint:
Remarks:

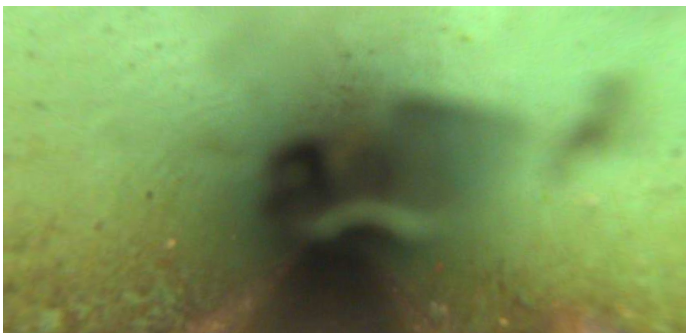
Code: **MSA**
Description: **Abandoned Survey**

Distance (ft): **18.6**
Structural Grade: **0**
O&M Grade: **0**
Clock Start/From:
Clock To:
1st Value:
2nd Value:
Value Percent:
Continuous Index:
Within 8" of Joint: **NO**
Remarks: **unknown**
