Profile/Photo Observation Report

Date:	03/31/2018	Weather:		Coding:	PACP 6.0
Pipe Length (ft):	100.0	Owner:	NA	Pre Clean:	Not Known
P.O.#:		Surveyor:	Jen Costello	PSR:	P-708-141-140
Customer:		Clean Date:	01/01/1900	Shape:	C

Street:	Lake	Flow Control:	Not Controlled
City:	Hobart, IN	Year Renewed:	
Location:	Light Highway	Tape/Media #:	
Purpose:	Maintenance Related	Dia/Height:	8"
Use:	Sanitary	Material:	PVC
Drain Area:	NA	Lining:	Cured in Place
Category:	NA		
Comment:	Flow direction wrong. Redeployment.		
Location Details:		Direction of Survey:	Upstream
US MH:	M-708-140	DS MH:	M-708-141
		Total Length Surveyed (ft):	18.6

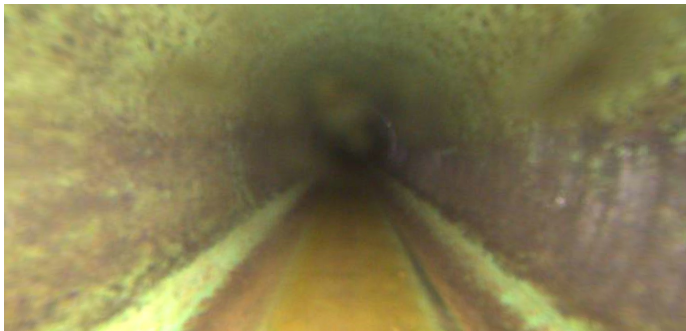
Code: **AMH**
Description: **Manhole**

Distance (ft): **.0**
Structural Grade: **0**
O&M Grade: **0**
Clock Start/From:
Clock To:
1st Value:
2nd Value:
Value Percent:
Continuous Index:
Within 8" of Joint: **NO**
Remarks: **M-708-141**

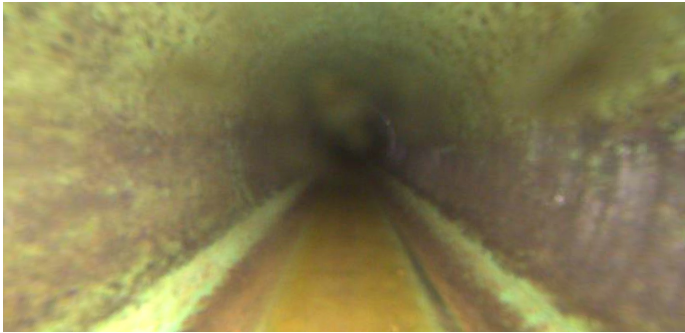
Code:	MWL
Description:	Water Level

Distance (ft):	.0
Structural Grade:	0
O&M Grade:	0
Clock Start/From:	
Clock To:	
1st Value:	
2nd Value:	
Value Percent:	5.000
Continuous Index:	
Within 8" of Joint:	NO
Remarks:

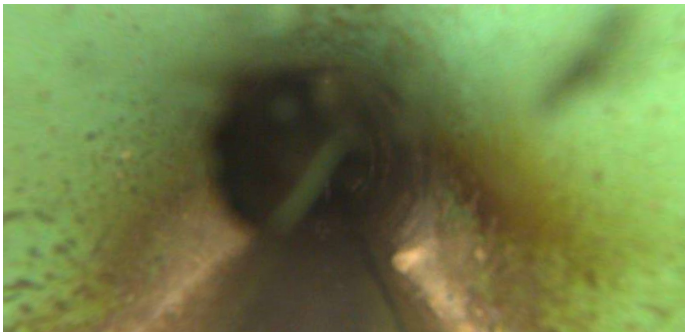
Code:	DAGS
Description:	Deposits Attached Grease

Distance (ft):	16.0
Structural Grade:	0
O&M Grade:	2
Clock Start/From:	7
Clock To:	5
1st Value:	
2nd Value:	
Value Percent:	5.000
Continuous Index:	
Within 8" of Joint:	NO
Remarks:

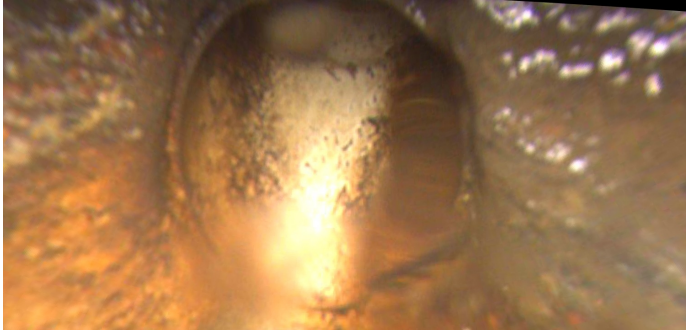
Code: **TFA**
Description: **Tap Factory Active**

Distance (ft): **17.4**
Structural Grade: **0**
O&M Grade: **0**
Clock Start/From: **12**
Clock To:
1st Value: **4.000**
2nd Value:
Value Percent:
Continuous Index:
Within 8" of Joint:
Remarks:

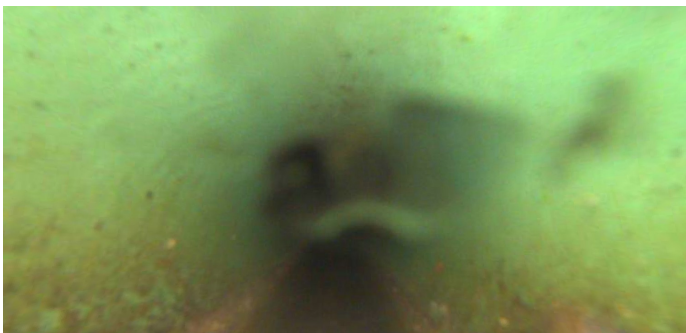
Code: **MSA**
Description: **Abandoned Survey**

Distance (ft): **18.6**
Structural Grade: **0**
O&M Grade: **0**
Clock Start/From:
Clock To:
1st Value:
2nd Value:
Value Percent:
Continuous Index:
Within 8" of Joint: **NO**
Remarks: **unknown**
