Profile/Photo Observation Report

Date:	03/31/2018	Weather:		Coding:	PACP 6.0
Pipe Length (ft):	100.0	Owner:	NA	Pre Clean:	Not Known
P.O.#:		Surveyor:	Jen Costello	PSR:	P-708-141-140
Customer:		Clean Date:	01/01/1900	Shape:	C

Street:	LAKE ST	Flow Control:	Not Controlled
City:	Hobart, IN	Year Renewed:	
Location:	Light Highway	Tape/Media #:	
Purpose:	Maintenance Related	Dia/Height:	8"
Use:	Sanitary	Material:	PVC
Drain Area:	NA	Lining:	Cured in Place
Category:	NA		
Comment:	No manhole found.

Location Details:		Direction of Survey:	Upstream
US MH:	M-708-140	DS MH:	M-708-141
		Total Length Surveyed (ft):	21.0

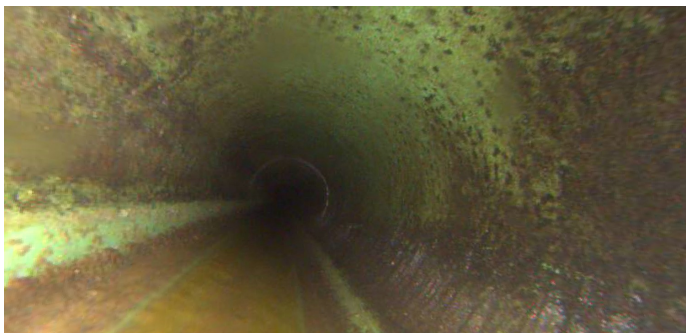
Code: **AMH**
Description: **Manhole**

Distance (ft): **.0**
Structural Grade: **0**
O&M Grade: **0**
Clock Start/From:
Clock To:
1st Value:
2nd Value:
Value Percent:
Continuous Index:
Within 8" of Joint: **NO**
Remarks: **M-708-141**

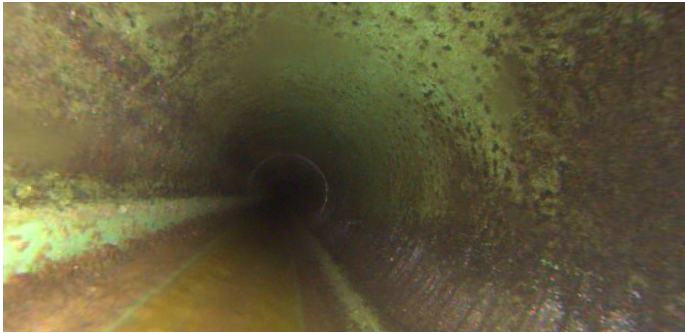
Code:	MWL
Description:	Water Level

Distance (ft):	.0
Structural Grade:	0
O&M Grade:	0
Clock Start/From:	
Clock To:	
1st Value:	
2nd Value:	
Value Percent:	5.000
Continuous Index:	
Within 8" of Joint:	NO
Remarks:

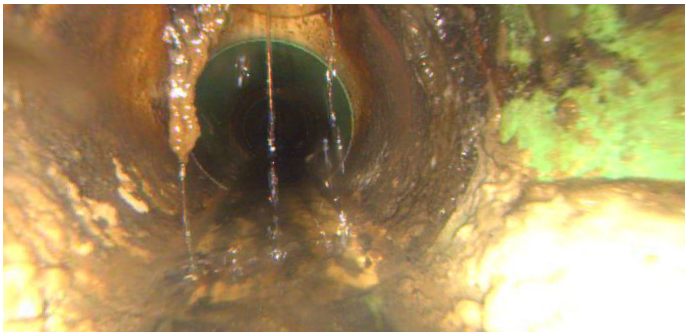
Code:	DAGS
Description:	Deposits Attached Grease

Distance (ft):	15.8
Structural Grade:	0
O&M Grade:	2
Clock Start/From:	7
Clock To:	5
1st Value:	
2nd Value:	
Value Percent:	10.000
Continuous Index:	
Within 8" of Joint:	NO
Remarks:

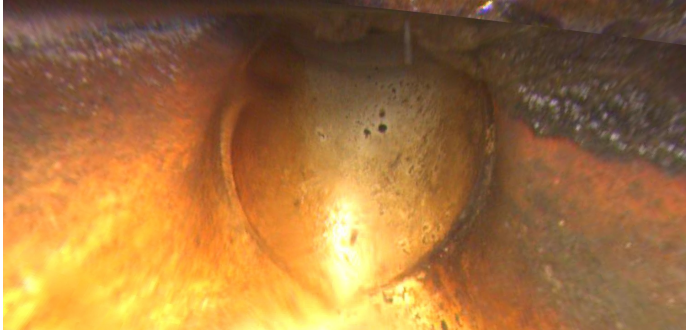
Code: **TFA**
Description: **Tap Factory Active**

Distance (ft): **16.5**
Structural Grade: **0**
O&M Grade: **0**
Clock Start/From: **12**
Clock To:
1st Value: **4.000**
2nd Value:
Value Percent:
Continuous Index:
Within 8" of Joint:
Remarks:

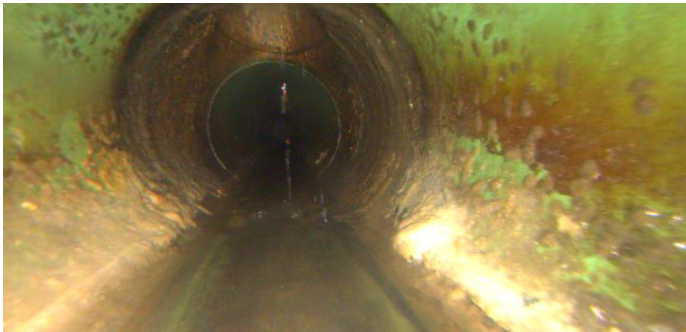
Code: **DAGS**
Description: **Deposits Attached Grease**

Distance (ft): **18.0**
Structural Grade: **0**
O&M Grade: **2**
Clock Start/From: **7**
Clock To: **5**
1st Value:
2nd Value:
Value Percent: **5.000**
Continuous Index:
Within 8" of Joint: **NO**
Remarks:

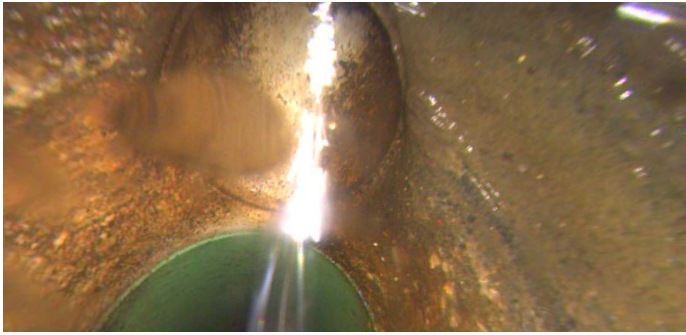
Code: **TFA**
Description: **Tap Factory Active**

Distance (ft): **18.9**
Structural Grade: **0**
O&M Grade: **0**
Clock Start/From: **12**
Clock To:
1st Value: **4.000**
2nd Value:
Value Percent:
Continuous Index:
Within 8" of Joint:
Remarks:

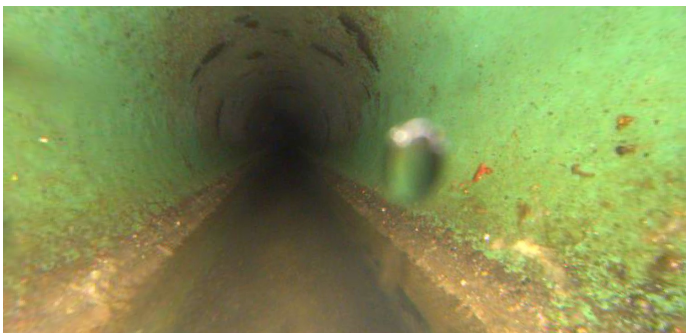
Code: **MSA**
Description: **Abandoned Survey**

Distance (ft): **21.0**
Structural Grade: **0**
O&M Grade: **0**
Clock Start/From:
Clock To:
1st Value:
2nd Value:
Value Percent:
Continuous Index:
Within 8" of Joint: **NO**
Remarks: **UNKNOWN**
