## Profile/Photo Observation Report

Street:	<b>Lake</b>	Flow Control:	<b>Not Controlled</b>
City:	<b>Hobart, IN</b>	Year Renewed:	
Location:	<b>Light Highway</b>	Tape/Media #:	
Purpose:	<b>Maintenance Related</b>	Dia/Height:	<b>8"</b>
Use:	<b>Sanitary</b>	Material:	<b>PVC</b>
Drain Area:	<b>NA</b>	Lining:	<b>Cured in Place</b>
Category:	<b>NA</b>		
Comment:	<b>No manhole found.</b>

Location Details:		Direction of Survey:	<b>Upstream</b>
US MH:	<b>M-708-140</b>	DS MH:	<b>M-708-141</b>
		Total Length Surveyed (ft):	<b>21.0</b>

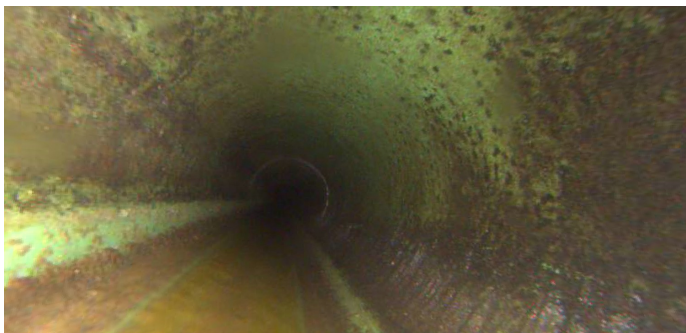
Code: **AMH**  
Description: **Manhole**

Distance (ft): **.0**  
Structural Grade: **0**  
O&M Grade: **0**  
Clock Start/From:  
Clock To:  
1st Value:  
2nd Value:  
Value Percent:  
Continuous Index:  
Within 8" of Joint: **NO**  
Remarks: **M-708-141**

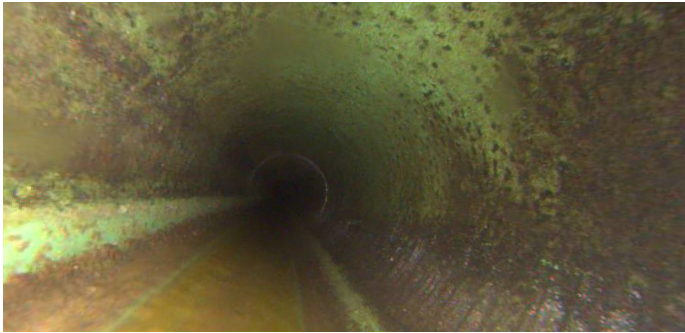
Code:	<b>MWL</b>
Description:	<b>Water Level</b>

Distance (ft):	<b>.0</b>
Structural Grade:	<b>0</b>
O&M Grade:	<b>0</b>
Clock Start/From:	
Clock To:	
1st Value:	
2nd Value:	
Value Percent:	<b>5.000</b>
Continuous Index:	
Within 8" of Joint:	<b>NO</b>
Remarks:

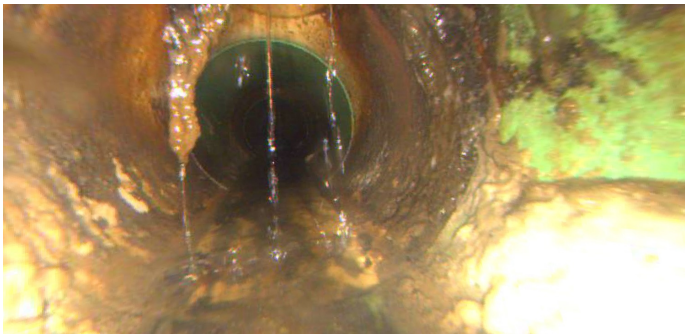
Code:	<b>DAGS</b>
Description:	<b>Deposits Attached Grease</b>

Distance (ft):	<b>15.8</b>
Structural Grade:	<b>0</b>
O&M Grade:	<b>2</b>
Clock Start/From:	<b>7</b>
Clock To:	<b>5</b>
1st Value:	
2nd Value:	
Value Percent:	<b>10.000</b>
Continuous Index:	
Within 8" of Joint:	<b>NO</b>
Remarks:

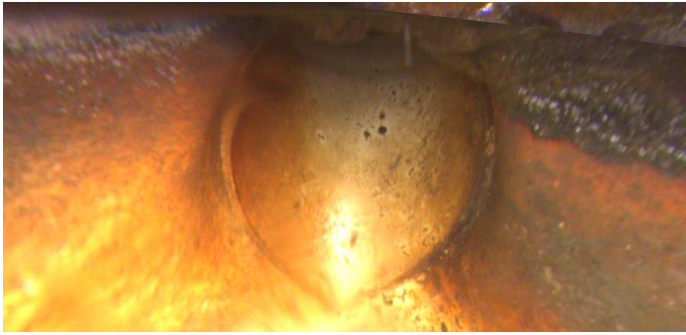
Code: **TFA**  
Description: **Tap Factory Active**

Distance (ft): **16.5**  
Structural Grade: **0**  
O&M Grade: **0**  
Clock Start/From: **12**  
Clock To:  
1st Value: **4.000**  
2nd Value:  
Value Percent:  
Continuous Index:  
Within 8" of Joint:  
Remarks:

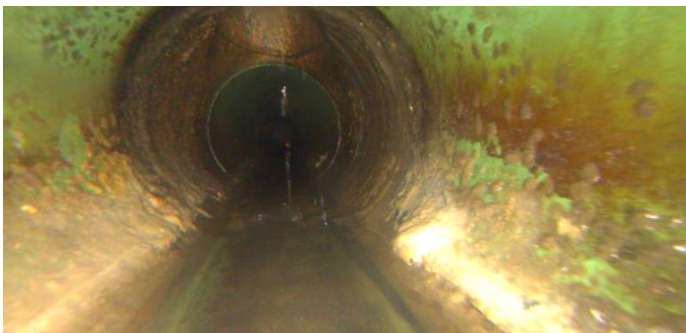
Code: **DAGS**  
Description: **Deposits Attached Grease**

Distance (ft): **18.0**  
Structural Grade: **0**  
O&M Grade: **2**  
Clock Start/From: **7**  
Clock To: **5**  
1st Value:  
2nd Value:  
Value Percent: **5.000**  
Continuous Index:  
Within 8" of Joint: **NO**  
Remarks:

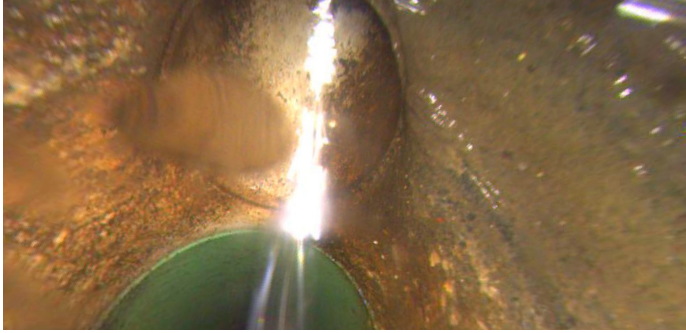
Code: **TFA**  
Description: **Tap Factory Active**

Distance (ft): **18.9**  
Structural Grade: **0**  
O&M Grade: **0**  
Clock Start/From: **12**  
Clock To:  
1st Value: **4.000**  
2nd Value:  
Value Percent:  
Continuous Index:  
Within 8" of Joint:  
Remarks:

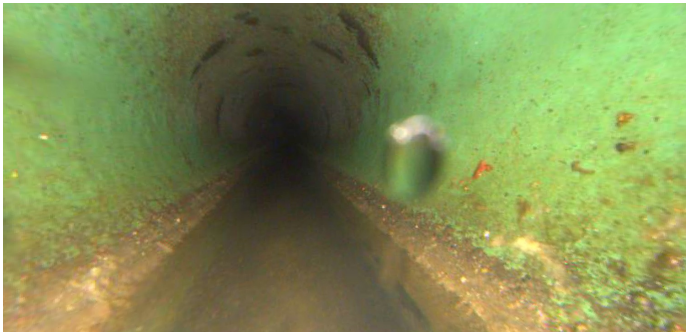
Code: **MSA**  
Description: **Abandoned Survey**

Distance (ft): **21.0**  
Structural Grade: **0**  
O&M Grade: **0**  
Clock Start/From:  
Clock To:  
1st Value:  
2nd Value:  
Value Percent:  
Continuous Index:  
Within 8" of Joint: **NO**  
Remarks: **UNKNOWN**
