## Profile/Photo Observation Report

Street:	<b>LAKE ST</b>	Flow Control:	<b>Not Controlled</b>
City:	<b>Hobart, IN</b>	Year Renewed:	
Location:	<b>Light Highway</b>	Tape/Media #:	
Purpose:	<b>Maintenance Related</b>	Dia/Height:	<b>8"</b>
Use:	<b>Sanitary</b>	Material:	<b>PVC</b>
Drain Area:	<b>NA</b>	Lining:	<b>Cured in Place</b>
Category:	<b>NA</b>		
Comment:	<b>Flow direction wrong.</b>

Location Details:		Direction of Survey:	<b>Downstream</b>
US MH:	<b>M-708-141</b>	DS MH:	<b>M-708-142</b>
		Total Length Surveyed (ft):	<b>98.4</b>

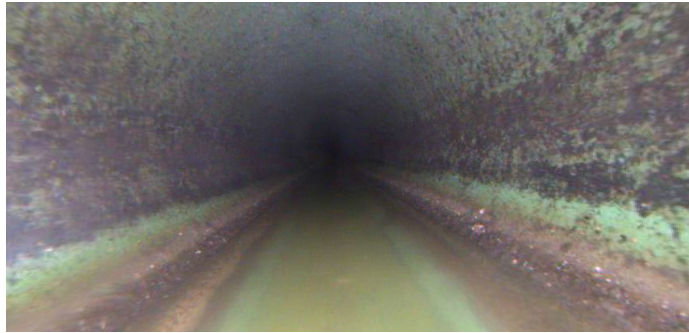
Code: **MWL**  
Description: **Water Level**

Distance (ft): **.0**  
Structural Grade: **0**  
O&M Grade: **0**  
Clock Start/From:  
Clock To:  
1st Value:  
2nd Value:  
Value Percent: **10.000**  
Continuous Index:  
Within 8" of Joint: **NO**  
Remarks:

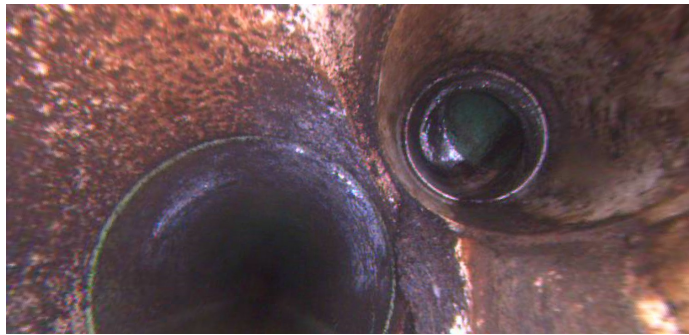
Code: **TFD**  
Description: **Tap Factory Defective**

Distance (ft): **21.2**  
Structural Grade: **0**  
O&M Grade: **2**  
Clock Start/From: **2**  
Clock To:  
1st Value: **4.000**  
2nd Value:  
Value Percent:  
Continuous Index:  
Within 8" of Joint:  
Remarks: **roots**

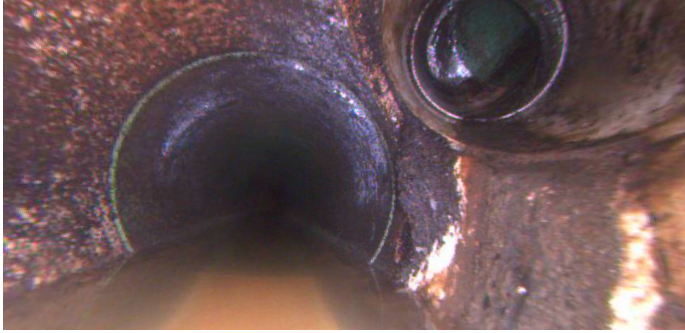
Code: **RMB**  
Description: **Roots Medium Barrel**

Distance (ft): **21.2**  
Structural Grade: **0**  
O&M Grade: **4**  
Clock Start/From: **2**  
Clock To:  
1st Value:  
2nd Value:  
Value Percent: **5.000**  
Continuous Index:  
Within 8" of Joint: **NO**  
Remarks:

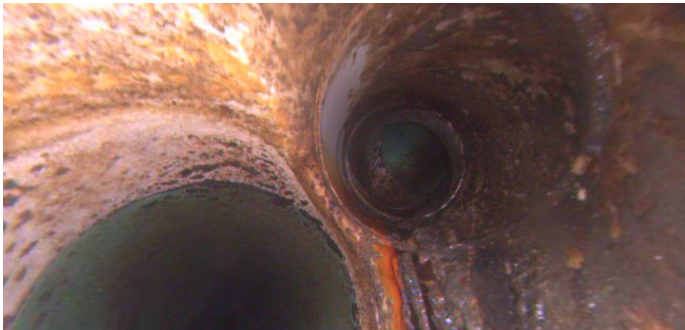
Code: **TF**  
Description: **Tap Factory**

Distance (ft): **79.4**  
Structural Grade: **0**  
O&M Grade: **0**  
Clock Start/From: **2**  
Clock To:  
1st Value: **4.000**  
2nd Value:  
Value Percent:  
Continuous Index:  
Within 8" of Joint:  
Remarks:

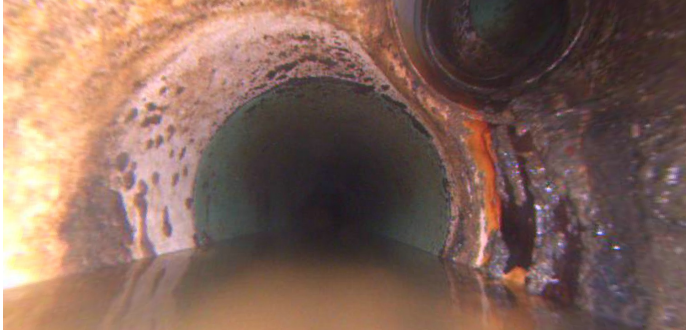
Code: **MWL**  
Description: **Water Level**

Distance (ft): **79.4**  
Structural Grade: **0**  
O&M Grade: **0**  
Clock Start/From:  
Clock To:  
1st Value:  
2nd Value:  
Value Percent: **20.000**  
Continuous Index:  
Within 8" of Joint: **NO**  
Remarks:

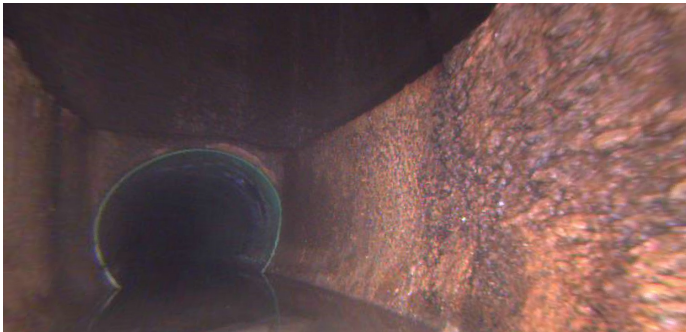
Code: **AMH**  
Description: **Manhole**

Distance (ft): **98.4**  
Structural Grade: **0**  
O&M Grade: **0**  
Clock Start/From:  
Clock To:  
1st Value:  
2nd Value:  
Value Percent:  
Continuous Index:  
Within 8" of Joint: **NO**  
Remarks: **M-708-142**
