## Profile/Photo Observation Report

Street:	<b>Lake</b>	Flow Control:	<b>Not Controlled</b>
City:	<b>Hobart, IN</b>	Year Renewed:	
Location:	<b>Light Highway</b>	Tape/Media #:	
Purpose:	<b>Maintenance Related</b>	Dia/Height:	<b>8"</b>
Use:	<b>Sanitary</b>	Material:	<b>PVC</b>
Drain Area:	<b>NA</b>	Lining:	<b>Cured in Place</b>
Category:	<b>NA</b>		
Comment:	<b>Flow direction wrong.</b>

Location Details:		Direction of Survey:	<b>Downstream</b>
US MH:	<b>M-708-141</b>	DS MH:	<b>M-708-142</b>
		Total Length Surveyed (ft):	<b>98.4</b>

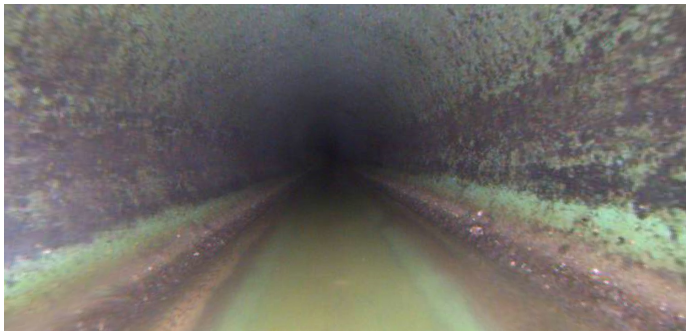
Code: **AMH**  
Description: **Manhole**

Distance (ft): **.0**  
Structural Grade: **0**  
O&M Grade: **0**  
Clock Start/From:  
Clock To:  
1st Value:  
2nd Value:  
Value Percent:  
Continuous Index:  
Within 8" of Joint: **NO**  
Remarks: **M-708-141**

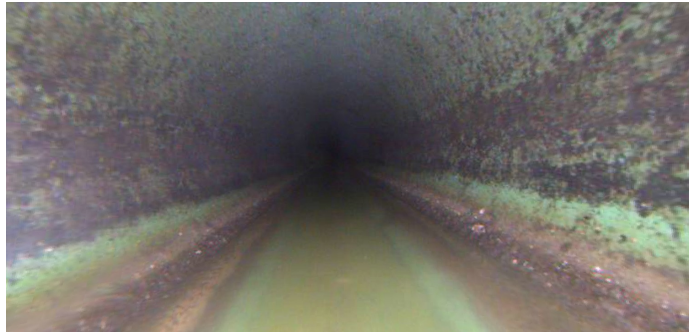
Code: **MWL**  
Description: **Water Level**

Distance (ft): **.0**  
Structural Grade: **0**  
O&M Grade: **0**  
Clock Start/From:  
Clock To:  
1st Value:  
2nd Value:  
Value Percent: **10.000**  
Continuous Index:  
Within 8" of Joint: **NO**  
Remarks:

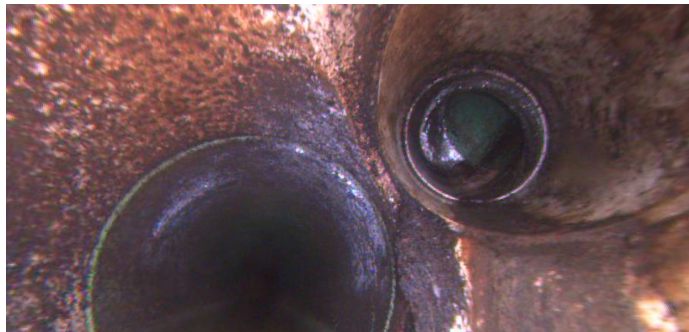
Code: **TFD**  
Description: **Tap Factory Defective**

Distance (ft): **21.2**  
Structural Grade: **0**  
O&M Grade: **2**  
Clock Start/From: **2**  
Clock To:  
1st Value: **4.000**  
2nd Value:  
Value Percent:  
Continuous Index:  
Within 8" of Joint:  
Remarks: **roots**

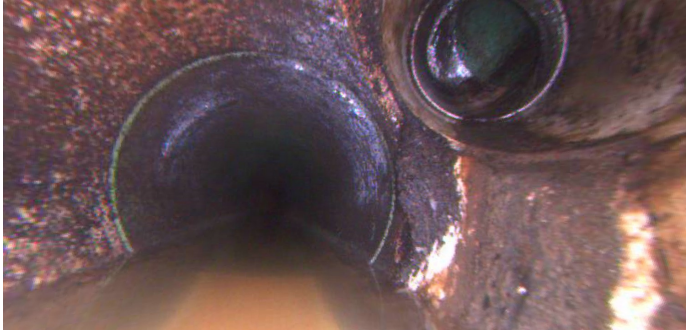
Code: **RMB**  
Description: **Roots Medium Barrel**

Distance (ft): **21.2**  
Structural Grade: **0**  
O&M Grade: **4**  
Clock Start/From: **2**  
Clock To:  
1st Value:  
2nd Value:  
Value Percent: **5.000**  
Continuous Index:  
Within 8" of Joint: **NO**  
Remarks:

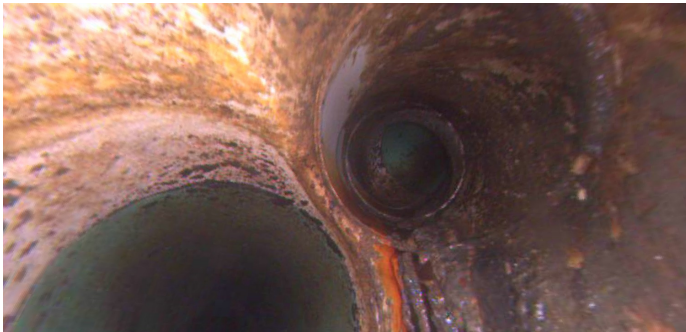
Code: **TF**  
Description: **Tap Factory**

Distance (ft): **79.4**  
Structural Grade: **0**  
O&M Grade: **0**  
Clock Start/From: **2**  
Clock To:  
1st Value: **4.000**  
2nd Value:  
Value Percent:  
Continuous Index:  
Within 8" of Joint:  
Remarks:

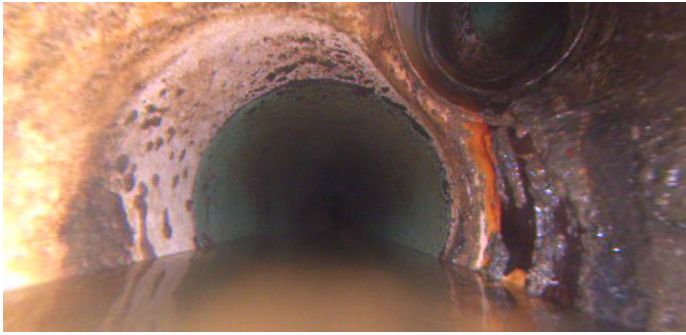
Code: **MWL**  
Description: **Water Level**

Distance (ft): **79.4**  
Structural Grade: **0**  
O&M Grade: **0**  
Clock Start/From:  
Clock To:  
1st Value:  
2nd Value:  
Value Percent: **20.000**  
Continuous Index:  
Within 8" of Joint: **NO**  
Remarks:

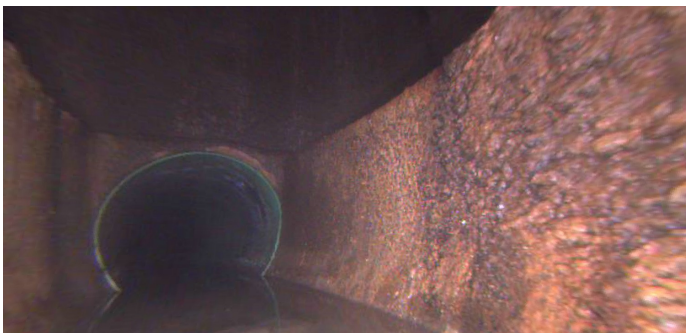
Code: **AMH**  
Description: **Manhole**

Distance (ft): **98.4**  
Structural Grade: **0**  
O&M Grade: **0**  
Clock Start/From:  
Clock To:  
1st Value:  
2nd Value:  
Value Percent:  
Continuous Index:  
Within 8" of Joint: **NO**  
Remarks: **M-708-142**
