## Profile/Photo Observation Report

Street:	<b>Lake</b>	Flow Control:	<b>Not Controlled</b>
City:	<b>Hobart, IN</b>	Year Renewed:	
Location:	<b>Sidewalk</b>	Tape/Media #:	
Purpose:	<b>Maintenance Related</b>	Dia/Height:	<b>12"</b>
Use:	<b>Sanitary</b>	Material:	<b>PVC</b>
Drain Area:	<b>NA</b>	Lining:	<b>Cured in Place</b>
Category:	<b>NA</b>		
Comment:

Location Details:		Direction of Survey:	<b>Upstream</b>
US MH:	<b>M-708-144</b>	DS MH:	<b>M-708-145</b>
		Total Length Surveyed (ft):	<b>158.5</b>

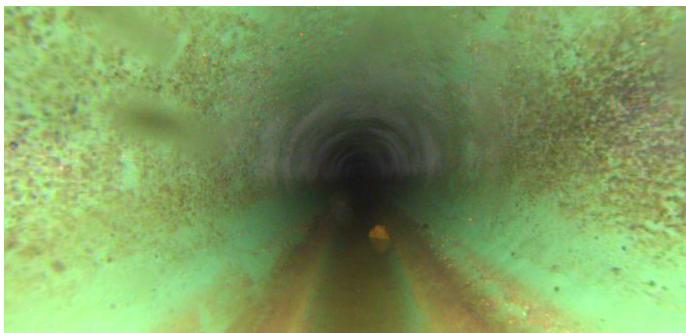
Code: **AMH**  
Description: **Manhole**

Distance (ft): **.0**  
Structural Grade: **0**  
O&M Grade: **0**  
Clock Start/From:  
Clock To:  
1st Value:  
2nd Value:  
Value Percent:  
Continuous Index:  
Within 8" of Joint: **NO**  
Remarks: **M-708-145**

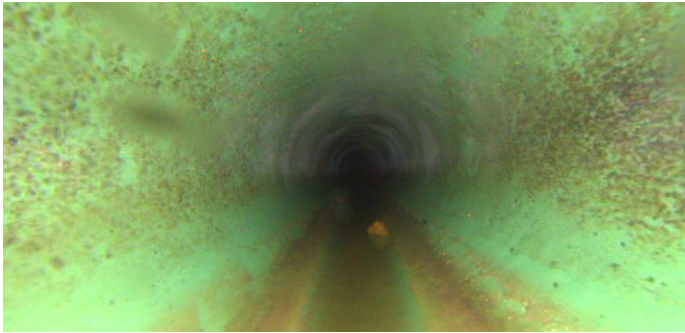
Code:	<b>MWL</b>
Description:	<b>Water Level</b>

Distance (ft):	<b>.0</b>
Structural Grade:	<b>0</b>
O&M Grade:	<b>0</b>
Clock Start/From:	
Clock To:	
1st Value:	
2nd Value:	
Value Percent:	<b>5.000</b>
Continuous Index:	
Within 8" of Joint:	<b>NO</b>
Remarks:

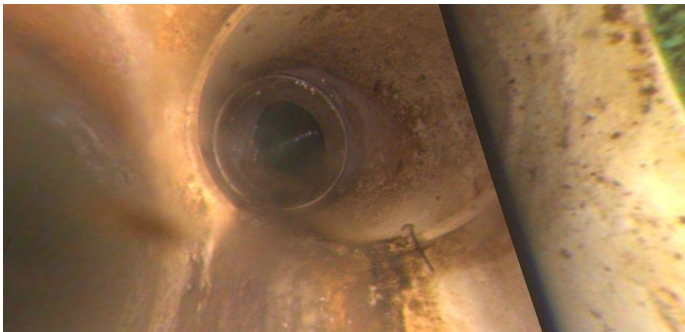
Code:	<b>TF</b>
Description:	<b>Tap Factory</b>

Distance (ft):	<b>59.3</b>
Structural Grade:	<b>0</b>
O&M Grade:	<b>0</b>
Clock Start/From:	<b>10</b>
Clock To:	
1st Value:	<b>4.000</b>
2nd Value:	
Value Percent:	
Continuous Index:	
Within 8" of Joint:	
Remarks:

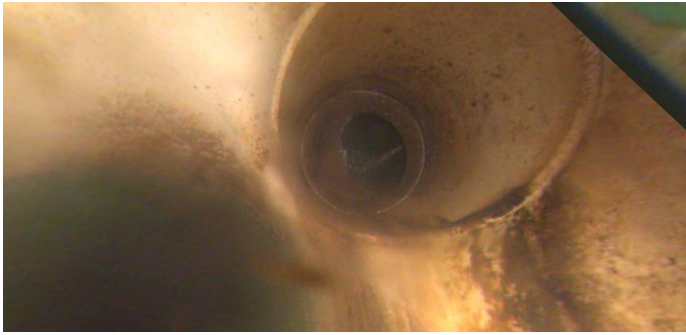
Code: **TF**  
Description: **Tap Factory**

Distance (ft): **62.0**  
Structural Grade: **0**  
O&M Grade: **0**  
Clock Start/From: **10**  
Clock To:  
1st Value: **4.000**  
2nd Value:  
Value Percent:  
Continuous Index:  
Within 8" of Joint:  
Remarks:

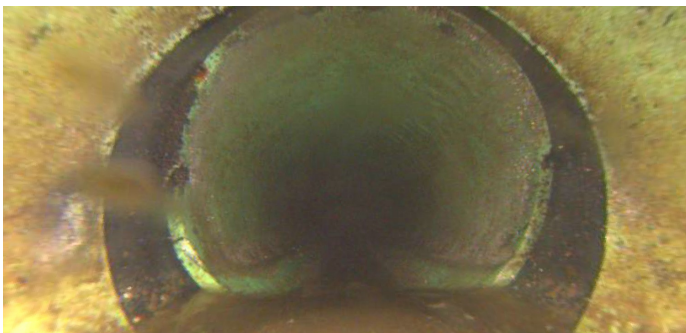
Code: **JSL**  
Description: **Joint Separated Large**

Distance (ft): **118.0**  
Structural Grade: **2**  
O&M Grade: **0**  
Clock Start/From:  
Clock To:  
1st Value:  
2nd Value:  
Value Percent:  
Continuous Index:  
Within 8" of Joint: **NO**  
Remarks:

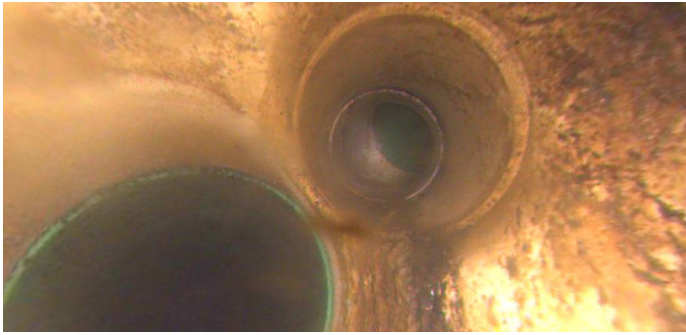
Code: **TF**  
Description: **Tap Factory**

Distance (ft): **126.5**  
Structural Grade: **0**  
O&M Grade: **0**  
Clock Start/From: **10**  
Clock To:  
1st Value: **4.000**  
2nd Value:  
Value Percent:  
Continuous Index:  
Within 8" of Joint:  
Remarks:

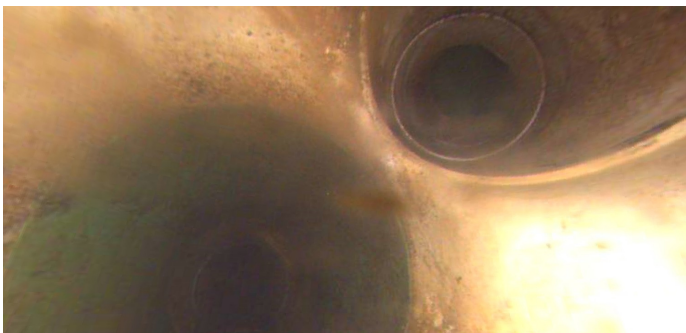
Code: **TF**  
Description: **Tap Factory**

Distance (ft): **128.9**  
Structural Grade: **0**  
O&M Grade: **0**  
Clock Start/From: **10**  
Clock To:  
1st Value: **4.000**  
2nd Value:  
Value Percent:  
Continuous Index:  
Within 8" of Joint:  
Remarks:

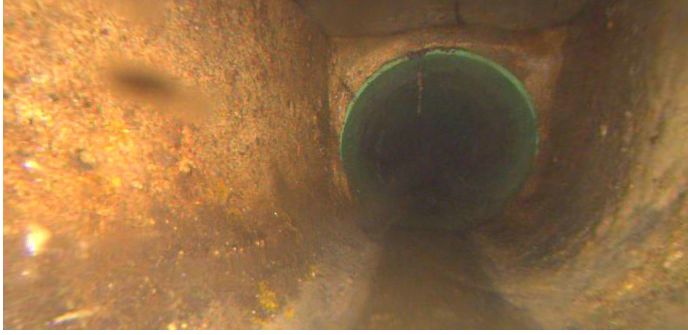
Code:	<b>AMH</b>
Description:	<b>Manhole</b>
Distance (ft):	<b>158.5</b>
Structural Grade:	<b>0</b>
O&M Grade:	<b>0</b>
Clock Start/From:	
Clock To:	
1st Value:	
2nd Value:	
Value Percent:	
Continuous Index:	
Within 8" of Joint:	<b>NO</b>
Remarks:	<b>M-708-144</b>
