## Profile/Photo Observation Report

Street:	<b>Lake</b>	Flow Control:	<b>Not Controlled</b>
City:	<b>Hobart, IN</b>	Year Renewed:	
Location:	<b>Sidewalk</b>	Tape/Media #:	
Purpose:	<b>Maintenance Related</b>	Dia/Height:	<b>8"</b>
Use:	<b>Sanitary</b>	Material:	<b>PVC</b>
Drain Area:	<b>NA</b>	Lining:	<b>Cured in Place</b>
Category:	<b>NA</b>		
Comment:	<b>Flow direction wrong.</b>

Location Details:		Direction of Survey:	<b>Upstream</b>
US MH:	<b>M-708-145</b>	DS MH:	<b>M-708-151</b>
		Total Length Surveyed (ft):	<b>153.3</b>

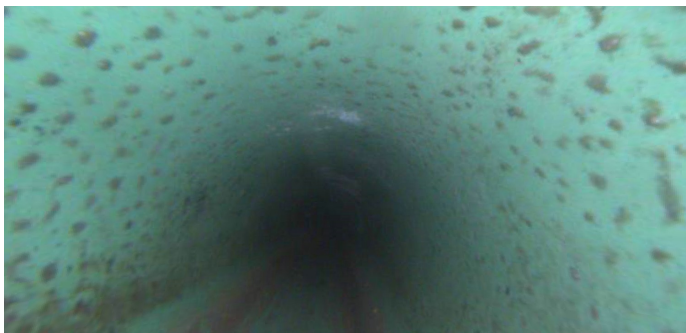
Code: **AMH**  
Description: **Manhole**

Distance (ft): **.0**  
Structural Grade: **0**  
O&M Grade: **0**  
Clock Start/From:  
Clock To:  
1st Value:  
2nd Value:  
Value Percent:  
Continuous Index:  
Within 8" of Joint: **NO**  
Remarks: **M-708-151**

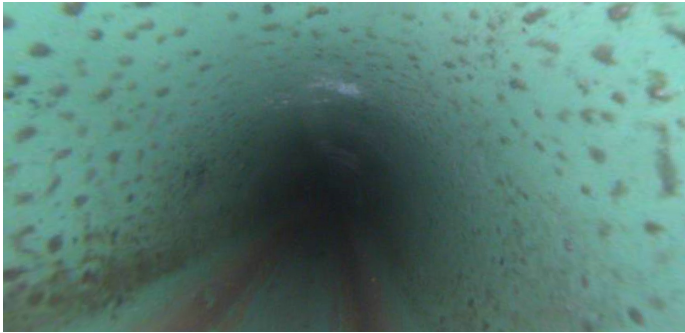
Code:	<b>MWL</b>
Description:	<b>Water Level</b>

Distance (ft):	<b>.0</b>
Structural Grade:	<b>0</b>
O&M Grade:	<b>0</b>
Clock Start/From:	
Clock To:	
1st Value:	
2nd Value:	
Value Percent:	<b>5.000</b>
Continuous Index:	
Within 8" of Joint:	<b>NO</b>
Remarks:

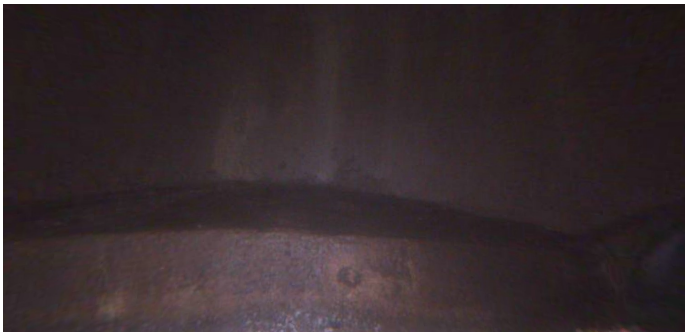
Code:	<b>AMH</b>
Description:	<b>Manhole</b>

Distance (ft):	<b>153.3</b>
Structural Grade:	<b>0</b>
O&M Grade:	<b>0</b>
Clock Start/From:	
Clock To:	
1st Value:	
2nd Value:	
Value Percent:	
Continuous Index:	
Within 8" of Joint:	<b>NO</b>
Remarks:	<b>M-708-145</b>
