Profile/Photo Observation Report

| Street: | LAKE ST | Flow Control: | Not Controlled |
| City: | Hobart, IN | Year Renewed: | |

| US MH: | M-708-146 | DS MH: | M-708-145 |

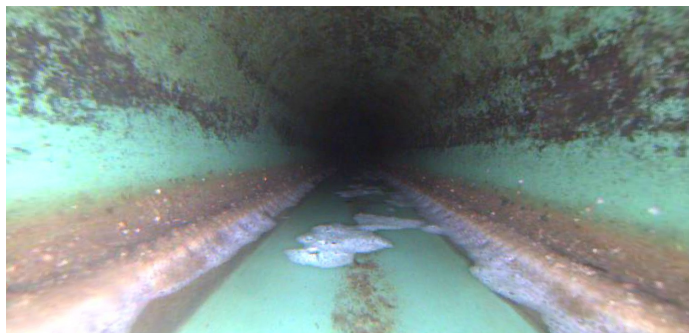
Code: **AMH**
 Description: **Manhole**
 Distance (ft): **.0**
 Structural Grade: **0**
 O&M Grade: **0**
 Clock Start/From:
 Clock To:
 1st Value:
 2nd Value:
 Value Percent:
 Continuous Index:
 Within 8" of Joint: **NO**
 Remarks: **M-708-145**

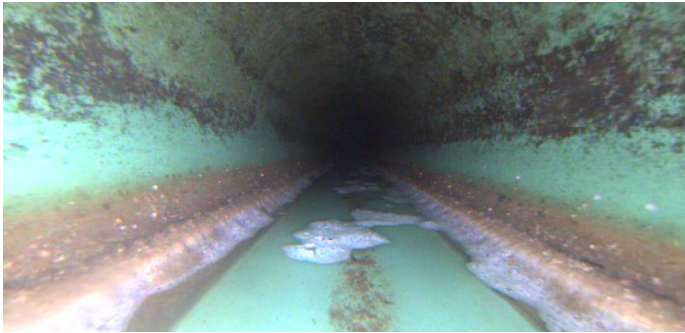
| Code: | MWL |
| Description: | Water Level |

| Value Percent: | 10.000 |

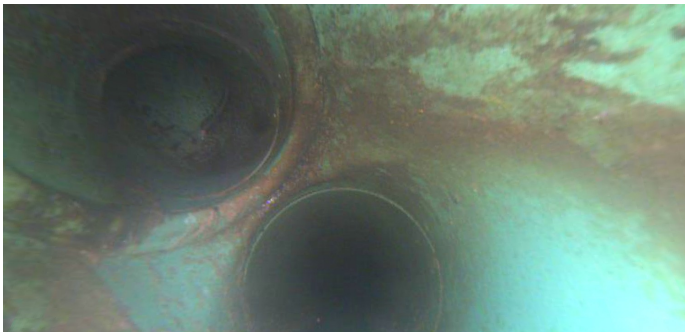
| Code: | TF |
| Description: | Tap Factory |

| Distance (ft): | 11.7 |
| Clock Start/From: | 10 |
| 1st Value: | 4.000 |

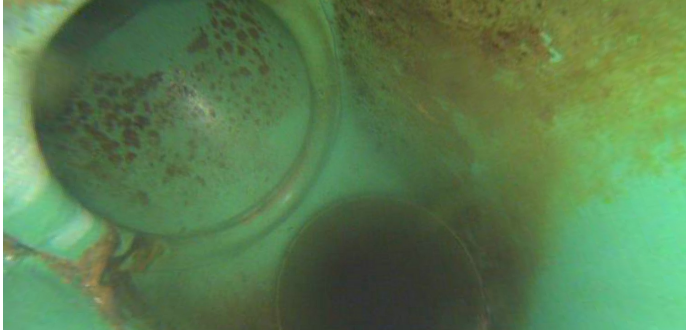
Code: **TF**
Description: **Tap Factory**

Distance (ft): **112.7**
Structural Grade: **0**
O&M Grade: **0**
Clock Start/From: **2**
Clock To:
1st Value: **4.000**
2nd Value:
Value Percent:
Continuous Index:
Within 8" of Joint:
Remarks:

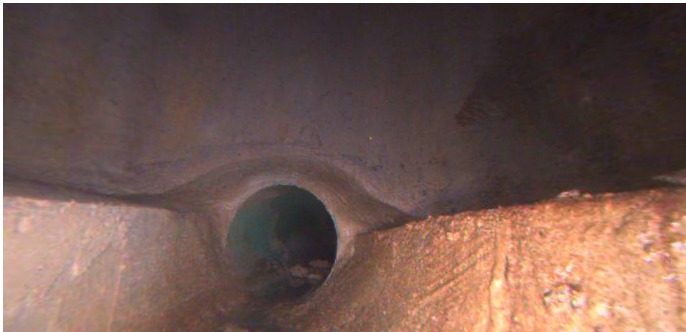
Code: **AMH**
Description: **Manhole**

Distance (ft): **174.5**
Structural Grade: **0**
O&M Grade: **0**
Clock Start/From:
Clock To:
1st Value:
2nd Value:
Value Percent:
Continuous Index:
Within 8" of Joint: **NO**
Remarks: **M-708-146**
