Profile/Photo Observation Report

Location Details:		Direction of Survey:	Upstream
US MH:	M-708-146	DS MH:	M-708-145
		Total Length Surveyed (ft):	174.5

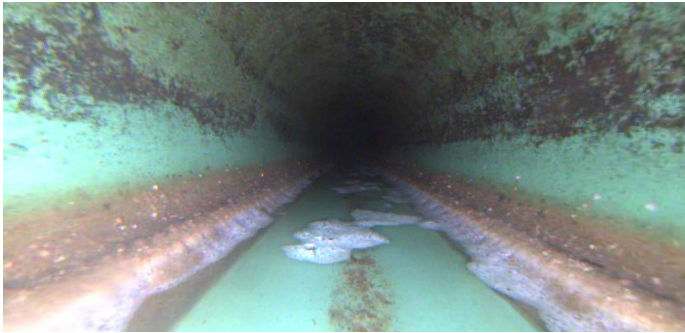
Code:	MWL
Description:	Water Level

Distance (ft):	.0
Structural Grade:	0
O&M Grade:	0
Clock Start/From:	
Clock To:	
1st Value:	
2nd Value:	
Value Percent:	10.000
Continuous Index:	
Within 8" of Joint:	NO
Remarks:

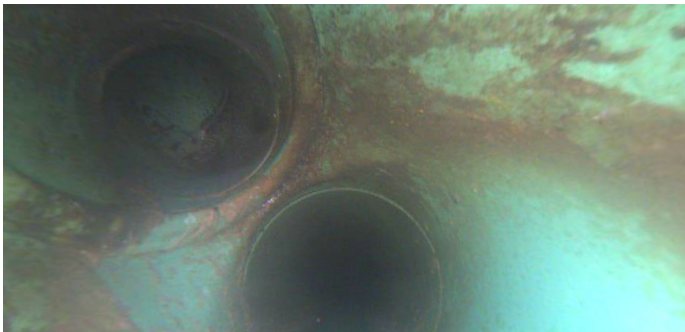
Code:	TF
Description:	Tap Factory

Distance (ft):	11.7
Structural Grade:	0
O&M Grade:	0
Clock Start/From:	10
Clock To:	
1st Value:	4.000
2nd Value:	
Value Percent:	
Continuous Index:	
Within 8" of Joint:	
Remarks:

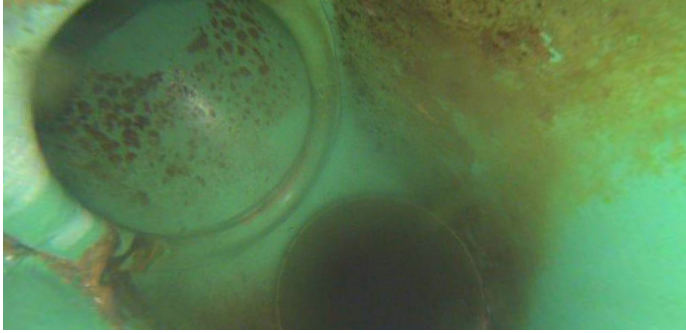
Code: **TF**
Description: **Tap Factory**

Distance (ft): **112.7**
Structural Grade: **0**
O&M Grade: **0**
Clock Start/From: **2**
Clock To:
1st Value: **4.000**
2nd Value:
Value Percent:
Continuous Index:
Within 8" of Joint:
Remarks:

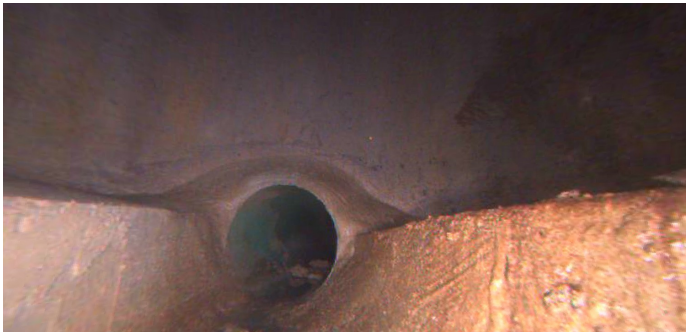
Code: **AMH**
Description: **Manhole**

Distance (ft): **174.5**
Structural Grade: **0**
O&M Grade: **0**
Clock Start/From:
Clock To:
1st Value:
2nd Value:
Value Percent:
Continuous Index:
Within 8" of Joint: **NO**
Remarks: **M-708-146**
