## Profile/Photo Observation Report

Street:	<b>Off Lake Street</b>	Flow Control:	
City:	<b>Hobart, IN</b>	Year Renewed:	
Location:	<b>Parking Lot</b>	Tape/Media #:	<b>969</b>
Purpose:	<b>Routine Assessment</b>	Dia/Height:	<b>8"</b>
Use:	<b>Sanitary</b>	Material:	<b>PVC</b>
Drain Area:		Lining:	
Category:	<b>NA</b>		
Comment:

Location Details:		Direction of Survey:	<b>Downstream</b>
US MH:	<b>M-708-146</b>	DS MH:	<b>M-708-147</b>
		Total Length Surveyed (ft):	<b>98.8</b>

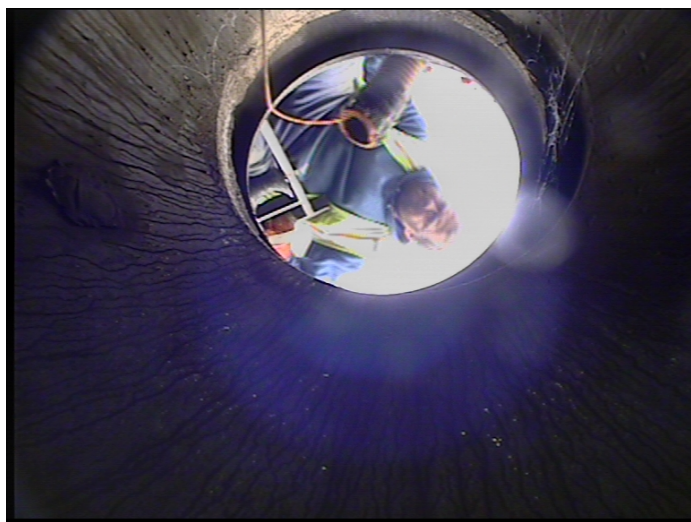
Code: **AMH**  
Description: **Manhole**

Distance (ft): **.0**  
Structural Grade: **0**  
O&M Grade: **0**  
Clock Start/From:  
Clock To:  
1st Value:  
2nd Value:  
Value Percent:  
Continuous Index:  
Within 8" of Joint: **NO**  
Remarks: **M-708-146**

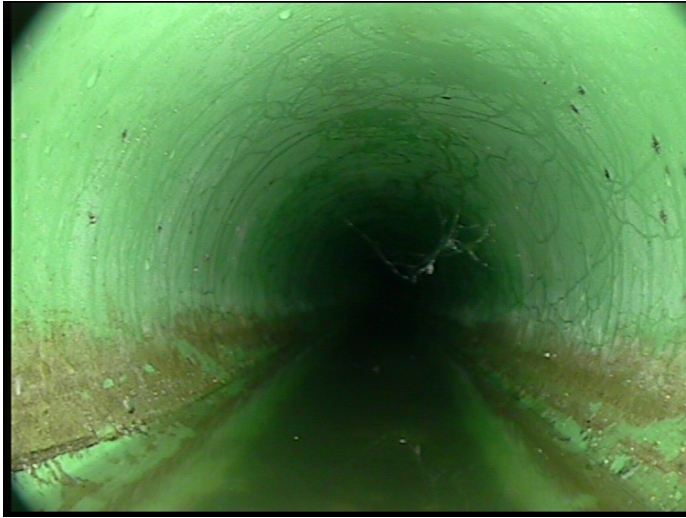
Code:	<b>MWL</b>
Description:	<b>Water Level</b>
Distance (ft):	<b>.0</b>
Structural Grade:	<b>0</b>
O&M Grade:	<b>0</b>
Clock Start/From:	
Clock To:	
1st Value:	
2nd Value:	
Value Percent:	<b>5.000</b>
Continuous Index:	
Within 8" of Joint:	<b>NO</b>
Remarks:

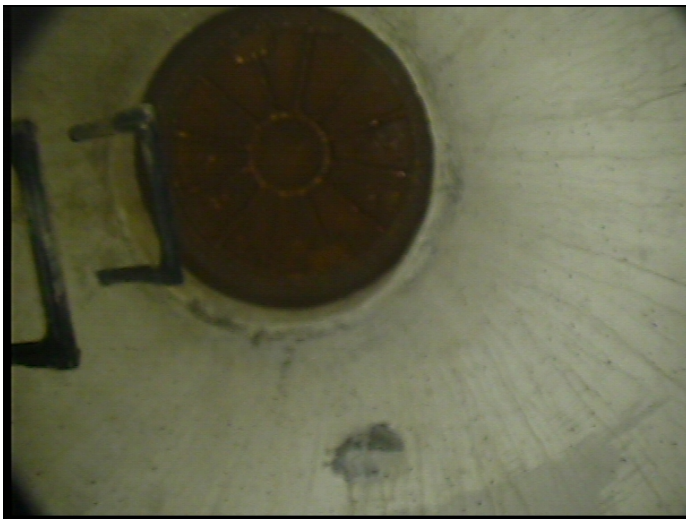
Code:	<b>AMH</b>
Description:	<b>Manhole</b>
Distance (ft):	<b>98.8</b>
Structural Grade:	<b>0</b>
O&M Grade:	<b>0</b>
Clock Start/From:	
Clock To:	
1st Value:	
2nd Value:	
Value Percent:	
Continuous Index:	
Within 8" of Joint:	<b>NO</b>
Remarks:	<b>M-708-147</b>
