Profile/Photo Observation Report

Date:	09/14/2023	Weather:		Coding:	PACP 7.0
Pipe Length (ft):	97.6	Owner:	City of Hobart	Pre Clean:	Light Cleaning
P.O.#:	YES502259	Surveyor:	S. Bucklin	PSR:	P-708-148-147
Customer:	City of Hobart	Clean Date:	09/07/2023	Shape:	C

Street:	South Lake Street	Flow Control:	Not Controlled
City:	Hobart, IN	Year Renewed:	
Location:	Easement/Right of Way	Tape/Media #:	
Purpose:	Routine Assessment	Dia/Height:	8"
Use:	Sanitary Sewage Pipe	Material:	PVC
Drain Area:		Lining:	None
Category:	NA		
Comment:			
Location Details:		Direction of Survey:	Downstream
US MH:	M-708-147	DS MH:	M-708-148
		Total Length Surveyed (ft):	97.6

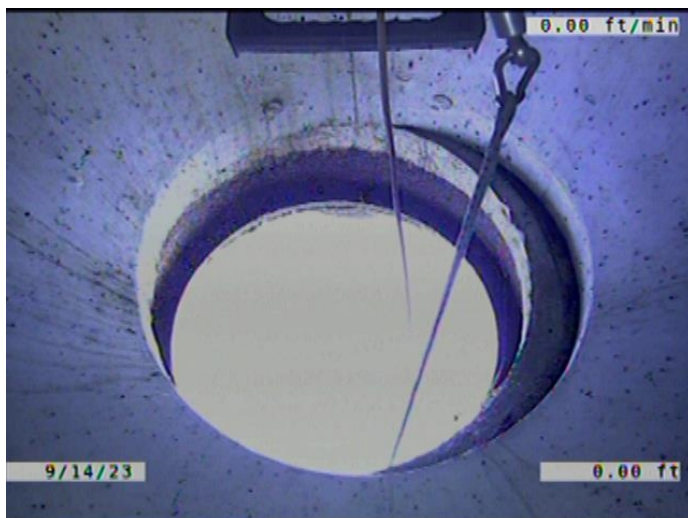
Code: **AMH**
 Description: **Manhole**

Distance (ft): **.0**
 Structural Grade: **0**
 O&M Grade: **0**
 Clock Start/From:
 Clock To:
 1st Value:
 2nd Value:
 Value Percent:
 Continuous Index:
 Within 8" of Joint: **NO**
 Remarks: **M-708-147**

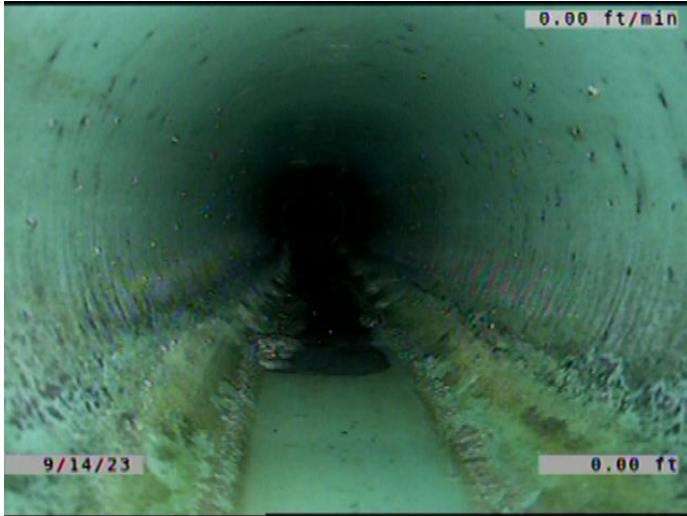
Code:	MWL
Description:	Miscellaneous Water Level
Distance (ft):	.0
Structural Grade:	0
O&M Grade:	0
Clock Start/From:	
Clock To:	
1st Value:	
2nd Value:	
Value Percent:	5.000
Continuous Index:	
Within 8" of Joint:	NO
Remarks:

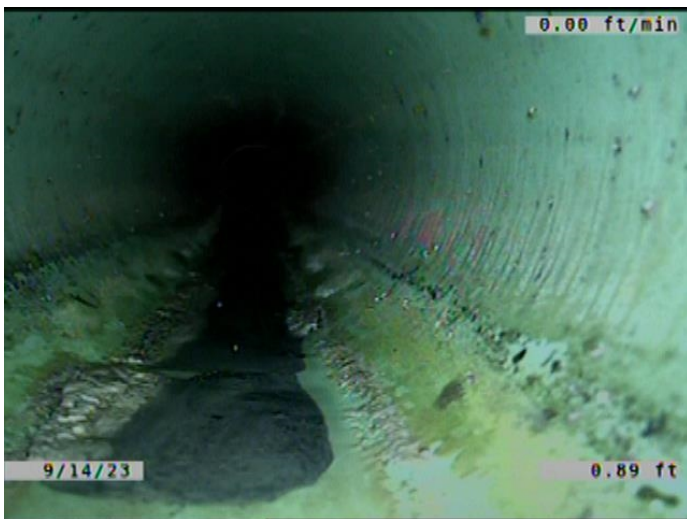
Code:	DSF
Description:	Deposits Settled Fine
Distance (ft):	.9
Structural Grade:	0
O&M Grade:	2
Clock Start/From:	5
Clock To:	7
1st Value:	
2nd Value:	
Value Percent:	5.000
Continuous Index:	S01
Within 8" of Joint:	YES
Remarks:

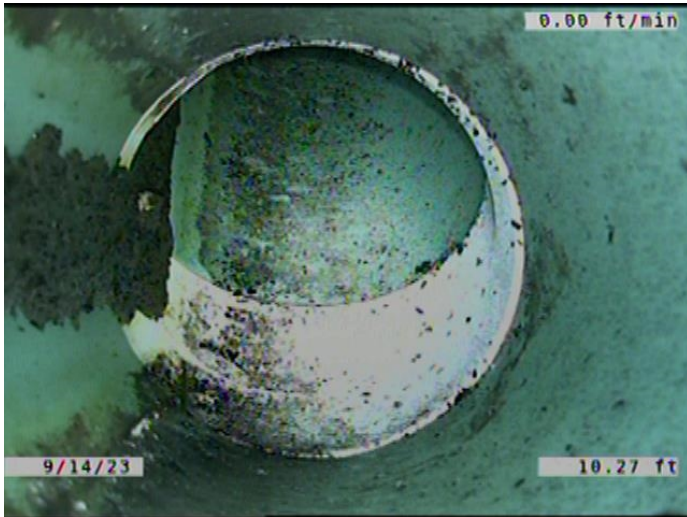
Code: **TF**
Description: **Tap Factory**

Distance (ft): **10.3**
Structural Grade: **0**
O&M Grade: **0**
Clock Start/From: **9**
Clock To:
1st Value: **6.000**
2nd Value:
Value Percent:
Continuous Index:
Within 8" of Joint: **YES**
Remarks:

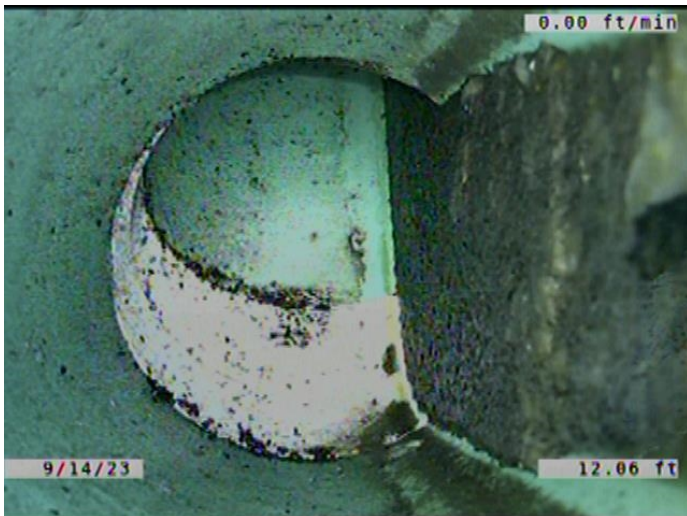
Code: **TF**
Description: **Tap Factory**

Distance (ft): **12.1**
Structural Grade: **0**
O&M Grade: **0**
Clock Start/From: **3**
Clock To:
1st Value: **6.000**
2nd Value:
Value Percent:
Continuous Index:
Within 8" of Joint: **YES**
Remarks:

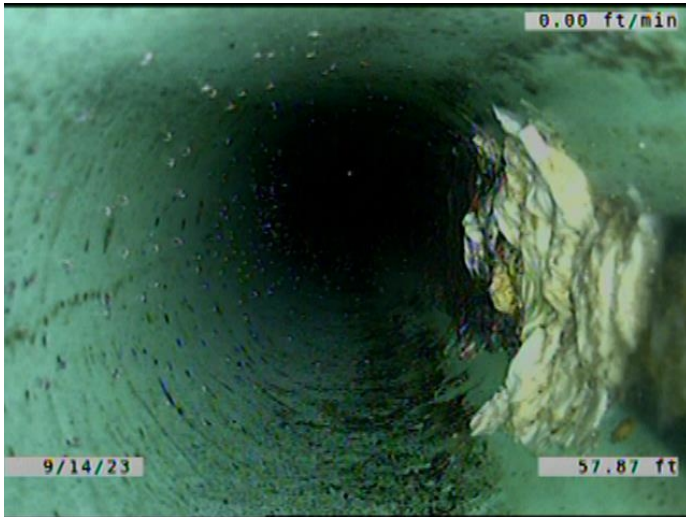
Code: **TF**
Description: **Tap Factory**

Distance (ft): **57.9**
Structural Grade: **0**
O&M Grade: **0**
Clock Start/From: **3**
Clock To:
1st Value: **6.000**
2nd Value:
Value Percent:
Continuous Index:
Within 8" of Joint: **YES**
Remarks:

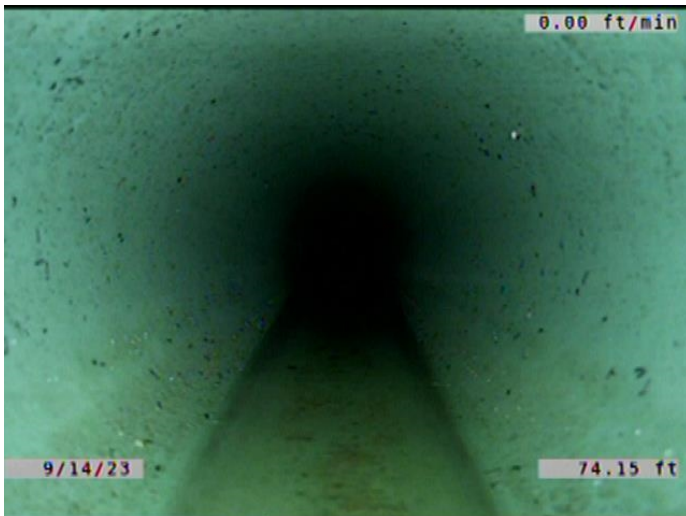
Code: **MWLS**
Description: **Miscellaneous Water Level Sag**

Distance (ft): **74.1**
Structural Grade: **2**
O&M Grade: **0**
Clock Start/From:
Clock To:
1st Value:
2nd Value:
Value Percent: **10.000**
Continuous Index: **S02**
Within 8" of Joint: **NO**
Remarks:

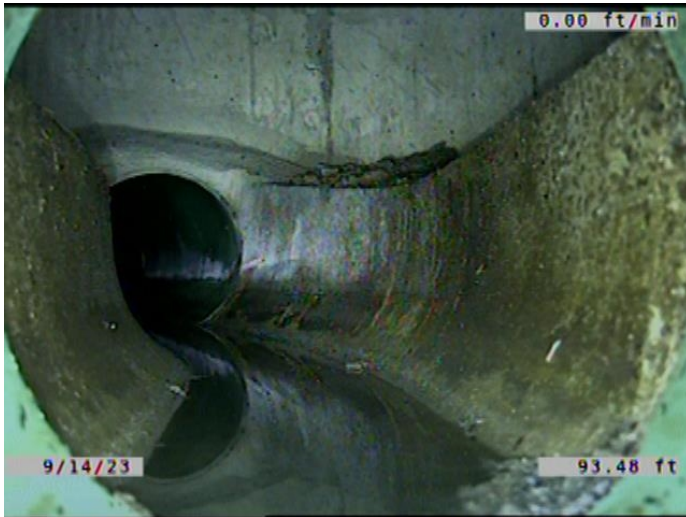
Code: **MWLS**
Description: **Miscellaneous Water Level Sag**

Distance (ft): **93.5**
Structural Grade: **2**
O&M Grade: **0**
Clock Start/From:
Clock To:
1st Value:
2nd Value:
Value Percent: **10.000**
Continuous Index: **F02**
Within 8" of Joint: **NO**
Remarks:

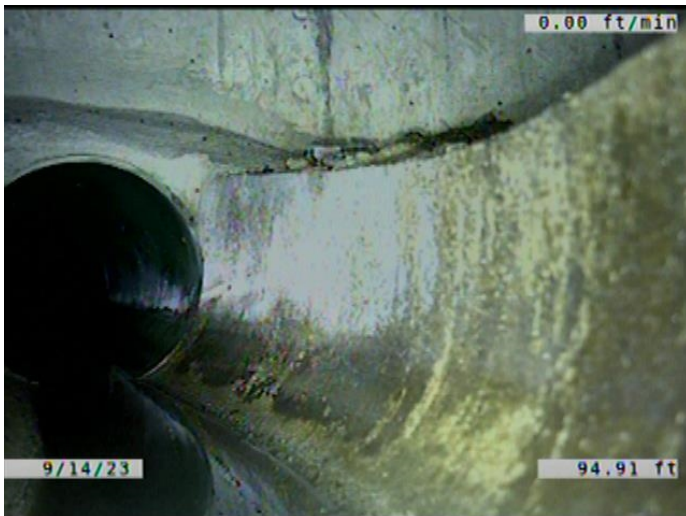
Code: **DSF**
Description: **Deposits Settled Fine**

Distance (ft): **94.9**
Structural Grade: **0**
O&M Grade: **2**
Clock Start/From: **5**
Clock To: **7**
1st Value:
2nd Value:
Value Percent: **5.000**
Continuous Index: **F01**
Within 8" of Joint: **YES**
Remarks:

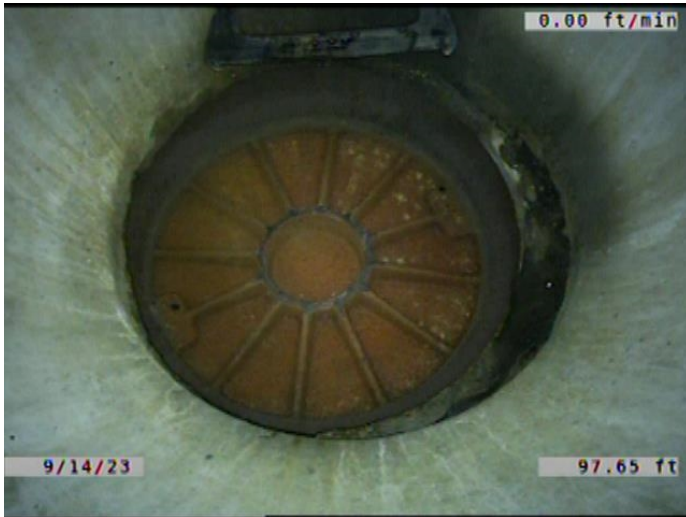
Code:	AMH
Description:	Manhole
Distance (ft):	97.6
Structural Grade:	0
O&M Grade:	0
Clock Start/From:	
Clock To:	
1st Value:	
2nd Value:	
Value Percent:	
Continuous Index:	
Within 8" of Joint:	NO
Remarks:	M-708-148
