Profile/Photo Observation Report

Street:	LAKE ST & CORAL CV	Flow Control:	Not Controlled
City:	Hobart, IN	Year Renewed:	
Location:	Sidewalk	Tape/Media #:	
Purpose:	Maintenance Related	Dia/Height:	12"
Use:	Sanitary	Material:	PVC
Drain Area:	NA	Lining:	Cured in Place
Category:	NA		
Comment:

Location Details:		Direction of Survey:	Downstream
US MH:	M-708-150	DS MH:	M-708-146
		Total Length Surveyed (ft):	143.6

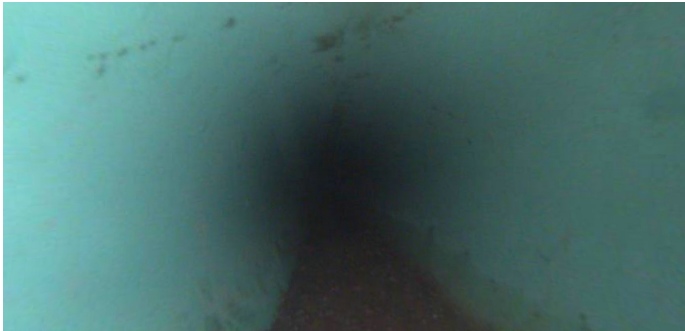
Code:	MWL
Description:	Water Level

Distance (ft):	.0
Structural Grade:	0
O&M Grade:	0
Clock Start/From:	
Clock To:	
1st Value:	
2nd Value:	
Value Percent:	0.000
Continuous Index:	
Within 8" of Joint:	NO
Remarks:

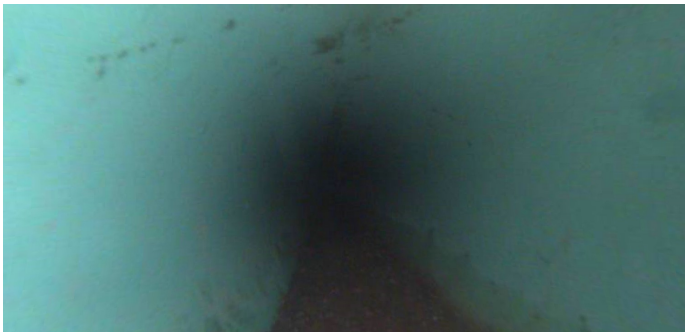
Code:	DSF
Description:	Deposits Settled Fine

Distance (ft):	.0
Structural Grade:	0
O&M Grade:	2
Clock Start/From:	6
Clock To:	
1st Value:	
2nd Value:	
Value Percent:	5.000
Continuous Index:	S01
Within 8" of Joint:	NO
Remarks:

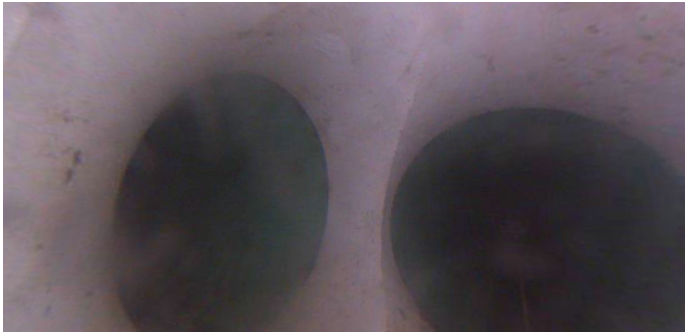
Code: **TF**
Description: **Tap Factory**

Distance (ft): **8.8**
Structural Grade: **0**
O&M Grade: **0**
Clock Start/From: **3**
Clock To:
1st Value: **4.000**
2nd Value:
Value Percent:
Continuous Index:
Within 8" of Joint:
Remarks:

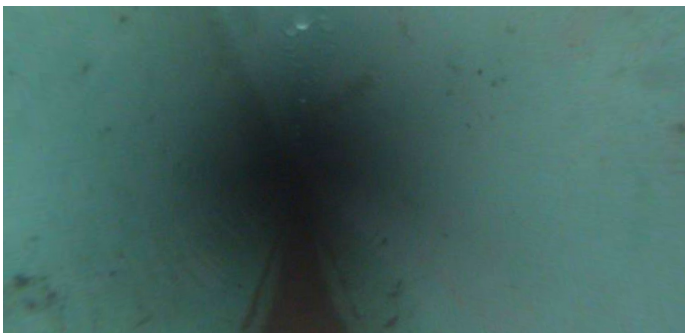
Code: **DSF**
Description: **Deposits Settled Fine**

Distance (ft): **8.8**
Structural Grade: **0**
O&M Grade: **2**
Clock Start/From: **6**
Clock To:
1st Value:
2nd Value:
Value Percent: **5.000**
Continuous Index: **F01**
Within 8" of Joint: **NO**
Remarks:

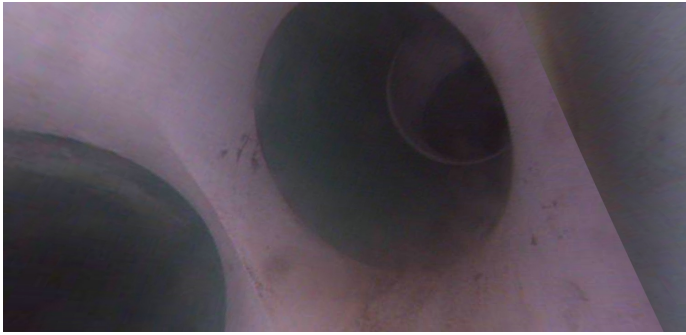
Code: **TF**
Description: **Tap Factory**

Distance (ft): **43.0**
Structural Grade: **0**
O&M Grade: **0**
Clock Start/From: **10**
Clock To:
1st Value: **4.000**
2nd Value:
Value Percent:
Continuous Index:
Within 8" of Joint:
Remarks:
