Profile/Photo Observation Report

Street:	GRAND ISLE CT	Flow Control:	Not Controlled
City:	Hobart, IN	Year Renewed:	
Location:	Sidewalk	Tape/Media #:	
Purpose:	Maintenance Related	Dia/Height:	8"
Use:	Sanitary	Material:	PVC
Drain Area:	NA	Lining:	Cured in Place
Category:	NA		
Comment:	Flow direction wrong.

Location Details:		Direction of Survey:	Downstream
US MH:	M-708-151	DS MH:	M-708-152
		Total Length Surveyed (ft):	264.2

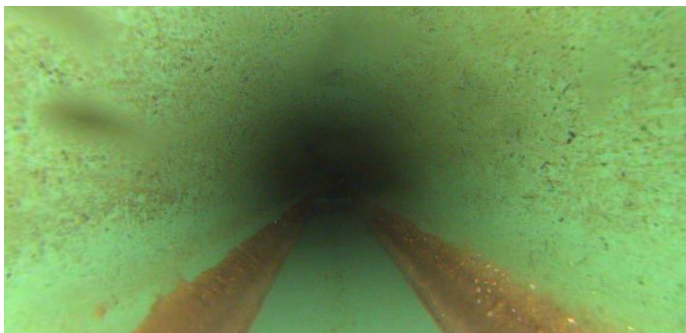
Code: **AMH**
Description: **Manhole**

Distance (ft): **.0**
Structural Grade: **0**
O&M Grade: **0**
Clock Start/From:
Clock To:
1st Value:
2nd Value:
Value Percent:
Continuous Index:
Within 8" of Joint: **NO**
Remarks: **M-708-151**

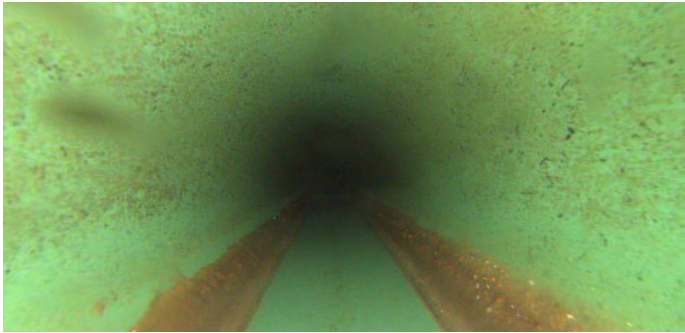
Code:	MWL
Description:	Water Level

Distance (ft):	.0
Structural Grade:	0
O&M Grade:	0
Clock Start/From:	
Clock To:	
1st Value:	
2nd Value:	
Value Percent:	5.000
Continuous Index:	
Within 8" of Joint:	NO
Remarks:

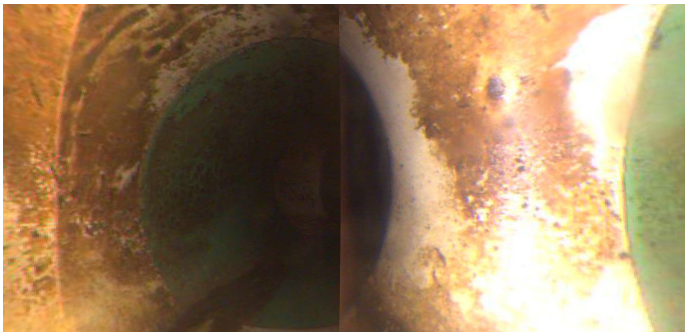
Code:	TFA
Description:	Tap Factory Active

Distance (ft):	10.5
Structural Grade:	0
O&M Grade:	0
Clock Start/From:	3
Clock To:	
1st Value:	4.000
2nd Value:	
Value Percent:	
Continuous Index:	
Within 8" of Joint:	
Remarks:

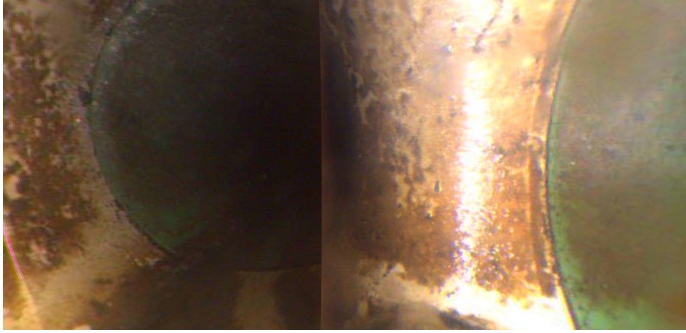
Code: **TF**
Description: **Tap Factory**

Distance (ft): **57.8**
Structural Grade: **0**
O&M Grade: **0**
Clock Start/From: **3**
Clock To:
1st Value: **4.000**
2nd Value:
Value Percent:
Continuous Index:
Within 8" of Joint:
Remarks:

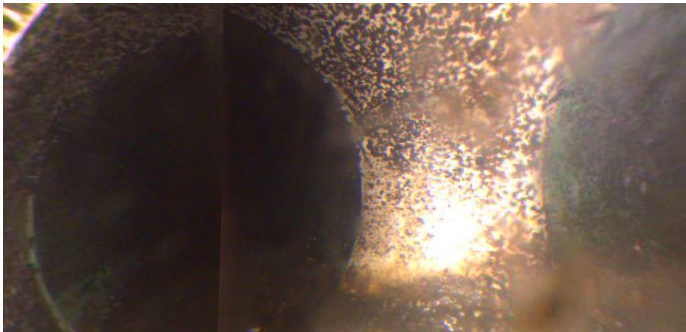
Code: **TFA**
Description: **Tap Factory Active**

Distance (ft): **165.6**
Structural Grade: **0**
O&M Grade: **0**
Clock Start/From: **3**
Clock To:
1st Value: **4.000**
2nd Value:
Value Percent:
Continuous Index:
Within 8" of Joint:
Remarks:

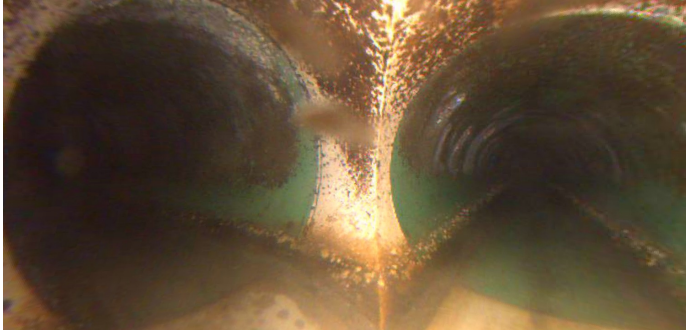
Code: **TFA**
Description: **Tap Factory Active**

Distance (ft): **180.8**
Structural Grade: **0**
O&M Grade: **0**
Clock Start/From: **9**
Clock To:
1st Value: **4.000**
2nd Value:
Value Percent:
Continuous Index:
Within 8" of Joint:
Remarks:

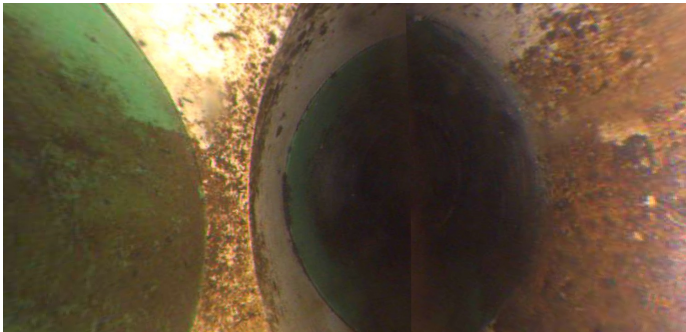
Code: **TF**
Description: **Tap Factory**

Distance (ft): **244.4**
Structural Grade: **0**
O&M Grade: **0**
Clock Start/From: **3**
Clock To:
1st Value: **4.000**
2nd Value:
Value Percent:
Continuous Index:
Within 8" of Joint:
Remarks:

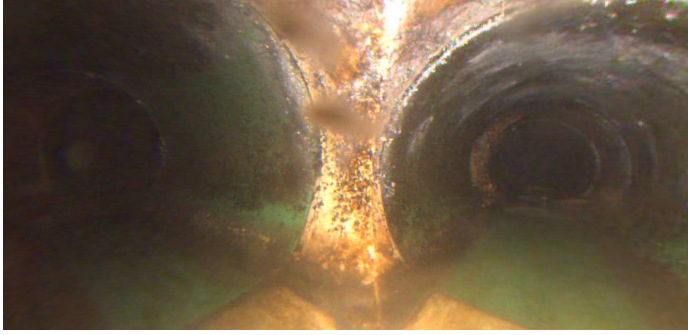
Code: **TFA**
Description: **Tap Factory Active**

Distance (ft): **246.1**
Structural Grade: **0**
O&M Grade: **0**
Clock Start/From: **9**
Clock To:
1st Value: **4.000**
2nd Value:
Value Percent:
Continuous Index:
Within 8" of Joint:
Remarks:

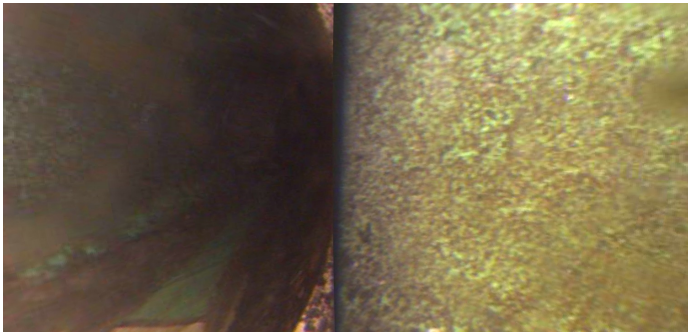
Code: **TFA**
Description: **Tap Factory Active**

Distance (ft): **249.0**
Structural Grade: **0**
O&M Grade: **0**
Clock Start/From: **9**
Clock To:
1st Value: **4.000**
2nd Value:
Value Percent:
Continuous Index:
Within 8" of Joint:
Remarks:

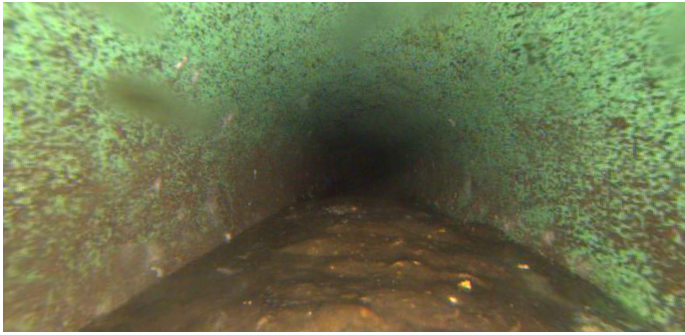
Code: **MWL**
Description: **Water Level**

Distance (ft): **256.6**
Structural Grade: **0**
O&M Grade: **0**
Clock Start/From:
Clock To:
1st Value:
2nd Value:
Value Percent: **30.000**
Continuous Index:
Within 8" of Joint: **NO**
Remarks:

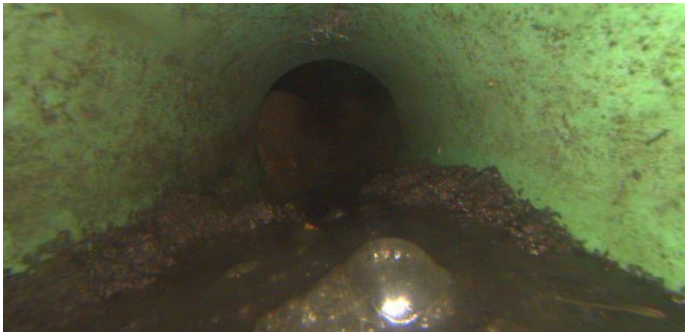
Code: **DSF**
Description: **Deposits Settled Fine**

Distance (ft): **261.4**
Structural Grade: **0**
O&M Grade: **3**
Clock Start/From: **4**
Clock To: **8**
1st Value:
2nd Value:
Value Percent: **20.000**
Continuous Index:
Within 8" of Joint: **NO**
Remarks:

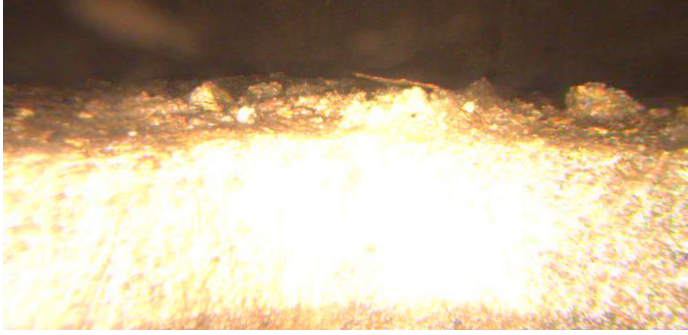
Code:	AMH
Description:	Manhole
Distance (ft):	264.2
Structural Grade:	0
O&M Grade:	0
Clock Start/From:	
Clock To:	
1st Value:	
2nd Value:	
Value Percent:	
Continuous Index:	
Within 8" of Joint:	NO
Remarks:	M-708-152
