Profile/Photo Observation Report

Date:	04/03/2018	Weather:		Coding:	PACP 6.0
Pipe Length (ft):	69.4	Owner:	NA	Pre Clean:	Not Known
P.O.#:		Surveyor:	Jen Costello	PSR:	P-708-161-160
Customer:		Clean Date:	01/01/1900	Shape:	C

Street:	HIDDEN OAK DR & 16TH ST	Flow Control:	Not Controlled
City:	Hobart, IN	Year Renewed:	
Location:	Sidewalk	Tape/Media #:	
Purpose:	Maintenance Related	Dia/Height:	8"
Use:	Sanitary	Material:	PVC
Drain Area:	NA	Lining:	Cured in Place
Category:	NA		
Comment:	Flow direction wrong.

Location Details:		Direction of Survey:	Upstream
US MH:	M-708-160	DS MH:	M-708-161
		Total Length Surveyed (ft):	94.6

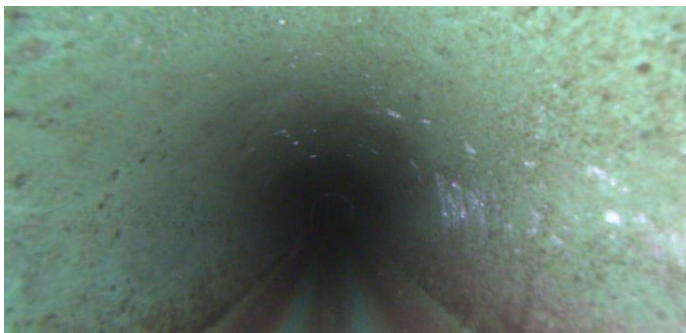
Code: **AMH**
Description: **Manhole**

Distance (ft): **.0**
Structural Grade: **0**
O&M Grade: **0**
Clock Start/From:
Clock To:
1st Value:
2nd Value:
Value Percent:
Continuous Index:
Within 8" of Joint: **NO**
Remarks: **M-708-161**

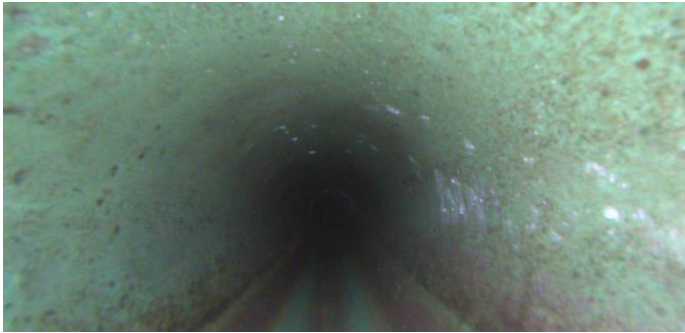
Code:	MWL
Description:	Water Level

Distance (ft):	.0
Structural Grade:	0
O&M Grade:	0
Clock Start/From:	
Clock To:	
1st Value:	
2nd Value:	
Value Percent:	5.000
Continuous Index:	
Within 8" of Joint:	NO
Remarks:

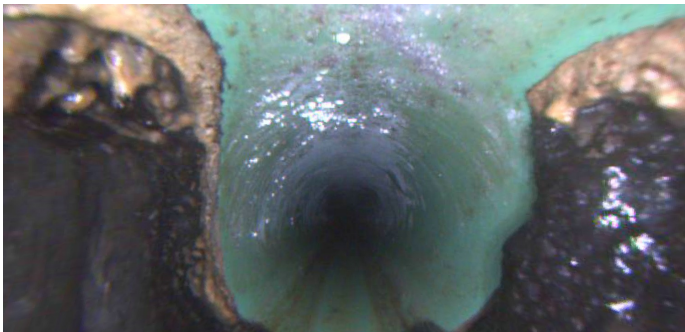
Code:	TBD
Description:	Tap Break-in Defective

Distance (ft):	34.3
Structural Grade:	0
O&M Grade:	3
Clock Start/From:	9
Clock To:	
1st Value:	4.000
2nd Value:	
Value Percent:	
Continuous Index:	
Within 8" of Joint:	
Remarks:	DAE

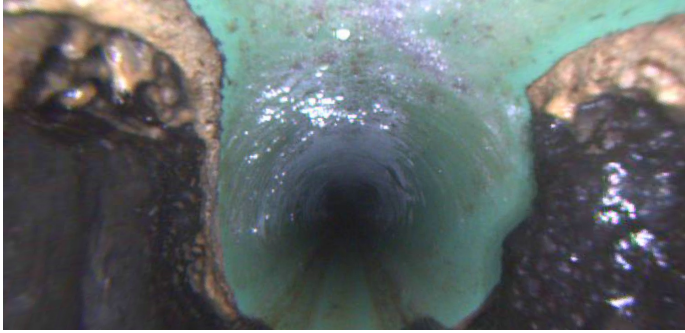
Code: **DAE**
Description: **Deposits Attached Encrustation**

Distance (ft): **34.3**
Structural Grade: **0**
O&M Grade: **2**
Clock Start/From: **7**
Clock To: **11**
1st Value:
2nd Value:
Value Percent: **5.000**
Continuous Index:
Within 8" of Joint: **NO**
Remarks:

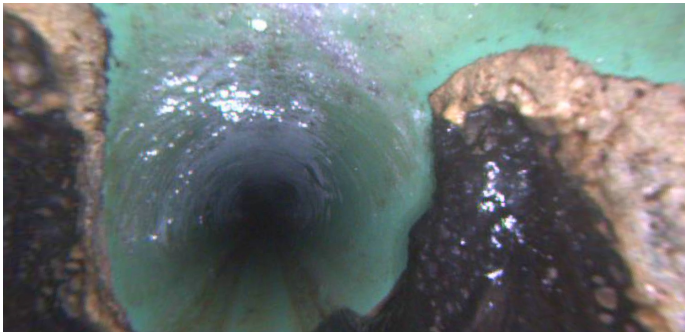
Code: **DAE**
Description: **Deposits Attached Encrustation**

Distance (ft): **34.3**
Structural Grade: **0**
O&M Grade: **2**
Clock Start/From: **2**
Clock To: **4**
1st Value:
2nd Value:
Value Percent: **5.000**
Continuous Index:
Within 8" of Joint: **NO**
Remarks:

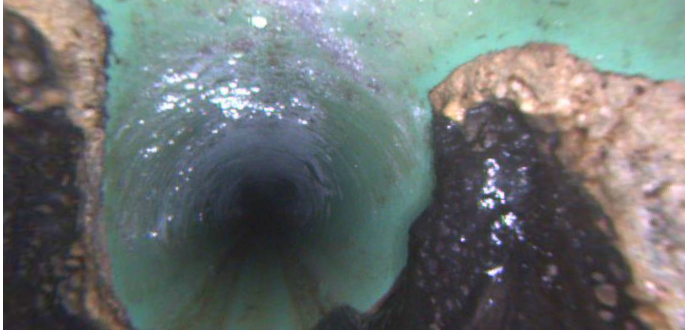
Code: **TBD**
Description: **Tap Break-in Defective**

Distance (ft): **34.3**
Structural Grade: **0**
O&M Grade: **3**
Clock Start/From: **3**
Clock To:
1st Value: **4.000**
2nd Value:
Value Percent:
Continuous Index:
Within 8" of Joint:
Remarks: **DAE**

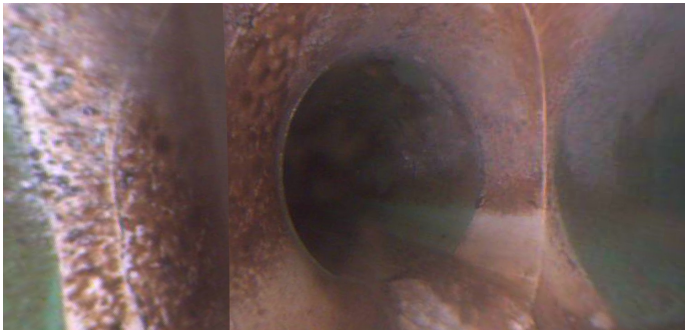
Code: **TFA**
Description: **Tap Factory Active**

Distance (ft): **74.5**
Structural Grade: **0**
O&M Grade: **0**
Clock Start/From: **3**
Clock To:
1st Value: **4.000**
2nd Value:
Value Percent:
Continuous Index:
Within 8" of Joint:
Remarks:

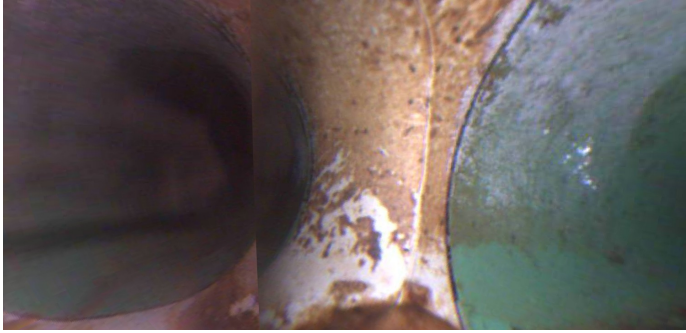
Code: **TF**
Description: **Tap Factory**

Distance (ft): **76.3**
Structural Grade: **0**
O&M Grade: **0**
Clock Start/From: **9**
Clock To:
1st Value: **4.000**
2nd Value:
Value Percent:
Continuous Index:
Within 8" of Joint:
Remarks:

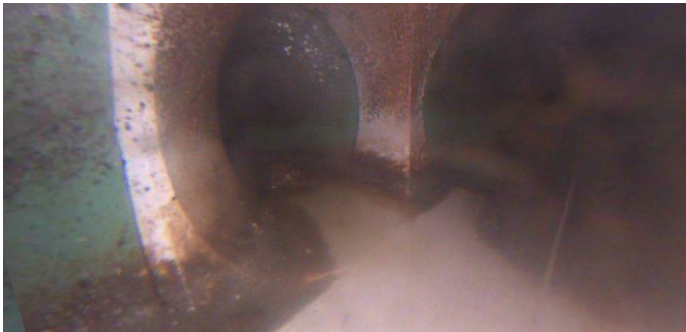
Code: **TFA**
Description: **Tap Factory Active**

Distance (ft): **89.9**
Structural Grade: **0**
O&M Grade: **0**
Clock Start/From: **3**
Clock To:
1st Value: **4.000**
2nd Value:
Value Percent:
Continuous Index:
Within 8" of Joint:
Remarks:

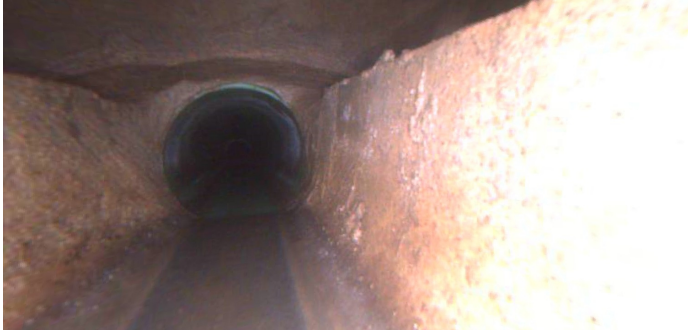
Code:	AMH
Description:	Manhole
Distance (ft):	94.6
Structural Grade:	0
O&M Grade:	0
Clock Start/From:	
Clock To:	
1st Value:	
2nd Value:	
Value Percent:	
Continuous Index:	
Within 8" of Joint:	NO
Remarks:	M-708-160
