Profile/Photo Observation Report

Date:	04/03/2018	Weather:		Coding:	PACP 6.0
Pipe Length (ft):	69.4	Owner:	NA	Pre Clean:	Not Known
P.O.#:		Surveyor:	Jen Costello	PSR:	P-708-161-160
Customer:		Clean Date:	01/01/1900	Shape:	C

Street:	State	Flow Control:	Not Controlled
City:	Hobart, IN	Year Renewed:	
Location:	Sidewalk	Tape/Media #:	
Purpose:	Maintenance Related	Dia/Height:	8"
Use:	Sanitary	Material:	PVC
Drain Area:	NA	Lining:	Cured in Place
Category:	NA		
Comment:	Flow direction wrong.

Location Details:		Direction of Survey:	Upstream
US MH:	M-708-160	DS MH:	M-708-161
		Total Length Surveyed (ft):	94.6

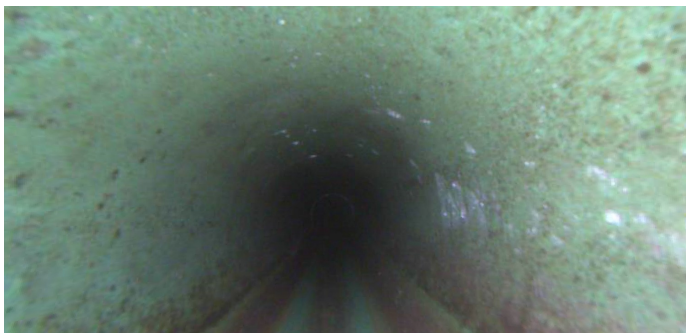
Code: **AMH**
Description: **Manhole**

Distance (ft): **.0**
Structural Grade: **0**
O&M Grade: **0**
Clock Start/From:
Clock To:
1st Value:
2nd Value:
Value Percent:
Continuous Index:
Within 8" of Joint: **NO**
Remarks: **M-708-161**

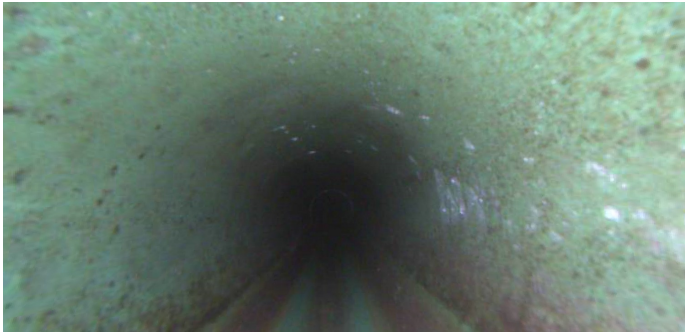
Code:	MWL
Description:	Water Level

Distance (ft):	.0
Structural Grade:	0
O&M Grade:	0
Clock Start/From:	
Clock To:	
1st Value:	
2nd Value:	
Value Percent:	5.000
Continuous Index:	
Within 8" of Joint:	NO
Remarks:

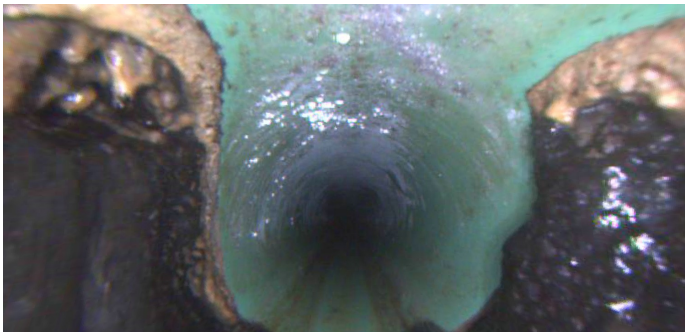
Code:	TBD
Description:	Tap Break-in Defective

Distance (ft):	34.3
Structural Grade:	0
O&M Grade:	3
Clock Start/From:	9
Clock To:	
1st Value:	4.000
2nd Value:	
Value Percent:	
Continuous Index:	
Within 8" of Joint:	
Remarks:	DAE

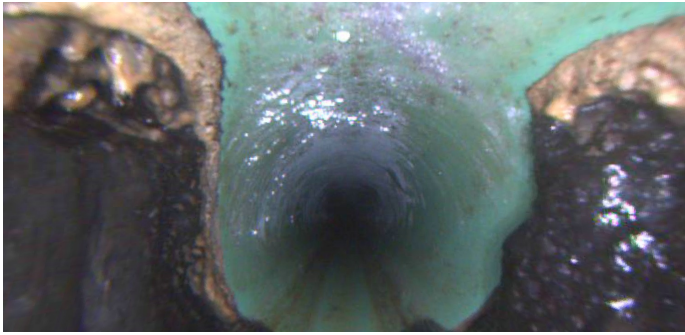
Code: **DAE**
Description: **Deposits Attached Encrustation**

Distance (ft): **34.3**
Structural Grade: **0**
O&M Grade: **2**
Clock Start/From: **7**
Clock To: **11**
1st Value:
2nd Value:
Value Percent: **5.000**
Continuous Index:
Within 8" of Joint: **NO**
Remarks:

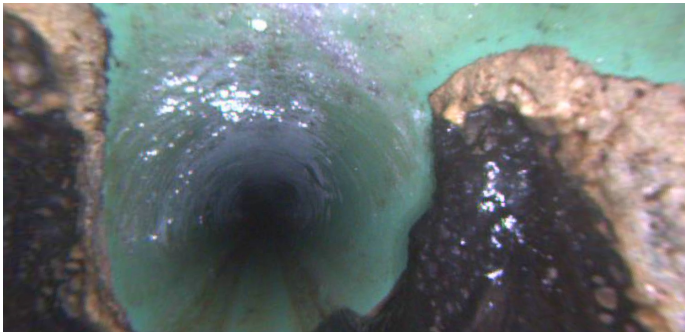
Code: **DAE**
Description: **Deposits Attached Encrustation**

Distance (ft): **34.3**
Structural Grade: **0**
O&M Grade: **2**
Clock Start/From: **2**
Clock To: **4**
1st Value:
2nd Value:
Value Percent: **5.000**
Continuous Index:
Within 8" of Joint: **NO**
Remarks:

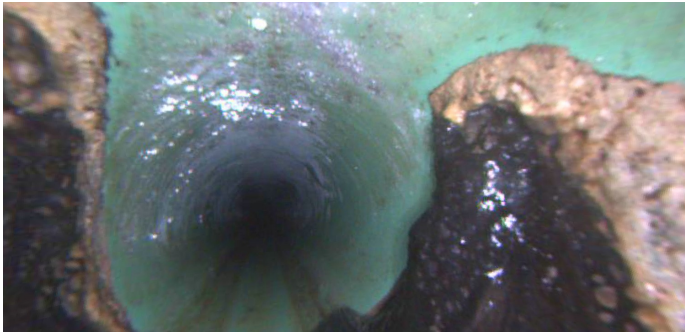
Code: **TBD**
Description: **Tap Break-in Defective**

Distance (ft): **34.3**
Structural Grade: **0**
O&M Grade: **3**
Clock Start/From: **3**
Clock To:
1st Value: **4.000**
2nd Value:
Value Percent:
Continuous Index:
Within 8" of Joint:
Remarks: **DAE**

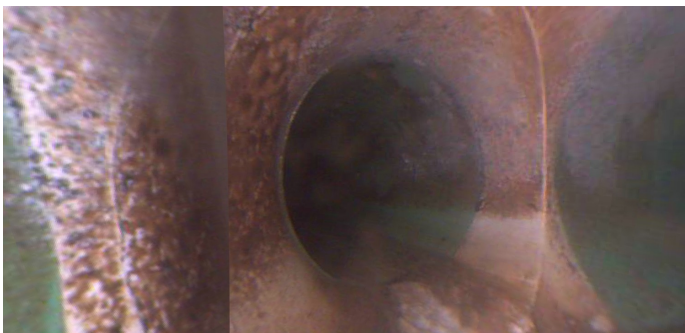
Code: **TFA**
Description: **Tap Factory Active**

Distance (ft): **74.5**
Structural Grade: **0**
O&M Grade: **0**
Clock Start/From: **3**
Clock To:
1st Value: **4.000**
2nd Value:
Value Percent:
Continuous Index:
Within 8" of Joint:
Remarks:

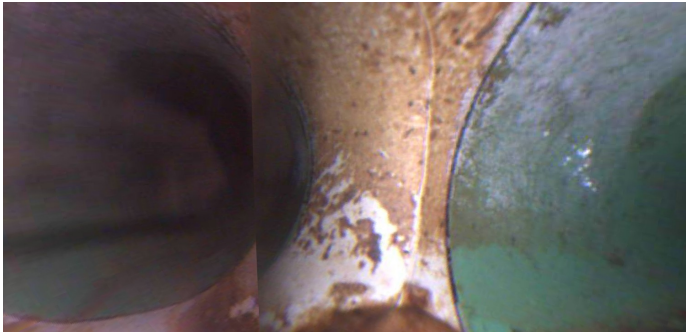
Code: **TF**
Description: **Tap Factory**

Distance (ft): **76.3**
Structural Grade: **0**
O&M Grade: **0**
Clock Start/From: **9**
Clock To:
1st Value: **4.000**
2nd Value:
Value Percent:
Continuous Index:
Within 8" of Joint:
Remarks:

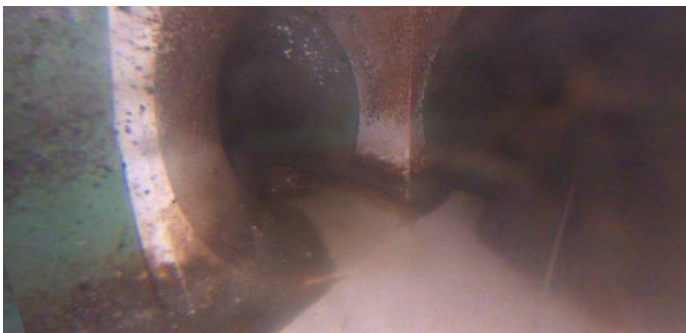
Code: **TFA**
Description: **Tap Factory Active**

Distance (ft): **89.9**
Structural Grade: **0**
O&M Grade: **0**
Clock Start/From: **3**
Clock To:
1st Value: **4.000**
2nd Value:
Value Percent:
Continuous Index:
Within 8" of Joint:
Remarks:

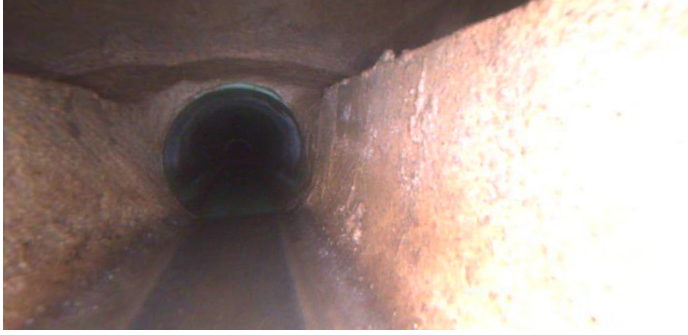
Code:	AMH
Description:	Manhole
Distance (ft):	94.6
Structural Grade:	0
O&M Grade:	0
Clock Start/From:	
Clock To:	
1st Value:	
2nd Value:	
Value Percent:	
Continuous Index:	
Within 8" of Joint:	NO
Remarks:	M-708-160
