## Profile/Photo Observation Report

Date:	<b>04/03/2018</b>	Weather:		Coding:	<b>PACP 6.0</b>
Pipe Length (ft):	<b>100.1</b>	Owner:	<b>NA</b>	Pre Clean:	<b>Not Known</b>
P.O.#:		Surveyor:	<b>Jen Costello</b>	PSR:	<b>P-708-162-161</b>
Customer:		Clean Date:	<b>01/01/1900</b>	Shape:	<b>C</b>

Street:	<b>HIDDEN OAK DR</b>	Flow Control:	<b>Not Controlled</b>
City:	<b>Hobart, IN</b>	Year Renewed:	
Location:	<b>Sidewalk</b>	Tape/Media #:	
Purpose:	<b>Maintenance Related</b>	Dia/Height:	<b>8"</b>
Use:	<b>Sanitary</b>	Material:	<b>PVC</b>
Drain Area:	<b>NA</b>	Lining:	<b>Cured in Place</b>
Category:	<b>NA</b>		
Comment:	<b>Flow direction wrong. Redeployment.</b>		
Location Details:		Direction of Survey:	<b>Downstream</b>
US MH:	<b>M-708-161</b>	DS MH:	<b>M-708-162</b>
		Total Length Surveyed (ft):	<b>96.4</b>

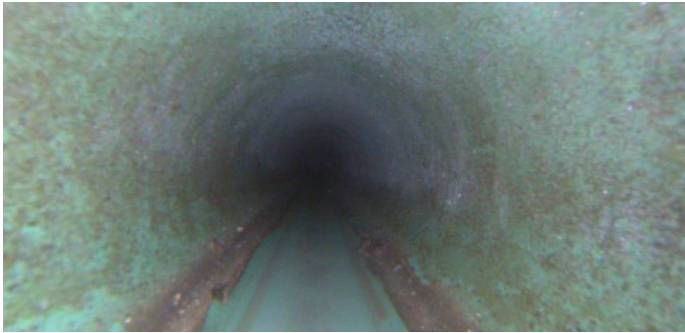
Code:	<b>MWL</b>
Description:	<b>Water Level</b>

Distance (ft):	<b>.0</b>
Structural Grade:	<b>0</b>
O&M Grade:	<b>0</b>
Clock Start/From:	
Clock To:	
1st Value:	
2nd Value:	
Value Percent:	<b>5.000</b>
Continuous Index:	
Within 8" of Joint:	<b>NO</b>
Remarks:

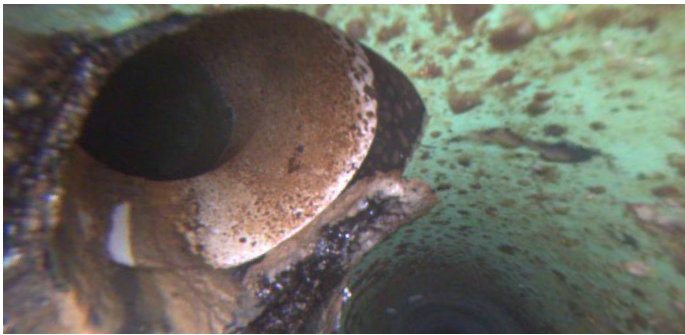
Code:	<b>TBA</b>
Description:	<b>Tap Break-in Active</b>

Distance (ft):	<b>26.3</b>
Structural Grade:	<b>0</b>
O&M Grade:	<b>0</b>
Clock Start/From:	<b>10</b>
Clock To:	
1st Value:	<b>4.000</b>
2nd Value:	
Value Percent:	
Continuous Index:	
Within 8" of Joint:	
Remarks:

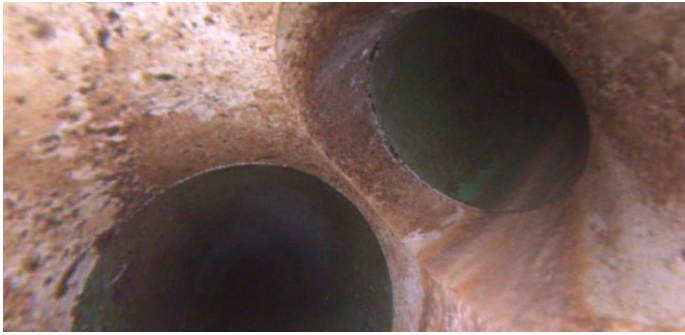
Code: **TF**  
Description: **Tap Factory**

Distance (ft): **85.8**  
Structural Grade: **0**  
O&M Grade: **0**  
Clock Start/From: **2**  
Clock To:  
1st Value: **4.000**  
2nd Value:  
Value Percent:  
Continuous Index:  
Within 8" of Joint:  
Remarks:

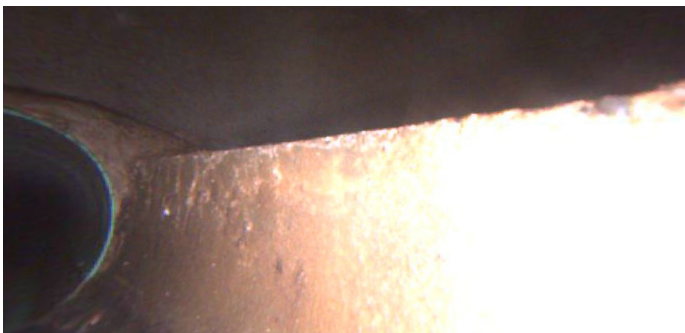
Code: **AMH**  
Description: **Manhole**

Distance (ft): **96.4**  
Structural Grade: **0**  
O&M Grade: **0**  
Clock Start/From:  
Clock To:  
1st Value:  
2nd Value:  
Value Percent:  
Continuous Index:  
Within 8" of Joint: **NO**  
Remarks: **M-708-162**
