## Profile/Photo Observation Report

Street:	<b>HIDDEN OAK DR</b>	Flow Control:	<b>Not Controlled</b>
City:	<b>Hobart, IN</b>	Year Renewed:	
Location:	<b>Sidewalk</b>	Tape/Media #:	
Purpose:	<b>Maintenance Related</b>	Dia/Height:	<b>8"</b>
Use:	<b>Sanitary</b>	Material:	<b>PVC</b>
Drain Area:	<b>NA</b>	Lining:	<b>Cured in Place</b>
Category:	<b>NA</b>		
Comment:	<b>Flow direction wrong. False OC.</b>		
Location Details:		Direction of Survey:	<b>Downstream</b>
US MH:	<b>M-708-161</b>	DS MH:	<b>M-708-162</b>
		Total Length Surveyed (ft):	<b>46.3</b>

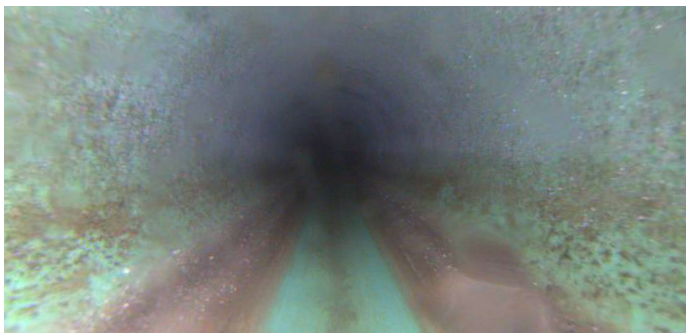
Code: **AMH**  
Description: **Manhole**

Distance (ft): **.0**  
Structural Grade: **0**  
O&M Grade: **0**  
Clock Start/From:  
Clock To:  
1st Value:  
2nd Value:  
Value Percent:  
Continuous Index:  
Within 8" of Joint: **NO**  
Remarks: **M-708-161**

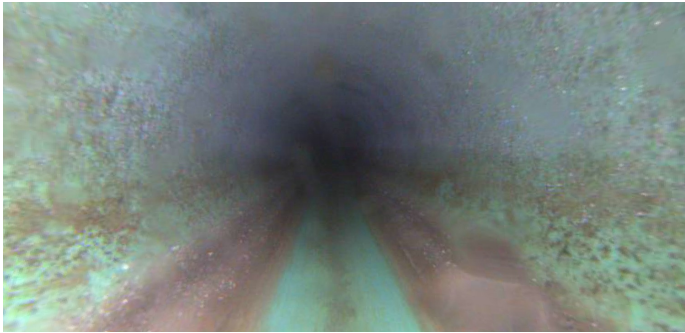
Code:	<b>MWL</b>
Description:	<b>Water Level</b>

Distance (ft):	<b>.0</b>
Structural Grade:	<b>0</b>
O&M Grade:	<b>0</b>
Clock Start/From:	
Clock To:	
1st Value:	
2nd Value:	
Value Percent:	<b>5.000</b>
Continuous Index:	
Within 8" of Joint:	<b>NO</b>
Remarks:

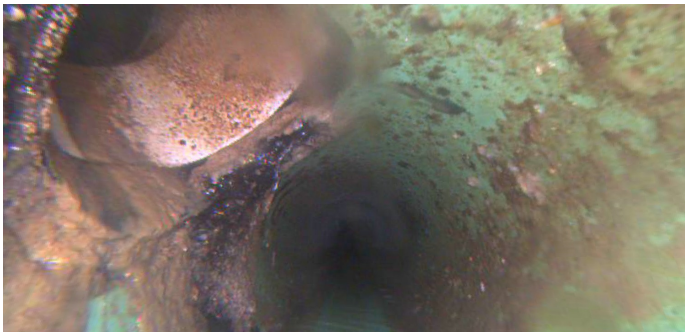
Code:	<b>TBA</b>
Description:	<b>Tap Break-in Active</b>

Distance (ft):	<b>25.1</b>
Structural Grade:	<b>0</b>
O&M Grade:	<b>0</b>
Clock Start/From:	<b>10</b>
Clock To:	
1st Value:	<b>4.000</b>
2nd Value:	
Value Percent:	
Continuous Index:	
Within 8" of Joint:	
Remarks:

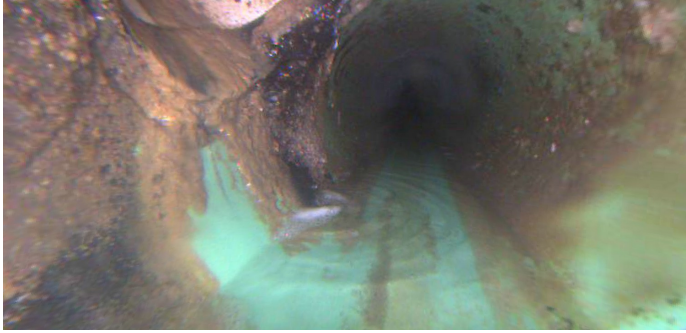
Code: **DAE**  
Description: **Deposits Attached Encrustation**

Distance (ft): **25.1**  
Structural Grade: **0**  
O&M Grade: **2**  
Clock Start/From: **8**  
Clock To: **10**  
1st Value:  
2nd Value:  
Value Percent: **5.000**  
Continuous Index:  
Within 8" of Joint: **NO**  
Remarks:

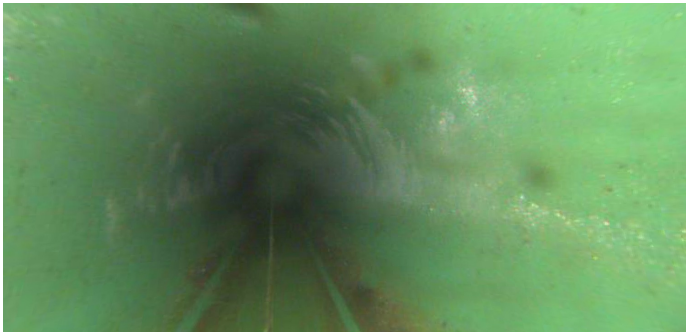
Code: **MGO**  
Description: **General Observation**

Distance (ft): **31.6**  
Structural Grade: **0**  
O&M Grade: **0**  
Clock Start/From:  
Clock To:  
1st Value:  
2nd Value:  
Value Percent:  
Continuous Index:  
Within 8" of Joint: **NO**  
Remarks: **rear camera**

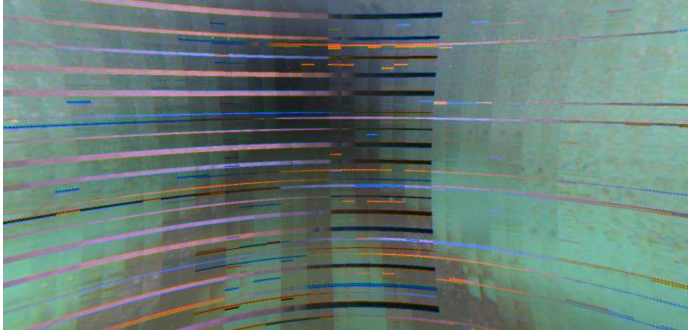
Code: **MSA**  
Description: **Abandoned Survey**

Distance (ft): **46.3**  
Structural Grade: **0**  
O&M Grade: **0**  
Clock Start/From:  
Clock To:  
1st Value:  
2nd Value:  
Value Percent:  
Continuous Index:  
Within 8" of Joint: **NO**  
Remarks: **unknown**
