## Profile/Photo Observation Report

Date:	<b>04/03/2018</b>	Weather:		Coding:	<b>PACP 6.0</b>
Pipe Length (ft):	<b>100.1</b>	Owner:	<b>NA</b>	Pre Clean:	<b>Not Known</b>
P.O.#:		Surveyor:	<b>Jen Costello</b>	PSR:	<b>P-708-162-161</b>
Customer:		Clean Date:	<b>01/01/1900</b>	Shape:	<b>C</b>

Street:	<b>State</b>	Flow Control:	<b>Not Controlled</b>
City:	<b>Hobart, IN</b>	Year Renewed:	
Location:	<b>Sidewalk</b>	Tape/Media #:	
Purpose:	<b>Maintenance Related</b>	Dia/Height:	<b>8"</b>
Use:	<b>Sanitary</b>	Material:	<b>PVC</b>
Drain Area:	<b>NA</b>	Lining:	<b>Cured in Place</b>
Category:	<b>NA</b>		
Comment:	<b>Flow direction wrong. False OC.</b>		
Location Details:		Direction of Survey:	<b>Downstream</b>
US MH:	<b>M-708-161</b>	DS MH:	<b>M-708-162</b>
		Total Length Surveyed (ft):	<b>46.3</b>

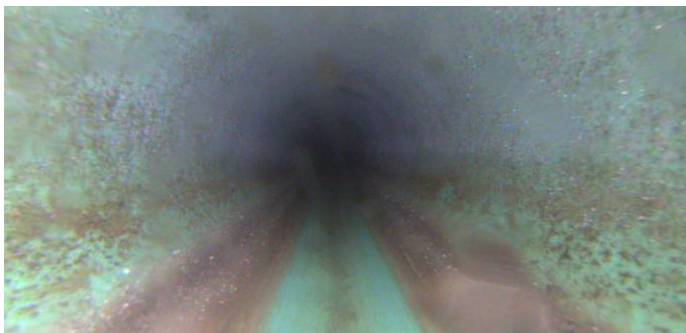
Code: **AMH**  
Description: **Manhole**

Distance (ft): **.0**  
Structural Grade: **0**  
O&M Grade: **0**  
Clock Start/From:  
Clock To:  
1st Value:  
2nd Value:  
Value Percent:  
Continuous Index:  
Within 8" of Joint: **NO**  
Remarks: **M-708-161**

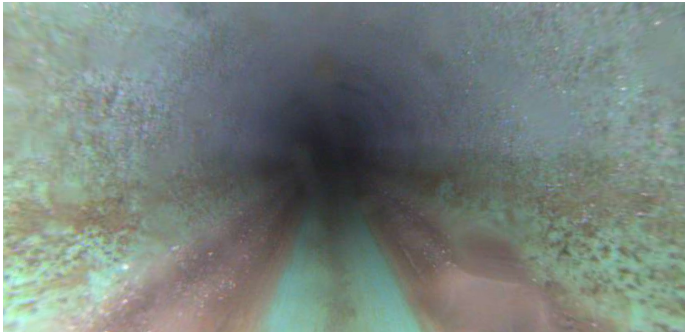
Code:	<b>MWL</b>
Description:	<b>Water Level</b>

Distance (ft):	<b>.0</b>
Structural Grade:	<b>0</b>
O&M Grade:	<b>0</b>
Clock Start/From:	
Clock To:	
1st Value:	
2nd Value:	
Value Percent:	<b>5.000</b>
Continuous Index:	
Within 8" of Joint:	<b>NO</b>
Remarks:

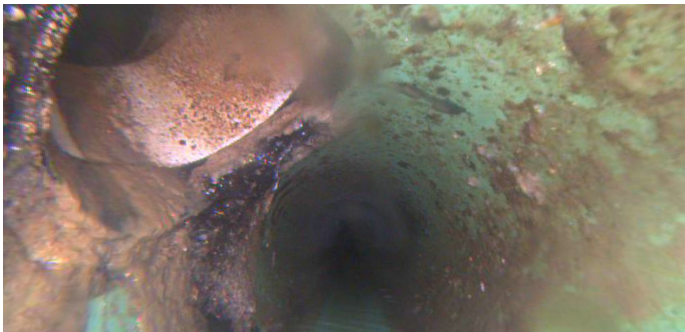
Code:	<b>TBA</b>
Description:	<b>Tap Break-in Active</b>

Distance (ft):	<b>25.1</b>
Structural Grade:	<b>0</b>
O&M Grade:	<b>0</b>
Clock Start/From:	<b>10</b>
Clock To:	
1st Value:	<b>4.000</b>
2nd Value:	
Value Percent:	
Continuous Index:	
Within 8" of Joint:	
Remarks:

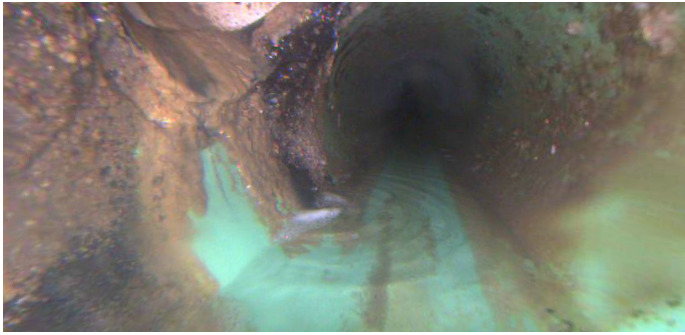
Code: **DAE**  
Description: **Deposits Attached Encrustation**

Distance (ft): **25.1**  
Structural Grade: **0**  
O&M Grade: **2**  
Clock Start/From: **8**  
Clock To: **10**  
1st Value:  
2nd Value:  
Value Percent: **5.000**  
Continuous Index:  
Within 8" of Joint: **NO**  
Remarks:

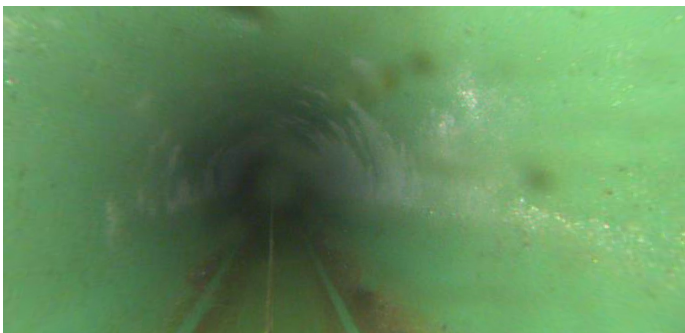
Code: **MGO**  
Description: **General Observation**

Distance (ft): **31.6**  
Structural Grade: **0**  
O&M Grade: **0**  
Clock Start/From:  
Clock To:  
1st Value:  
2nd Value:  
Value Percent:  
Continuous Index:  
Within 8" of Joint: **NO**  
Remarks: **rear camera**

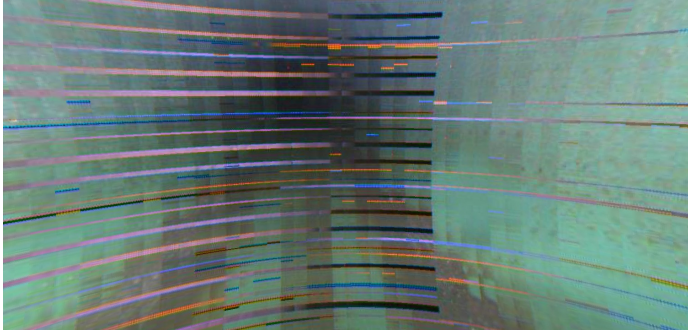
Code: **MSA**  
Description: **Abandoned Survey**

Distance (ft): **46.3**  
Structural Grade: **0**  
O&M Grade: **0**  
Clock Start/From:  
Clock To:  
1st Value:  
2nd Value:  
Value Percent:  
Continuous Index:  
Within 8" of Joint: **NO**  
Remarks: **unknown**
