## Profile/Photo Observation Report

Street:	<b>Hidden Oak Drive</b>	Flow Control:	
City:	<b>Hobart, IN</b>	Year Renewed:	
Location:	<b>Light Highway</b>	Tape/Media #:	<b>948</b>
Purpose:	<b>Routine Assessment</b>	Dia/Height:	<b>8"</b>
Use:	<b>Sanitary</b>	Material:	<b>PVC</b>
Drain Area:		Lining:	
Category:	<b>NA</b>		
Comment:

Location Details:		Direction of Survey:	<b>Upstream</b>
US MH:	<b>M-708-163</b>	DS MH:	<b>M-708-164</b>
		Total Length Surveyed (ft):	<b>269.6</b>

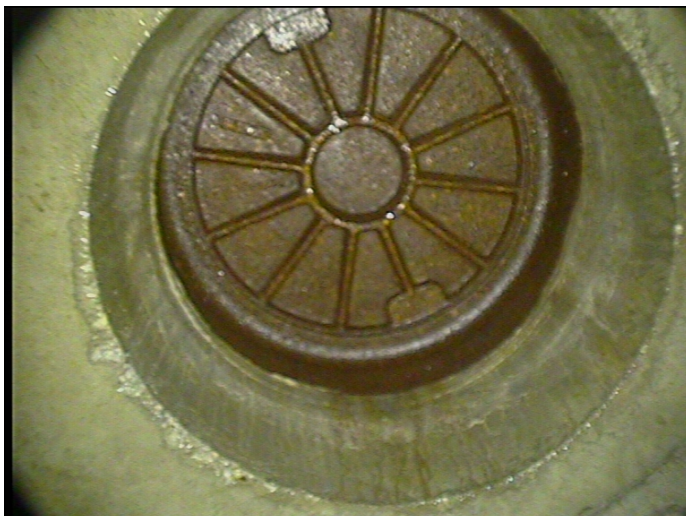
Code: **AMH**  
 Description: **Manhole**

Distance (ft): **.0**  
 Structural Grade: **0**  
 O&M Grade: **0**  
 Clock Start/From:  
 Clock To:  
 1st Value:  
 2nd Value:  
 Value Percent:  
 Continuous Index:  
 Within 8" of Joint: **NO**  
 Remarks: **M-708-164**

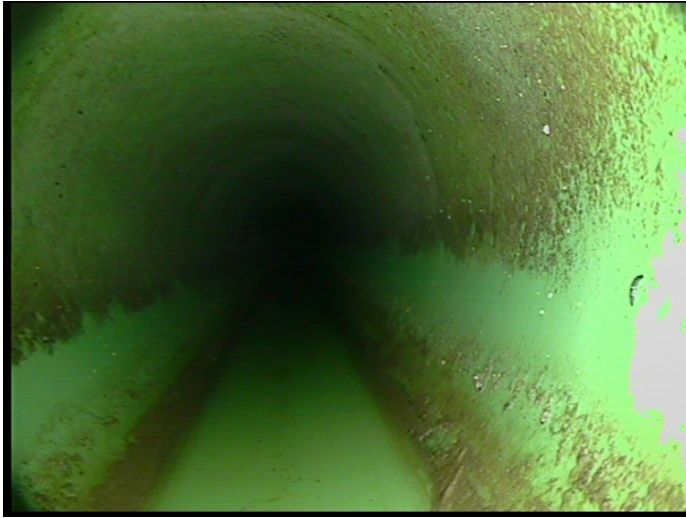
Code:	<b>MWL</b>
Description:	<b>Water Level</b>
Distance (ft):	<b>.0</b>
Structural Grade:	<b>0</b>
O&M Grade:	<b>0</b>
Clock Start/From:	
Clock To:	
1st Value:	
2nd Value:	
Value Percent:	<b>5.000</b>
Continuous Index:	
Within 8" of Joint:	<b>NO</b>
Remarks:

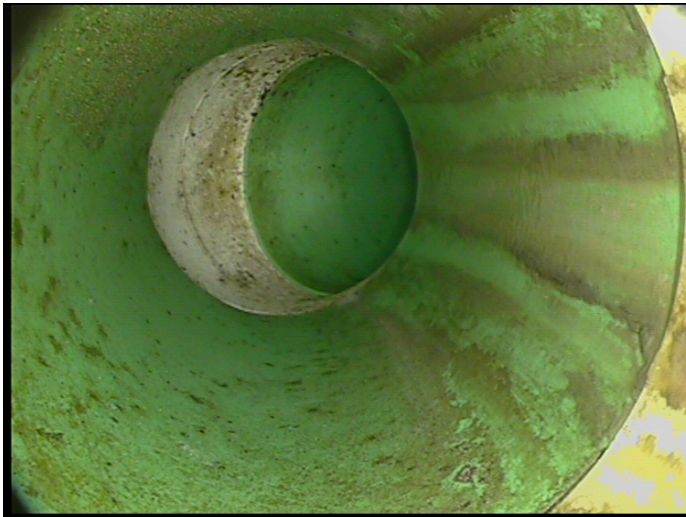
Code:	<b>TF</b>
Description:	<b>Tap Factory</b>
Distance (ft):	<b>20.1</b>
Structural Grade:	<b>0</b>
O&M Grade:	<b>0</b>
Clock Start/From:	<b>3</b>
Clock To:	
1st Value:	<b>4.000</b>
2nd Value:	
Value Percent:	
Continuous Index:	
Within 8" of Joint:	<b>NO</b>
Remarks:

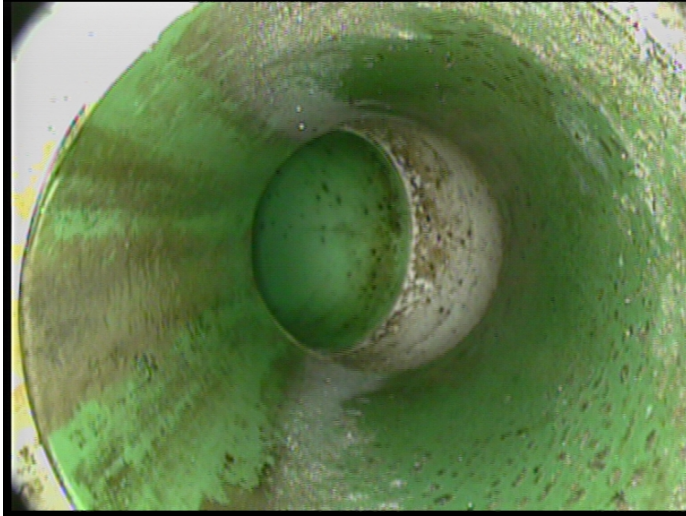
Code: **TF**  
Description: **Tap Factory**

Distance (ft): **54.2**  
Structural Grade: **0**  
O&M Grade: **0**  
Clock Start/From: **10**  
Clock To:  
1st Value: **4.000**  
2nd Value:  
Value Percent:  
Continuous Index:  
Within 8" of Joint: **NO**  
Remarks:

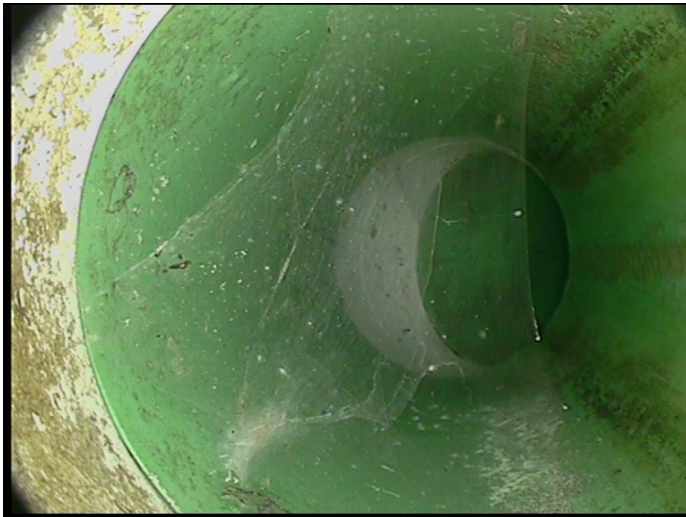
Code: **TF**  
Description: **Tap Factory**

Distance (ft): **118.5**  
Structural Grade: **0**  
O&M Grade: **0**  
Clock Start/From: **2**  
Clock To:  
1st Value: **4.000**  
2nd Value:  
Value Percent:  
Continuous Index:  
Within 8" of Joint: **NO**  
Remarks:

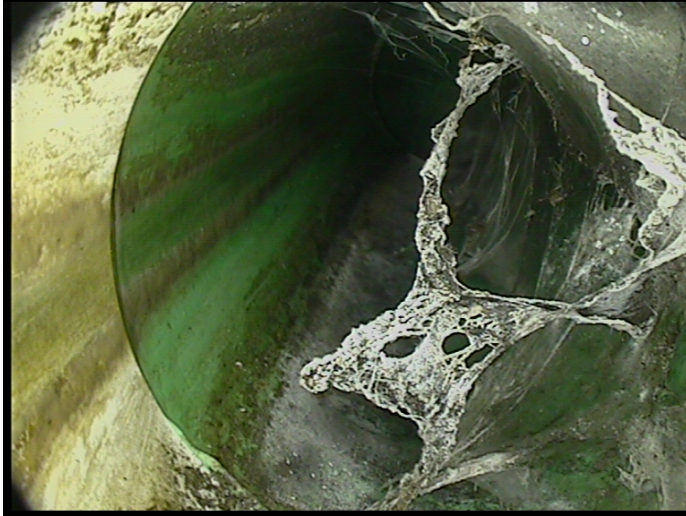
Code: **TF**  
Description: **Tap Factory**

Distance (ft): **141.0**  
Structural Grade: **0**  
O&M Grade: **0**  
Clock Start/From: **10**  
Clock To:  
1st Value: **4.000**  
2nd Value:  
Value Percent:  
Continuous Index:  
Within 8" of Joint: **NO**  
Remarks:

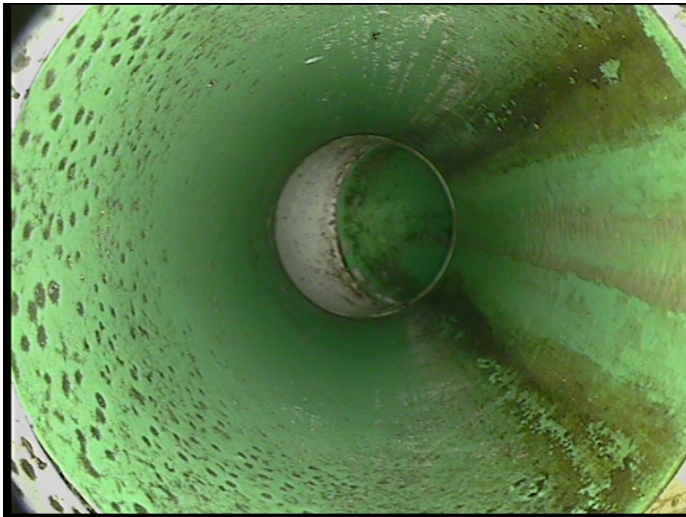
Code: **TF**  
Description: **Tap Factory**

Distance (ft): **220.7**  
Structural Grade: **0**  
O&M Grade: **0**  
Clock Start/From: **3**  
Clock To:  
1st Value: **4.000**  
2nd Value:  
Value Percent:  
Continuous Index:  
Within 8" of Joint: **NO**  
Remarks:

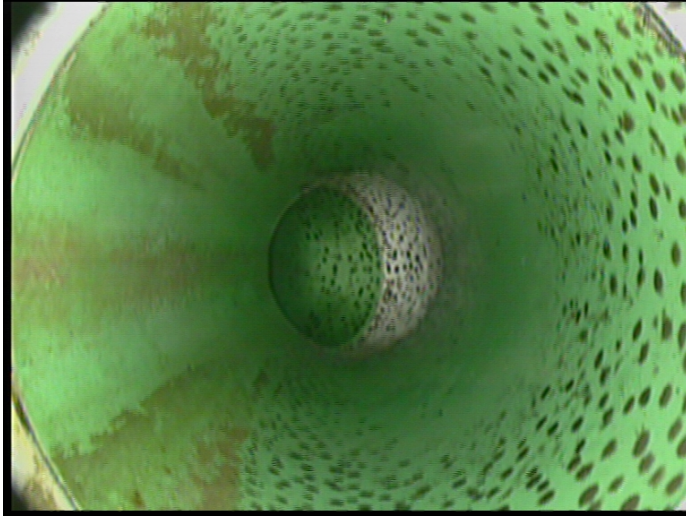
Code: **TF**  
Description: **Tap Factory**

Distance (ft): **230.4**  
Structural Grade: **0**  
O&M Grade: **0**  
Clock Start/From: **10**  
Clock To:  
1st Value: **4.000**  
2nd Value:  
Value Percent:  
Continuous Index:  
Within 8" of Joint: **NO**  
Remarks:

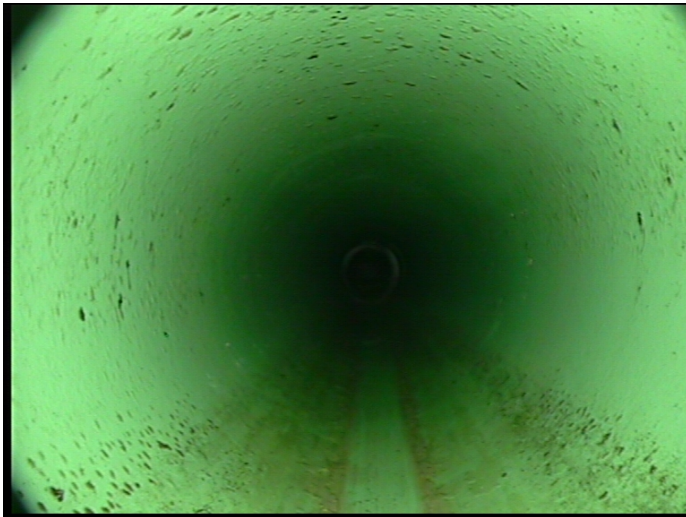
Code: **MSA**  
Description: **Abandoned Survey**

Distance (ft): **269.6**  
Structural Grade: **0**  
O&M Grade: **0**  
Clock Start/From:  
Clock To:  
1st Value:  
2nd Value:  
Value Percent:  
Continuous Index:  
Within 8" of Joint: **NO**  
Remarks: **M-708-163**
