Profile/Photo Observation Report

Date:	04/01/2018	Weather:		Coding:	PACP 6.0
Pipe Length (ft):	112.2	Owner:	NA	Pre Clean:	Not Known
P.O.#:		Surveyor:	Jen Costello	PSR:	P-708-166-165
Customer:		Clean Date:	01/01/1900	Shape:	C

Street:	Lincoln	Flow Control:	Not Controlled
City:	Hobart, IN	Year Renewed:	
Location:	Sidewalk	Tape/Media #:	
Purpose:	Maintenance Related	Dia/Height:	8"
Use:	Sanitary	Material:	PVC
Drain Area:	NA	Lining:	Cured in Place
Category:	NA		
Comment:

Location Details:		Direction of Survey:	Downstream
US MH:	M-708-165	DS MH:	M-708-166
		Total Length Surveyed (ft):	111.6

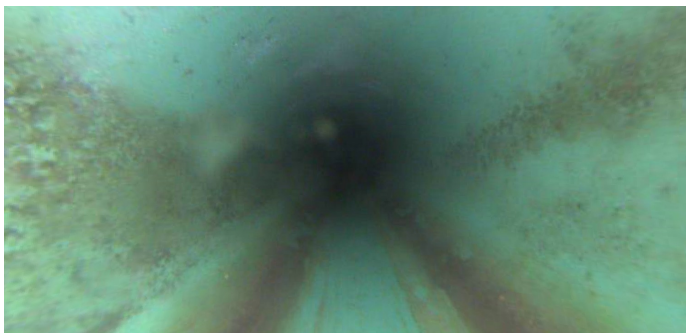
Code: **AMH**
Description: **Manhole**

Distance (ft): **.0**
Structural Grade: **0**
O&M Grade: **0**
Clock Start/From:
Clock To:
1st Value:
2nd Value:
Value Percent:
Continuous Index:
Within 8" of Joint: **NO**
Remarks: **M-708-165**

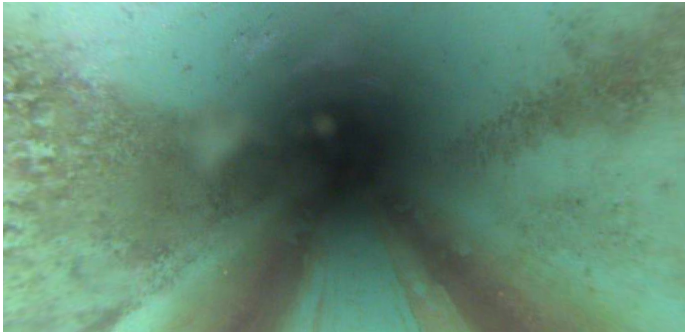
Code:	MWL
Description:	Water Level

Distance (ft):	.0
Structural Grade:	0
O&M Grade:	0
Clock Start/From:	
Clock To:	
1st Value:	
2nd Value:	
Value Percent:	5.000
Continuous Index:	
Within 8" of Joint:	NO
Remarks:

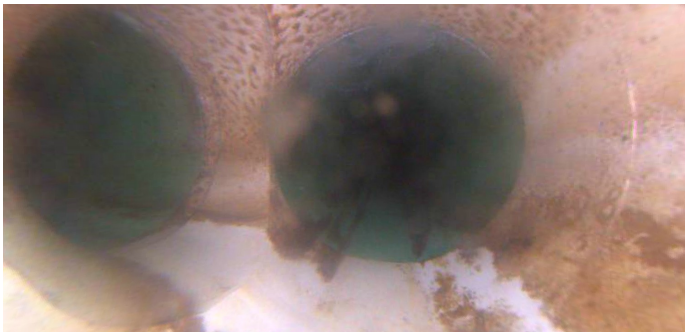
Code:	TF
Description:	Tap Factory

Distance (ft):	25.2
Structural Grade:	0
O&M Grade:	0
Clock Start/From:	9
Clock To:	
1st Value:	4.000
2nd Value:	
Value Percent:	
Continuous Index:	
Within 8" of Joint:	
Remarks:

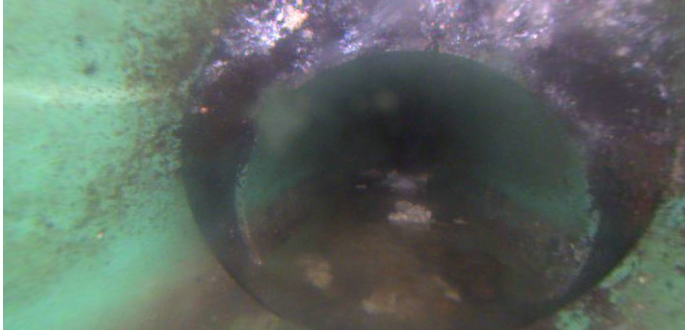
Code: **JOL**
Description: **Joint Offset Large**

Distance (ft): **31.5**
Structural Grade: **2**
O&M Grade: **0**
Clock Start/From:
Clock To:
1st Value:
2nd Value:
Value Percent:
Continuous Index:
Within 8" of Joint: **NO**
Remarks:

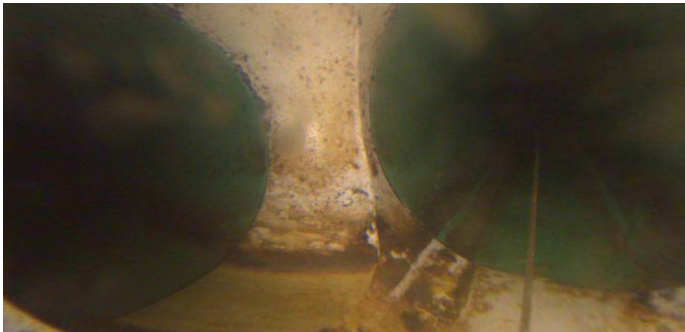
Code: **TFA**
Description: **Tap Factory Active**

Distance (ft): **67.0**
Structural Grade: **0**
O&M Grade: **0**
Clock Start/From: **3**
Clock To:
1st Value: **4.000**
2nd Value:
Value Percent:
Continuous Index:
Within 8" of Joint:
Remarks:

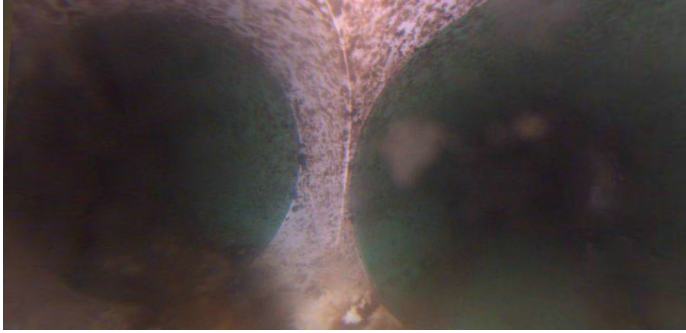
Code: **TFA**
Description: **Tap Factory Active**

Distance (ft): **104.4**
Structural Grade: **0**
O&M Grade: **0**
Clock Start/From: **9**
Clock To:
1st Value: **4.000**
2nd Value:
Value Percent:
Continuous Index:
Within 8" of Joint:
Remarks:

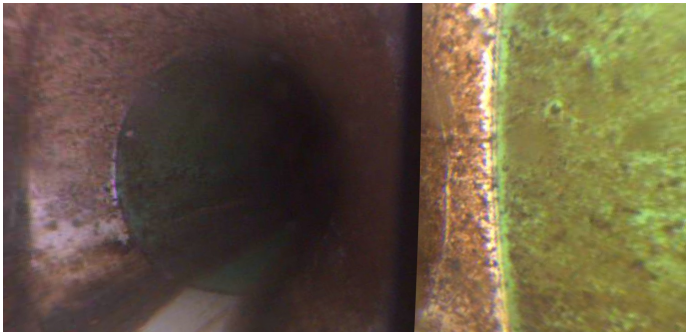
Code: **TFA**
Description: **Tap Factory Active**

Distance (ft): **106.2**
Structural Grade: **0**
O&M Grade: **0**
Clock Start/From: **3**
Clock To:
1st Value: **4.000**
2nd Value:
Value Percent:
Continuous Index:
Within 8" of Joint:
Remarks:
