Profile/Photo Observation Report

Date:	04/06/2018	Weather:		Coding:	PACP 6.0
Pipe Length (ft):	399.0	Owner:	NA	Pre Clean:	Not Known
P.O.#:		Surveyor:	Jen Costello	PSR:	P-708-019-021
Customer:		Clean Date:	01/01/1900	Shape:	C

Street:	Hobart	Flow Control:	Not Controlled
City:	Hobart, IN	Year Renewed:	
Location:	Light Highway	Tape/Media #:	
Purpose:	Maintenance Related	Dia/Height:	8"
Use:	Sanitary	Material:	PVC
Drain Area:	NA	Lining:	Cured in Place
Category:	NA		
Comment:

Location Details:		Direction of Survey:	Downstream
US MH:	M-708-198	DS MH:	M-708-021
		Total Length Surveyed (ft):	399.6

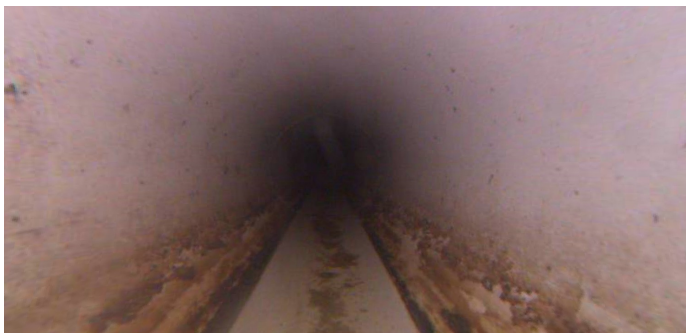
Code: **AMH**
Description: **Manhole**

Distance (ft): **.0**
Structural Grade: **0**
O&M Grade: **0**
Clock Start/From:
Clock To:
1st Value:
2nd Value:
Value Percent:
Continuous Index:
Within 8" of Joint: **NO**
Remarks: **M-708-198**

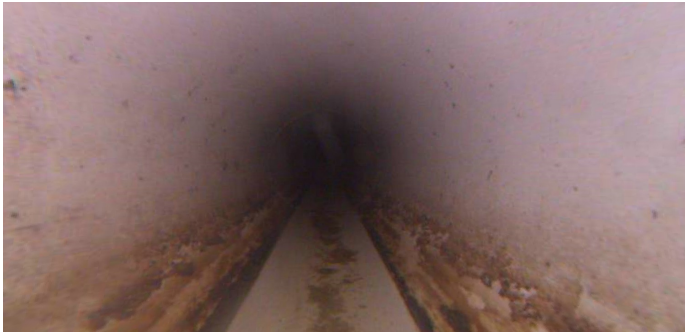
Code:	MWL
Description:	Water Level

Distance (ft):	.0
Structural Grade:	0
O&M Grade:	0
Clock Start/From:	
Clock To:	
1st Value:	
2nd Value:	
Value Percent:	5.000
Continuous Index:	
Within 8" of Joint:	NO
Remarks:

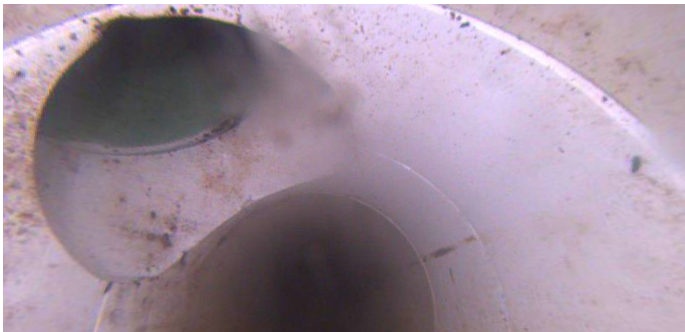
Code:	TF
Description:	Tap Factory

Distance (ft):	43.7
Structural Grade:	0
O&M Grade:	0
Clock Start/From:	11
Clock To:	
1st Value:	4.000
2nd Value:	
Value Percent:	
Continuous Index:	
Within 8" of Joint:	
Remarks:

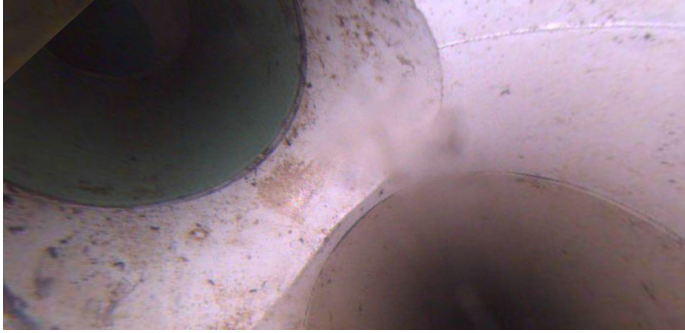
Code: **TF**
Description: **Tap Factory**

Distance (ft): **104.1**
Structural Grade: **0**
O&M Grade: **0**
Clock Start/From: **10**
Clock To:
1st Value: **4.000**
2nd Value:
Value Percent:
Continuous Index:
Within 8" of Joint:
Remarks:

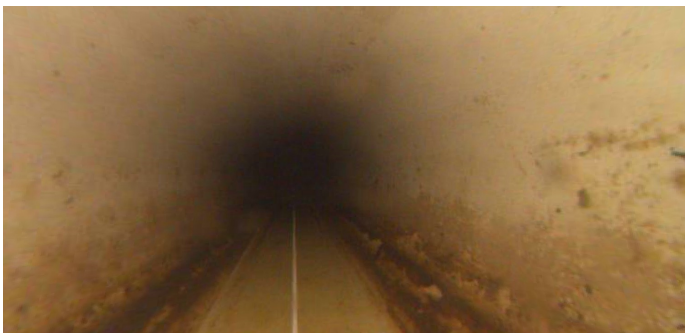
Code: **MGO**
Description: **General Observation**

Distance (ft): **126.7**
Structural Grade: **0**
O&M Grade: **0**
Clock Start/From:
Clock To:
1st Value:
2nd Value:
Value Percent:
Continuous Index:
Within 8" of Joint: **NO**
Remarks: **rear camera**

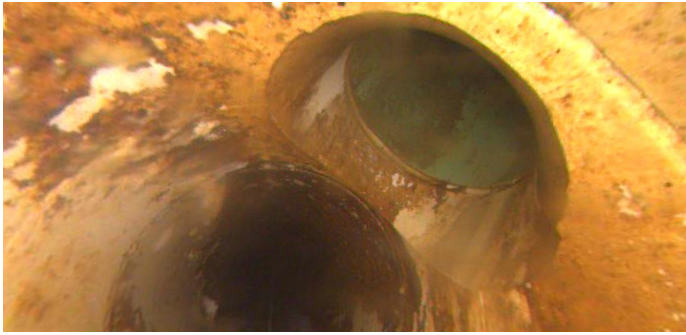
Code: **TF**
Description: **Tap Factory**

Distance (ft): **154.8**
Structural Grade: **0**
O&M Grade: **0**
Clock Start/From: **11**
Clock To:
1st Value: **4.000**
2nd Value:
Value Percent:
Continuous Index:
Within 8" of Joint:
Remarks:

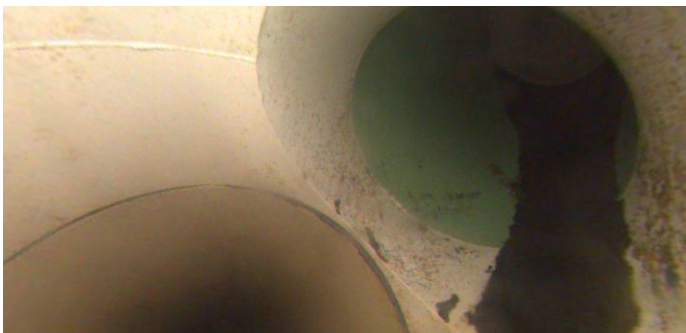
Code: **TF**
Description: **Tap Factory**

Distance (ft): **184.4**
Structural Grade: **0**
O&M Grade: **0**
Clock Start/From: **11**
Clock To:
1st Value: **4.000**
2nd Value:
Value Percent:
Continuous Index:
Within 8" of Joint:
Remarks:

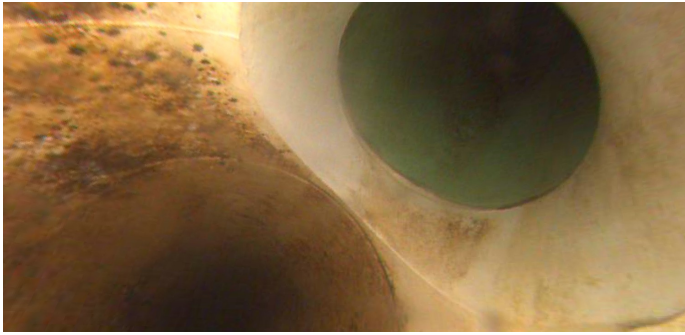
Code: **TF**
Description: **Tap Factory**

Distance (ft): **223.9**
Structural Grade: **0**
O&M Grade: **0**
Clock Start/From: **10**
Clock To:
1st Value: **4.000**
2nd Value:
Value Percent:
Continuous Index:
Within 8" of Joint:
Remarks:

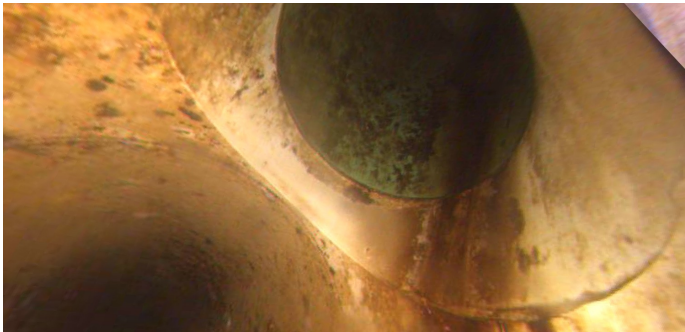
Code: **TF**
Description: **Tap Factory**

Distance (ft): **294.1**
Structural Grade: **0**
O&M Grade: **0**
Clock Start/From: **11**
Clock To:
1st Value: **4.000**
2nd Value:
Value Percent:
Continuous Index:
Within 8" of Joint:
Remarks:

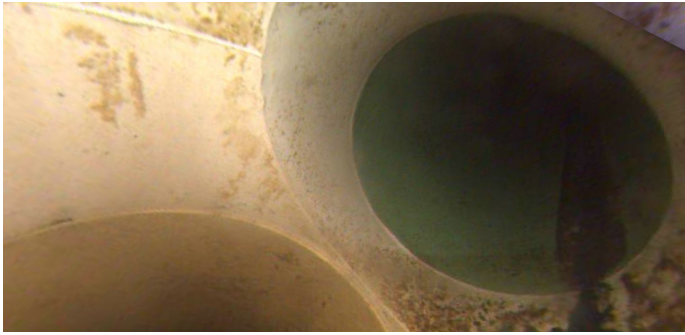
Code: **TF**
Description: **Tap Factory**

Distance (ft): **346.6**
Structural Grade: **0**
O&M Grade: **0**
Clock Start/From: **11**
Clock To:
1st Value: **4.000**
2nd Value:
Value Percent:
Continuous Index:
Within 8" of Joint:
Remarks:

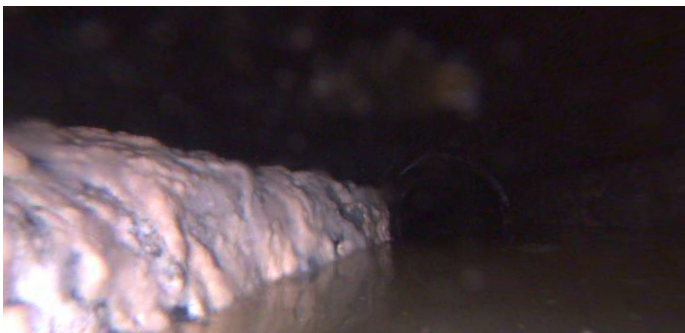
Code: **AMH**
Description: **Manhole**

Distance (ft): **399.6**
Structural Grade: **0**
O&M Grade: **0**
Clock Start/From:
Clock To:
1st Value:
2nd Value:
Value Percent:
Continuous Index:
Within 8" of Joint: **NO**
Remarks: **M-708-021**
