Profile/Photo Observation Report

Street:	Capitol Drive	Flow Control:	
City:	Hobart, IN	Year Renewed:	
Location:	Light Highway	Tape/Media #:	950
Purpose:	Routine Assessment	Dia/Height:	10"
Use:	Sanitary	Material:	PVC
Drain Area:		Lining:	
Category:	NA		
Comment:

Location Details:		Direction of Survey:	Downstream
US MH:	M-708-201	DS MH:	M-708-202
		Total Length Surveyed (ft):	111.1

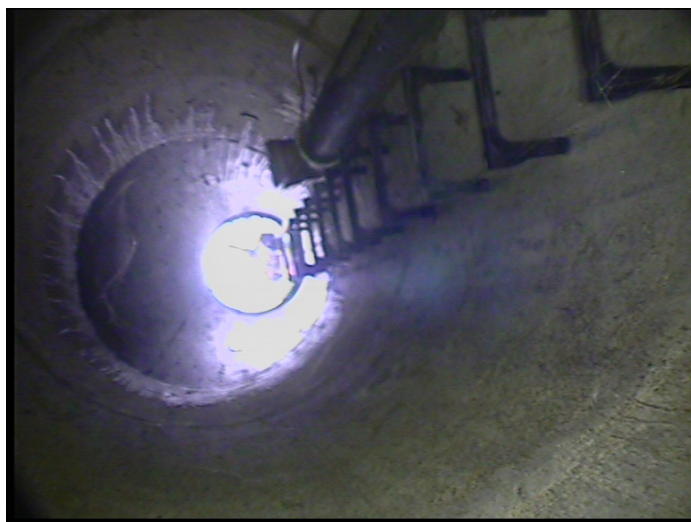
Code: **AMH**
Description: **Manhole**

Distance (ft): **.0**
Structural Grade: **0**
O&M Grade: **0**
Clock Start/From:
Clock To:
1st Value:
2nd Value:
Value Percent:
Continuous Index:
Within 8" of Joint: **NO**
Remarks: **M-708-201**

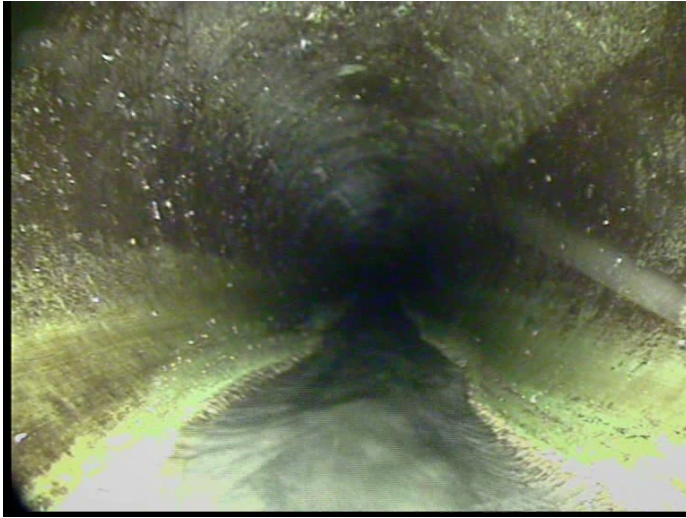
Code:	MWL
Description:	Water Level
Distance (ft):	.0
Structural Grade:	0
O&M Grade:	0
Clock Start/From:	
Clock To:	
1st Value:	
2nd Value:	
Value Percent:	10.000
Continuous Index:	
Within 8" of Joint:	NO
Remarks:

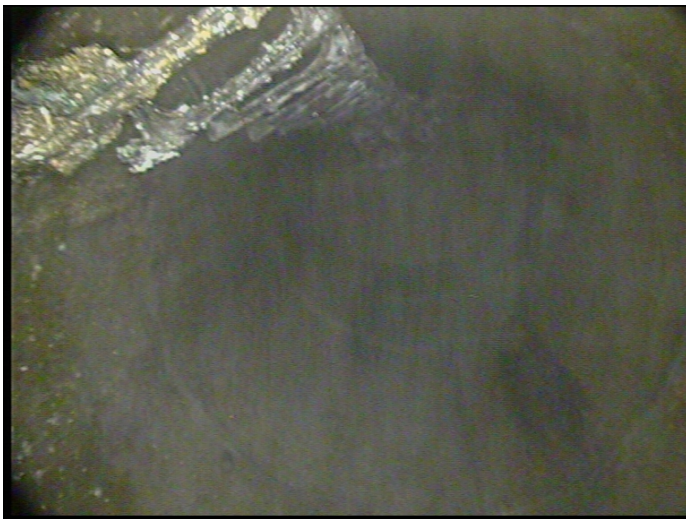
Code:	AMH
Description:	Manhole
Distance (ft):	111.1
Structural Grade:	0
O&M Grade:	0
Clock Start/From:	
Clock To:	
1st Value:	
2nd Value:	
Value Percent:	
Continuous Index:	
Within 8" of Joint:	NO
Remarks:	M-708-202
