## Profile/Photo Observation Report

Street:	<b>BRACKEN PKWY</b>	Flow Control:	<b>Not Controlled</b>
City:	<b>Hobart, IN</b>	Year Renewed:	
Location:	<b>Sidewalk</b>	Tape/Media #:	
Purpose:	<b>Maintenance Related</b>	Dia/Height:	<b>8"</b>
Use:	<b>Sanitary</b>	Material:	<b>PVC</b>
Drain Area:	<b>NA</b>	Lining:	
Category:	<b>NA</b>		
Comment:

Location Details:		Direction of Survey:	<b>Downstream</b>
US MH:	<b>M-709-001</b>	DS MH:	<b>M-709-002</b>
		Total Length Surveyed (ft):	<b>170.0</b>

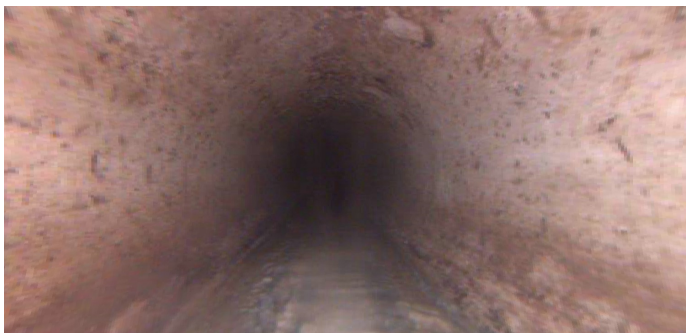
Code: **AMH**  
Description: **Manhole**

Distance (ft): **.0**  
Structural Grade: **0**  
O&M Grade: **0**  
Clock Start/From:  
Clock To:  
1st Value:  
2nd Value:  
Value Percent:  
Continuous Index:  
Within 8" of Joint: **NO**  
Remarks: **M-709-001**

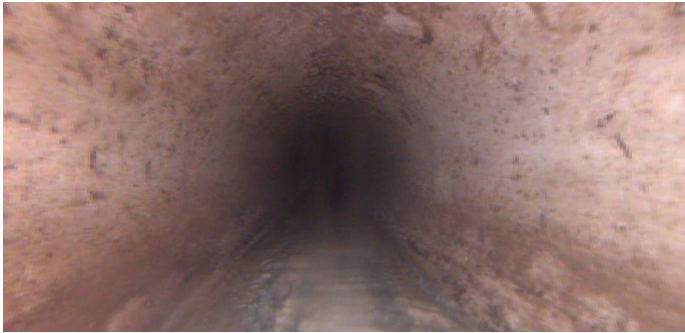
Code:	<b>MWL</b>
Description:	<b>Water Level</b>

Distance (ft):	<b>.0</b>
Structural Grade:	<b>0</b>
O&M Grade:	<b>0</b>
Clock Start/From:	
Clock To:	
1st Value:	
2nd Value:	
Value Percent:	<b>5.000</b>
Continuous Index:	
Within 8" of Joint:	<b>NO</b>
Remarks:

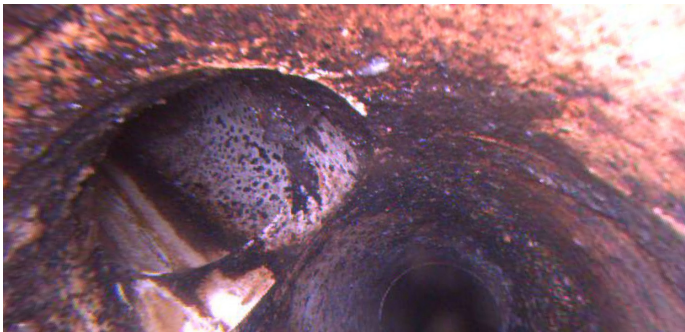
Code:	<b>TF</b>
Description:	<b>Tap Factory</b>

Distance (ft):	<b>26.8</b>
Structural Grade:	<b>0</b>
O&M Grade:	<b>0</b>
Clock Start/From:	<b>1</b>
Clock To:	
1st Value:	<b>4.000</b>
2nd Value:	
Value Percent:	
Continuous Index:	
Within 8" of Joint:	
Remarks:

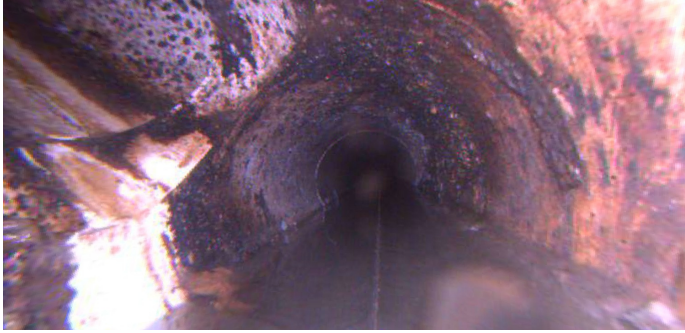
Code: **DAGS**  
Description: **Deposits Attached Grease**

Distance (ft): **26.8**  
Structural Grade: **0**  
O&M Grade: **2**  
Clock Start/From: **8**  
Clock To: **4**  
1st Value:  
2nd Value:  
Value Percent: **5.000**  
Continuous Index:  
Within 8" of Joint: **NO**  
Remarks:

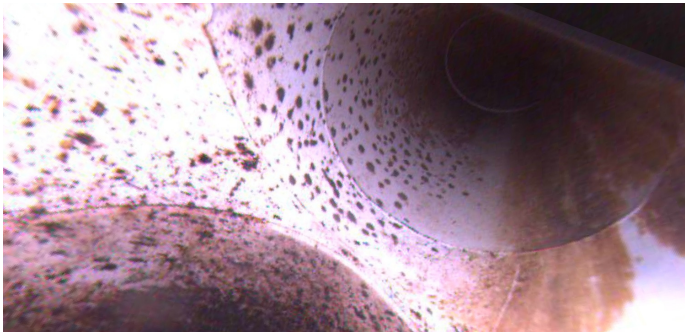
Code: **TF**  
Description: **Tap Factory**

Distance (ft): **28.0**  
Structural Grade: **0**  
O&M Grade: **0**  
Clock Start/From: **11**  
Clock To:  
1st Value: **4.000**  
2nd Value:  
Value Percent:  
Continuous Index:  
Within 8" of Joint:  
Remarks:

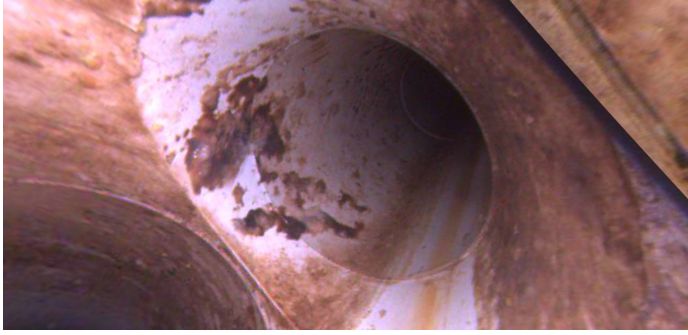
Code: **TF**  
Description: **Tap Factory**

Distance (ft): **129.5**  
Structural Grade: **0**  
O&M Grade: **0**  
Clock Start/From: **10**  
Clock To:  
1st Value: **4.000**  
2nd Value:  
Value Percent:  
Continuous Index:  
Within 8" of Joint:  
Remarks:

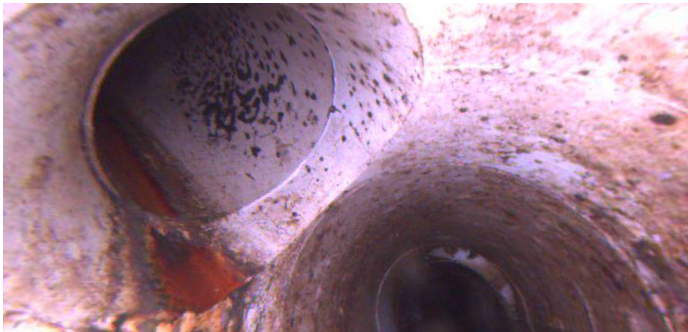
Code: **TF**  
Description: **Tap Factory**

Distance (ft): **131.3**  
Structural Grade: **0**  
O&M Grade: **0**  
Clock Start/From: **2**  
Clock To:  
1st Value: **4.000**  
2nd Value:  
Value Percent:  
Continuous Index:  
Within 8" of Joint:  
Remarks:

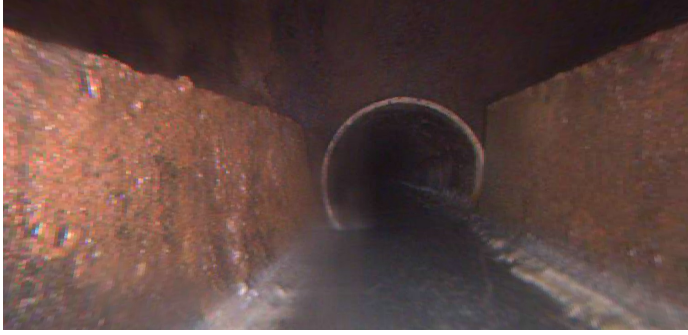
Code:	<b>AMH</b>
Description:	<b>Manhole</b>
Distance (ft):	<b>170.0</b>
Structural Grade:	<b>0</b>
O&M Grade:	<b>0</b>
Clock Start/From:	
Clock To:	
1st Value:	
2nd Value:	
Value Percent:	
Continuous Index:	
Within 8" of Joint:	<b>NO</b>
Remarks:	<b>M-709-002</b>
