| Profile/Photo Observation Report | | | | | | | |
| Street: Bracken Parkway | | | Flow Control: | | | | |
| US MH: | M-709-2 | DS MH: | M-709-3 | Total Length Surveyed (ft |): 169.0 | | |

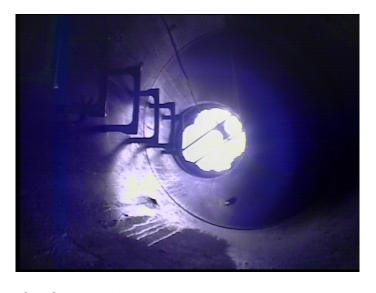
| Description: | Manhole |
| Distance (ft): Structural Grade: | .0 0 |
| Continuous Index: Within 8" of Joint: Remarks: | NO M-709-2 |

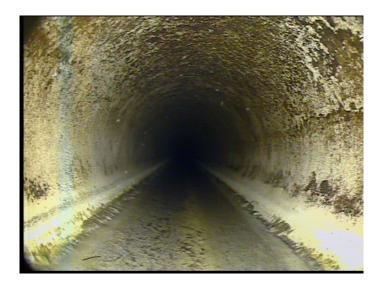
Code: MWL
Description: Water Level

Distance (ft): .0
Structural Grade: 0
O&M Grade: 0
Clock Start/From:

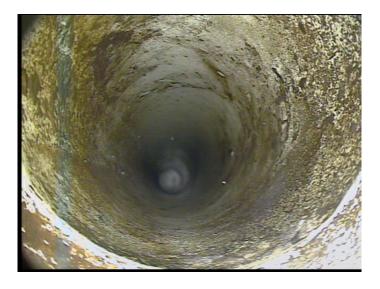
Code: TF
Description: Tap Factory

Distance (ft): 36.1
Structural Grade: 0

Clock Start/From: 10

1st Value: **4.000**

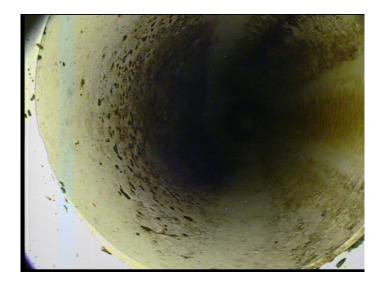
Code: **TF**

Description: Tap Factory

Distance (ft): 71.3
Structural Grade: 0
O&M Grade: 0
Clock Start/From: 2

1st Value: **4.000**

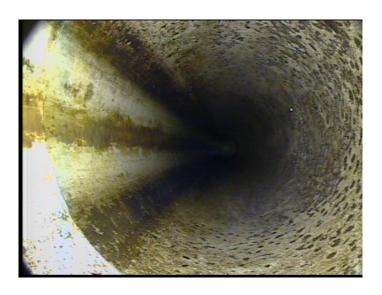
Code: **TF**

Description: Tap Factory

Distance (ft): 121.2
Structural Grade: 0
O&M Grade: 0
Clock Start/From: 10

1st Value: **4.000**

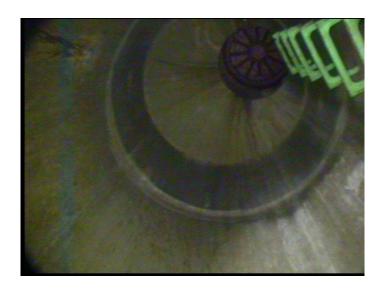
Code: AMH
Description: Manhole

Distance (ft): 169.0
Structural Grade: 0
O&M Grade: 0

Remarks: M-709-3
