Profile/Photo Observation Report

Date:	03/21/2018	Weather:		Coding:	PACP 6.0
Pipe Length (ft):	174.7	Owner:	NA	Pre Clean:	Not Known
P.O.#:		Surveyor:	Selasie Honu	PSR:	P-709-004-005
Customer:		Clean Date:	01/01/1900	Shape:	C

Street:	Oak	Flow Control:	Not Controlled
City:	Hobart, IN	Year Renewed:	
Location:	Sidewalk	Tape/Media #:	
Purpose:	Maintenance Related	Dia/Height:	8"
Use:	Sanitary	Material:	PVC
Drain Area:	NA	Lining:	
Category:	NA		
Comment:

Location Details:		Direction of Survey:	Downstream
US MH:	M-709-004	DS MH:	M-709-005
		Total Length Surveyed (ft):	175.9

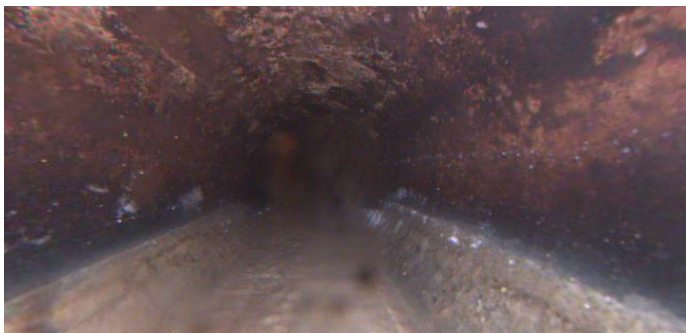
Code: **DAGS**
Description: **Deposits Attached Grease**

Distance (ft): **.0**
Structural Grade: **0**
O&M Grade: **2**
Clock Start/From: **8**
Clock To: **4**
1st Value:
2nd Value:
Value Percent: **5.000**
Continuous Index: **S01**
Within 8" of Joint: **NO**
Remarks:

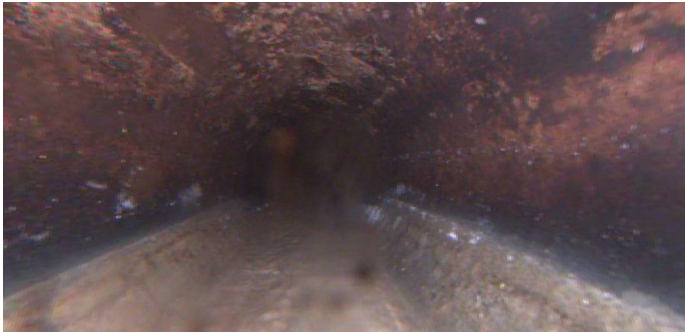
Code:	AMH
Description:	Manhole

Distance (ft):	.0
Structural Grade:	0
O&M Grade:	0
Clock Start/From:	
Clock To:	
1st Value:	
2nd Value:	
Value Percent:	
Continuous Index:	
Within 8" of Joint:	NO
Remarks:	M-709-004

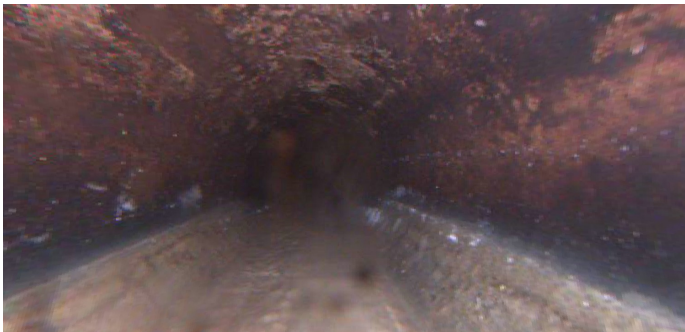
Code:	MWL
Description:	Water Level

Distance (ft):	.0
Structural Grade:	0
O&M Grade:	0
Clock Start/From:	
Clock To:	
1st Value:	
2nd Value:	
Value Percent:	5.000
Continuous Index:	
Within 8" of Joint:	NO
Remarks:

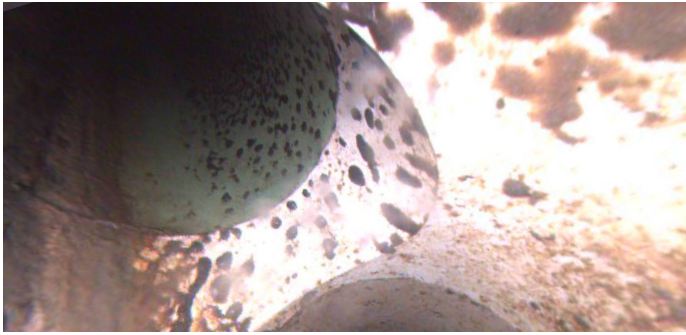
Code: **TF**
Description: **Tap Factory**

Distance (ft): **38.4**
Structural Grade: **0**
O&M Grade: **0**
Clock Start/From: **11**
Clock To:
1st Value: **4.000**
2nd Value:
Value Percent:
Continuous Index:
Within 8" of Joint:
Remarks:

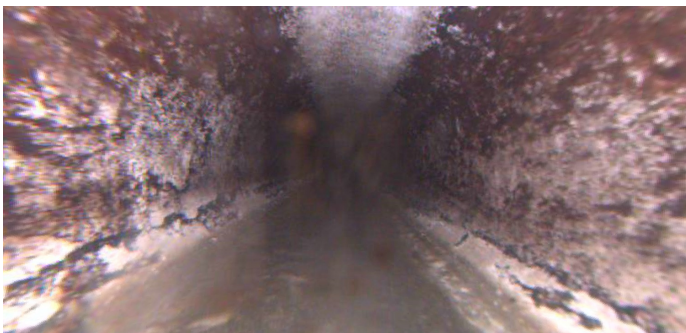
Code: **DAGS**
Description: **Deposits Attached Grease**

Distance (ft): **45.9**
Structural Grade: **0**
O&M Grade: **2**
Clock Start/From: **8**
Clock To: **4**
1st Value:
2nd Value:
Value Percent: **5.000**
Continuous Index: **F01**
Within 8" of Joint: **NO**
Remarks:

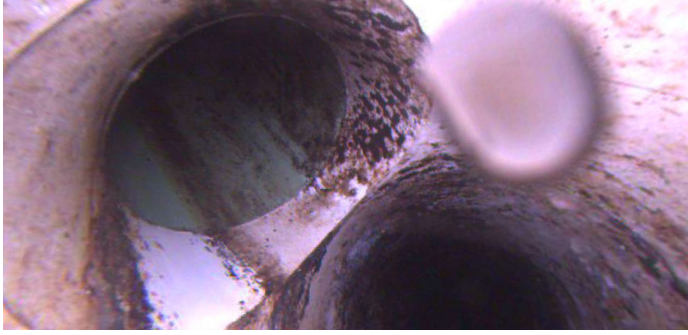
Code: **TF**
Description: **Tap Factory**

Distance (ft): **80.2**
Structural Grade: **0**
O&M Grade: **0**
Clock Start/From: **2**
Clock To:
1st Value: **4.000**
2nd Value:
Value Percent:
Continuous Index:
Within 8" of Joint:
Remarks:

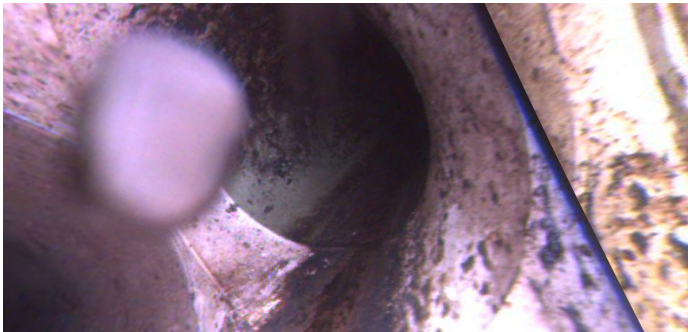
Code: **TF**
Description: **Tap Factory**

Distance (ft): **133.2**
Structural Grade: **0**
O&M Grade: **0**
Clock Start/From: **10**
Clock To:
1st Value: **4.000**
2nd Value:
Value Percent:
Continuous Index:
Within 8" of Joint:
Remarks:

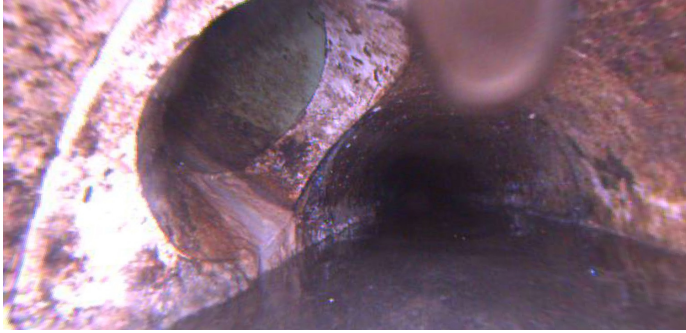
Code: **TF**
Description: **Tap Factory**

Distance (ft): **158.7**
Structural Grade: **0**
O&M Grade: **0**
Clock Start/From: **2**
Clock To:
1st Value: **4.000**
2nd Value:
Value Percent:
Continuous Index:
Within 8" of Joint:
Remarks:

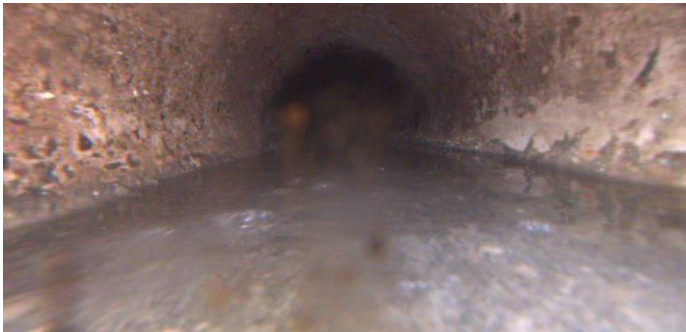
Code: **MWL**
Description: **Water Level**

Distance (ft): **158.7**
Structural Grade: **0**
O&M Grade: **0**
Clock Start/From:
Clock To:
1st Value:
2nd Value:
Value Percent: **30.000**
Continuous Index:
Within 8" of Joint: **NO**
Remarks:

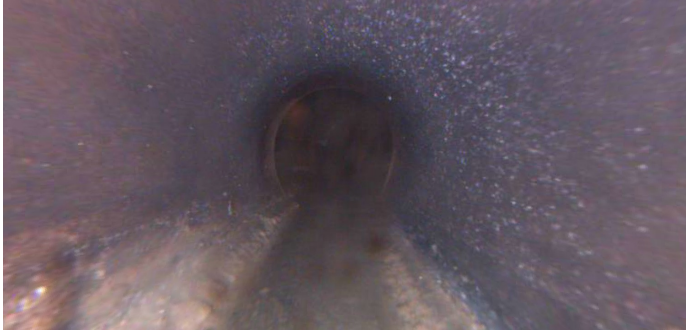
Code: **MWL**
Description: **Water Level**

Distance (ft): **172.6**
Structural Grade: **0**
O&M Grade: **0**
Clock Start/From:
Clock To:
1st Value:
2nd Value:
Value Percent: **5.000**
Continuous Index:
Within 8" of Joint: **NO**
Remarks:

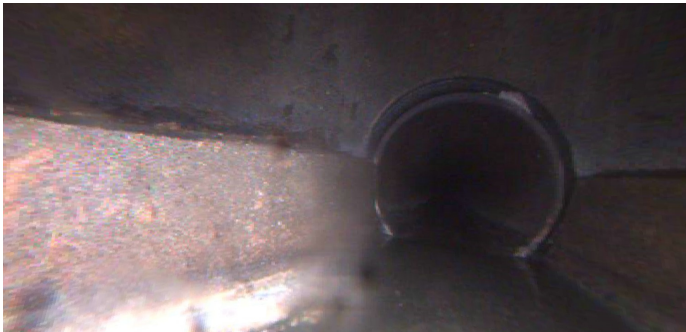
Code: **AMH**
Description: **Manhole**

Distance (ft): **175.9**
Structural Grade: **0**
O&M Grade: **0**
Clock Start/From:
Clock To:
1st Value:
2nd Value:
Value Percent:
Continuous Index:
Within 8" of Joint: **NO**
Remarks: **M-709-005**
