Profile/Photo Observation Report

Date:	03/21/2018	Weather:		Coding:	PACP 6.0
Pipe Length (ft):	92.6	Owner:	NA	Pre Clean:	Not Known
P.O.#:		Surveyor:	Selasie Honu	PSR:	P-709-010-005
Customer:		Clean Date:	01/01/1900	Shape:	C

Location Details:		Direction of Survey:	Downstream
US MH:	M-709-005	DS MH:	M-709-010
		Total Length Surveyed (ft):	90.9

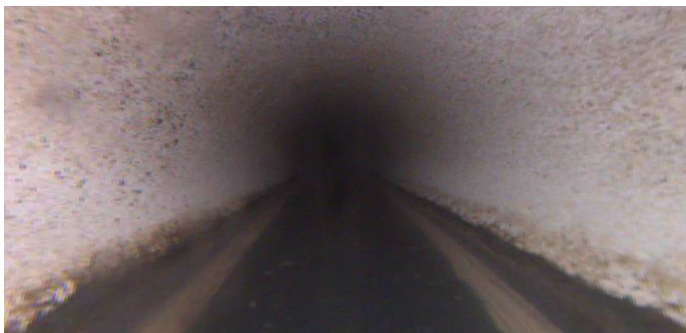
Code: **AMH**
Description: **Manhole**

Distance (ft): **.0**
Structural Grade: **0**
O&M Grade: **0**
Clock Start/From:
Clock To:
1st Value:
2nd Value:
Value Percent:
Continuous Index:
Within 8" of Joint: **NO**
Remarks: **M-709-005**

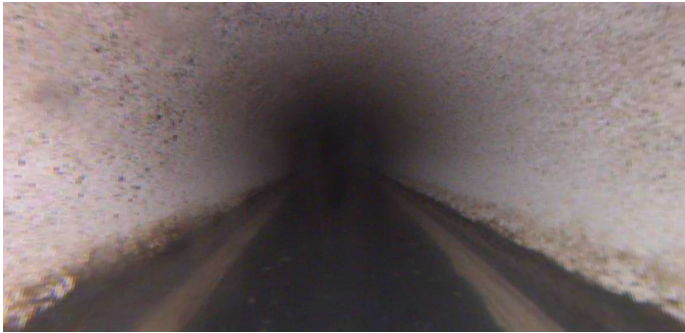
Code:	MWL
Description:	Water Level

Distance (ft):	.0
Structural Grade:	0
O&M Grade:	0
Clock Start/From:	
Clock To:	
1st Value:	
2nd Value:	
Value Percent:	5.000
Continuous Index:	
Within 8" of Joint:	NO
Remarks:

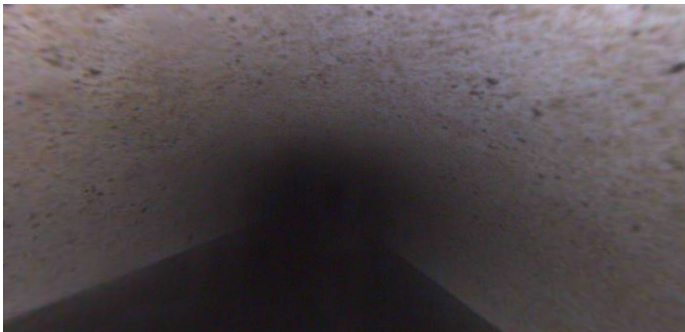
Code:	MWL
Description:	Water Level

Distance (ft):	14.0
Structural Grade:	0
O&M Grade:	0
Clock Start/From:	
Clock To:	
1st Value:	
2nd Value:	
Value Percent:	30.000
Continuous Index:	
Within 8" of Joint:	NO
Remarks:

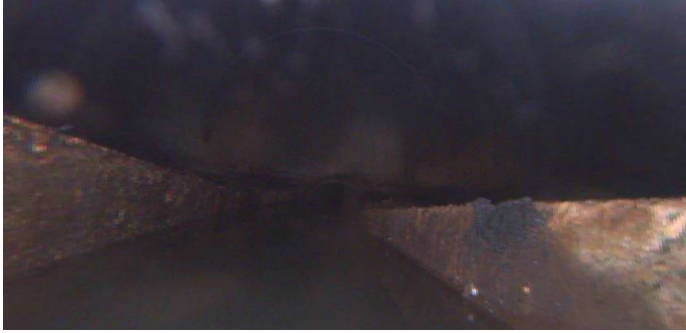
Code:	AMH
Description:	Manhole
Distance (ft):	90.9
Structural Grade:	0
O&M Grade:	0
Clock Start/From:	
Clock To:	
1st Value:	
2nd Value:	
Value Percent:	
Continuous Index:	
Within 8" of Joint:	NO
Remarks:	M-709-010
