Profile/Photo Observation Report

Street:	BRACKEN PKWY & MERGANSER ST	Flow Control:	Not Controlled
City:	Hobart, IN	Year Renewed:	
Location:	Yard	Tape/Media #:	
Purpose:	Maintenance Related	Dia/Height:	8"
Use:	Sanitary	Material:	PVC
Drain Area:	NA	Lining:	
Category:	NA		
Comment:	black sludge at 52'.

Location Details:		Direction of Survey:	Downstream
US MH:	M-709-006	DS MH:	M-709-007
		Total Length Surveyed (ft):	53.2

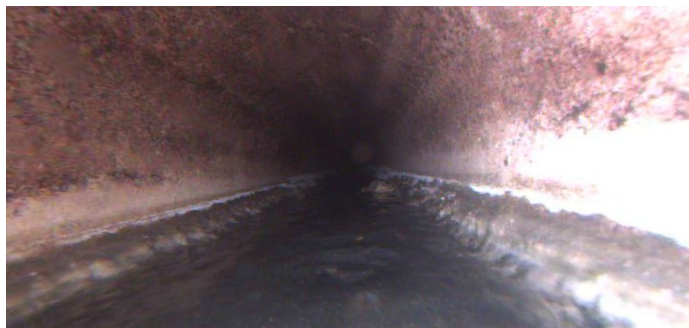
Code: **AMH**
Description: **Manhole**

Distance (ft): **.0**
Structural Grade: **0**
O&M Grade: **0**
Clock Start/From:
Clock To:
1st Value:
2nd Value:
Value Percent:
Continuous Index:
Within 8" of Joint: **NO**
Remarks: **M-709-006**

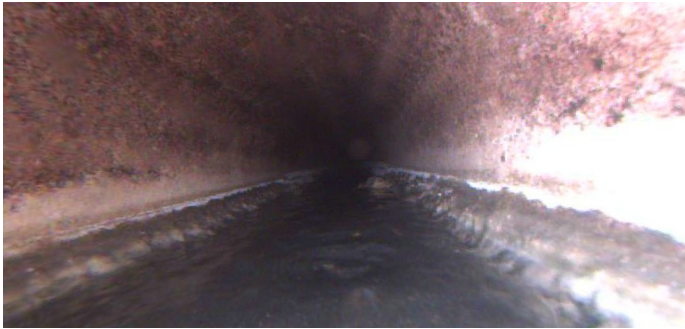
Code:	MWL
Description:	Water Level

Distance (ft):	.0
Structural Grade:	0
O&M Grade:	0
Clock Start/From:	
Clock To:	
1st Value:	
2nd Value:	
Value Percent:	30.000
Continuous Index:	
Within 8" of Joint:	NO
Remarks:

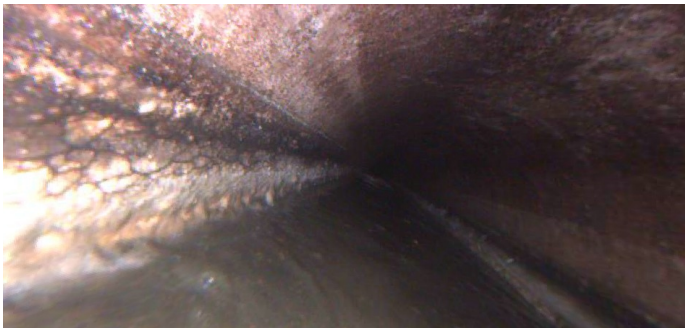
Code:	MSA
Description:	Abandoned Survey

Distance (ft):	53.2
Structural Grade:	0
O&M Grade:	0
Clock Start/From:	
Clock To:	
1st Value:	
2nd Value:	
Value Percent:	
Continuous Index:	
Within 8" of Joint:	NO
Remarks:	Unknown
