## Profile/Photo Observation Report

Street:	<b>Oak</b>	Flow Control:	<b>Not Controlled</b>
City:	<b>Hobart, IN</b>	Year Renewed:	
Location:	<b>Yard</b>	Tape/Media #:	
Purpose:	<b>Maintenance Related</b>	Dia/Height:	<b>8"</b>
Use:	<b>Sanitary</b>	Material:	<b>PVC</b>
Drain Area:	<b>NA</b>	Lining:	
Category:	<b>NA</b>		
Comment:	<b>black sludge at 52'.</b>

Location Details:		Direction of Survey:	<b>Downstream</b>
US MH:	<b>M-709-006</b>	DS MH:	<b>M-709-007</b>
		Total Length Surveyed (ft):	<b>53.2</b>

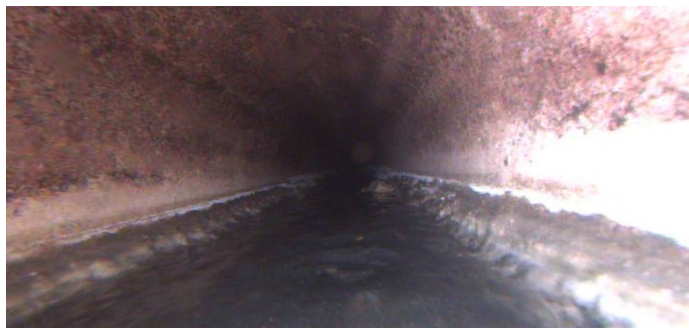
Code: **AMH**  
Description: **Manhole**

Distance (ft): **.0**  
Structural Grade: **0**  
O&M Grade: **0**  
Clock Start/From:  
Clock To:  
1st Value:  
2nd Value:  
Value Percent:  
Continuous Index:  
Within 8" of Joint: **NO**  
Remarks: **M-709-006**

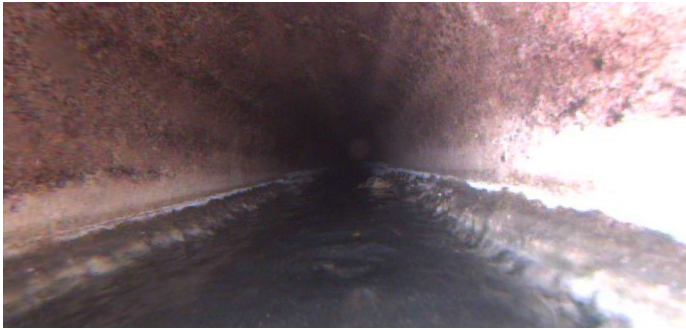
Code:	<b>MWL</b>
Description:	<b>Water Level</b>

Distance (ft):	<b>.0</b>
Structural Grade:	<b>0</b>
O&M Grade:	<b>0</b>
Clock Start/From:	
Clock To:	
1st Value:	
2nd Value:	
Value Percent:	<b>30.000</b>
Continuous Index:	
Within 8" of Joint:	<b>NO</b>
Remarks:

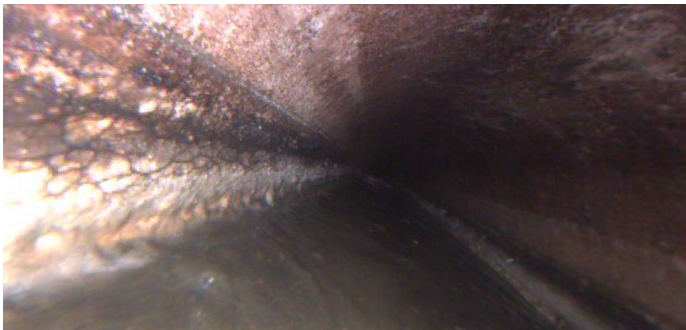
Code:	<b>MSA</b>
Description:	<b>Abandoned Survey</b>

Distance (ft):	<b>53.2</b>
Structural Grade:	<b>0</b>
O&M Grade:	<b>0</b>
Clock Start/From:	
Clock To:	
1st Value:	
2nd Value:	
Value Percent:	
Continuous Index:	
Within 8" of Joint:	<b>NO</b>
Remarks:	<b>Unknown</b>
