Profile/Photo Observation Report

Street:	BRACKEN PKWY & MERGANSER ST	Flow Control:	Not Controlled
City:	Hobart, IN	Year Renewed:	
Location:	Yard	Tape/Media #:	
Purpose:	Maintenance Related	Dia/Height:	10"
Use:	Sanitary	Material:	PVC
Drain Area:	NA	Lining:	
Category:	NA		
Comment:	Reverse setup. heavy silt/rock at 27'.

Location Details:		Direction of Survey:	Upstream
US MH:	M-709-006	DS MH:	M-709-007
		Total Length Surveyed (ft):	29.0

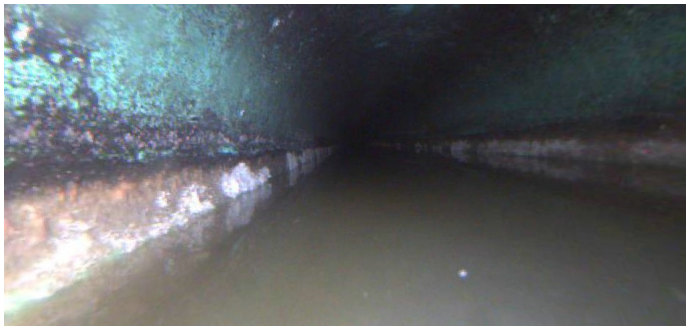
Code: **AMH**
Description: **Manhole**

Distance (ft): **.0**
Structural Grade: **0**
O&M Grade: **0**
Clock Start/From:
Clock To:
1st Value:
2nd Value:
Value Percent:
Continuous Index:
Within 8" of Joint: **NO**
Remarks: **M-709-007**

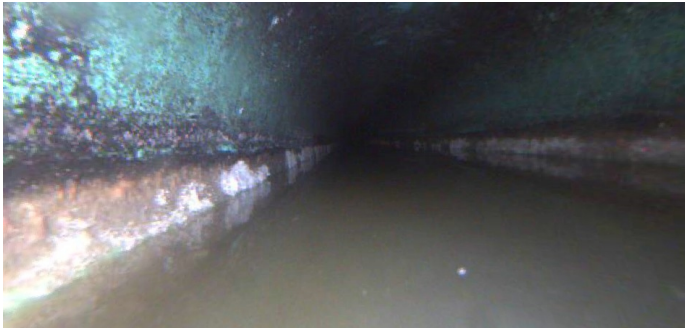
Code:	MWL
Description:	Water Level

Distance (ft):	.0
Structural Grade:	0
O&M Grade:	0
Clock Start/From:	
Clock To:	
1st Value:	
2nd Value:	
Value Percent:	35.000
Continuous Index:	
Within 8" of Joint:	NO
Remarks:

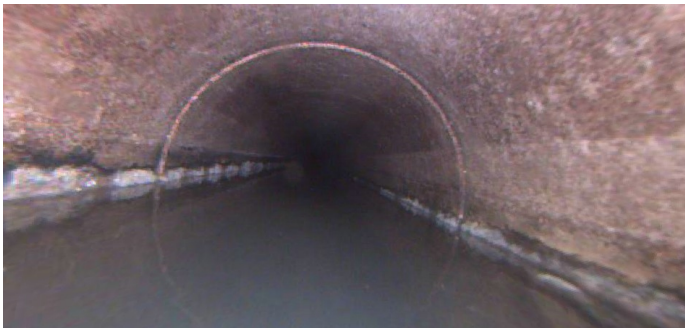
Code:	MWL
Description:	Water Level

Distance (ft):	24.6
Structural Grade:	0
O&M Grade:	0
Clock Start/From:	
Clock To:	
1st Value:	
2nd Value:	
Value Percent:	40.000
Continuous Index:	
Within 8" of Joint:	NO
Remarks:

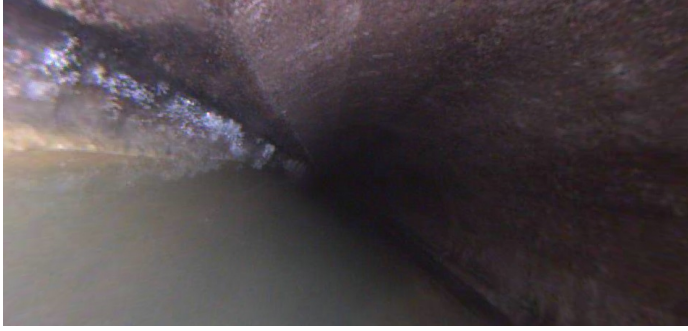
Code:	MSA
Description:	Abandoned Survey
Distance (ft):	29.0
Structural Grade:	0
O&M Grade:	0
Clock Start/From:	
Clock To:	
1st Value:	
2nd Value:	
Value Percent:	
Continuous Index:	
Within 8" of Joint:	NO
Remarks:	Unknown
