Profile/Photo Observation Report

Date:	03/20/2018	Weather:		Coding:	PACP 6.0
Pipe Length (ft):	86.2	Owner:	NA	Pre Clean:	Not Known
P.O.#:		Surveyor:	John Kuglmaier	PSR:	P-709-006-007
Customer:		Clean Date:	01/01/1900	Shape:	C

Street:	Oak	Flow Control:	Not Controlled
City:	Hobart, IN	Year Renewed:	
Location:	Yard	Tape/Media #:	
Purpose:	Maintenance Related	Dia/Height:	10"
Use:	Sanitary	Material:	PVC
Drain Area:	NA	Lining:	
Category:	NA		
Comment:	Reverse setup. heavy silt/rock at 27'.

Location Details:		Direction of Survey:	Upstream
US MH:	M-709-006	DS MH:	M-709-007
		Total Length Surveyed (ft):	29.0

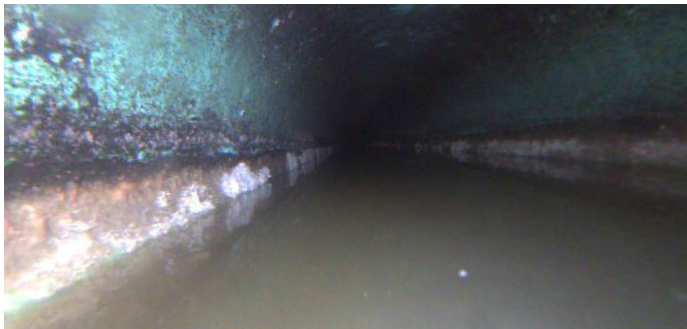
Code: **AMH**
Description: **Manhole**

Distance (ft): **.0**
Structural Grade: **0**
O&M Grade: **0**
Clock Start/From:
Clock To:
1st Value:
2nd Value:
Value Percent:
Continuous Index:
Within 8" of Joint: **NO**
Remarks: **M-709-007**

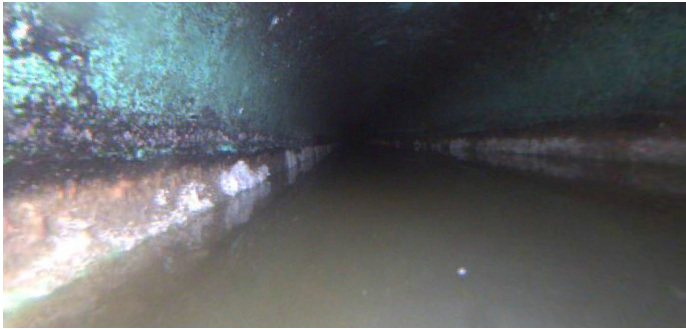
Code:	MWL
Description:	Water Level

Distance (ft):	.0
Structural Grade:	0
O&M Grade:	0
Clock Start/From:	
Clock To:	
1st Value:	
2nd Value:	
Value Percent:	35.000
Continuous Index:	
Within 8" of Joint:	NO
Remarks:

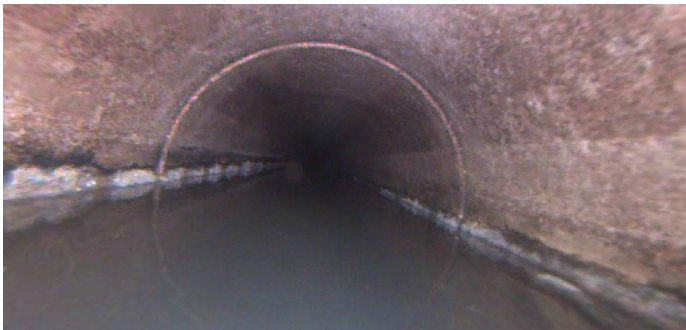
Code:	MWL
Description:	Water Level

Distance (ft):	24.6
Structural Grade:	0
O&M Grade:	0
Clock Start/From:	
Clock To:	
1st Value:	
2nd Value:	
Value Percent:	40.000
Continuous Index:	
Within 8" of Joint:	NO
Remarks:

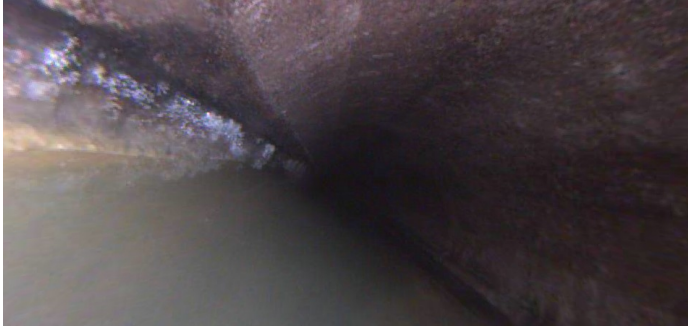
Code:	MSA
Description:	Abandoned Survey
Distance (ft):	29.0
Structural Grade:	0
O&M Grade:	0
Clock Start/From:	
Clock To:	
1st Value:	
2nd Value:	
Value Percent:	
Continuous Index:	
Within 8" of Joint:	NO
Remarks:	Unknown
