Profile/Photo Observation Report

| Street: | BRACKEN PKWY & TANAGER ST | Flow Control: | Not Controlled |
| City: | Hobart, IN | Year Renewed: | |

| US MH: | M-709-007 | DS MH: | M-709-008 |

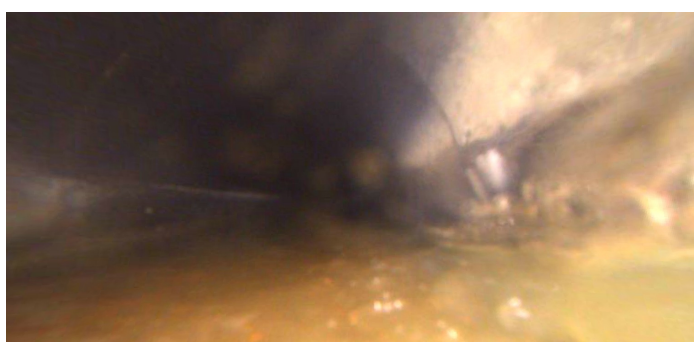
Code: **AMH**
Description: **Manhole**

Distance (ft): **.0**
Structural Grade: **0**
O&M Grade: **0**
Clock Start/From:
Clock To:
1st Value:
2nd Value:
Value Percent:
Continuous Index:
Within 8" of Joint: **NO**
Remarks: **M-709-007**

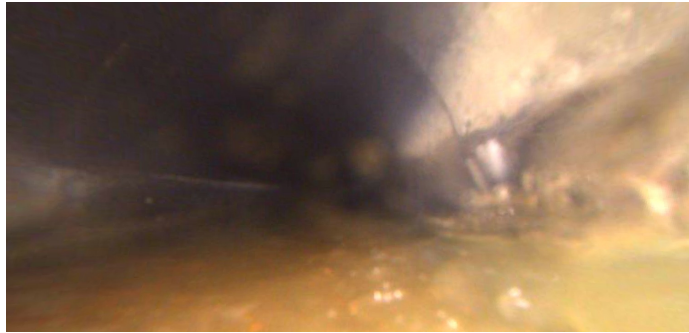
| Code: | MWL |

| Code: | MWL |
|---|---|
| Description: | Water Level |
| Distance (ft): | .0 |
| Value Percent: | 40.000 |

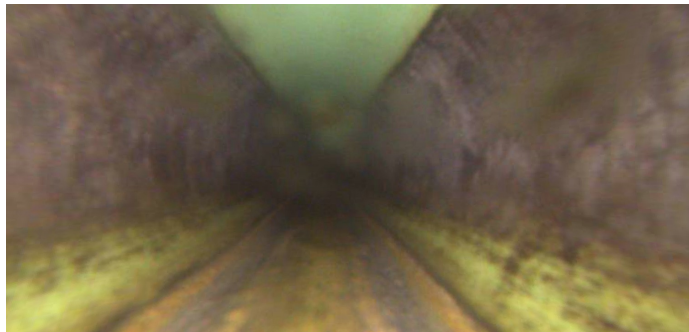
| Code: | MWL |

| Code: | MWL |
|---|---|
| Description: | Water Level |
| Distance (ft): | 281.7 |
| Value Percent: | 5.000 |

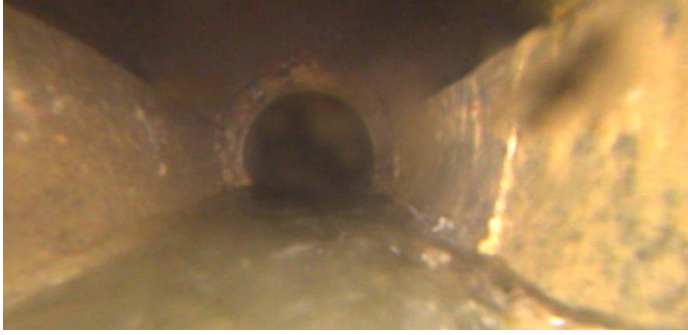
| Code: | AMH |

| Description: | Manhole |
| Distance (ft): | 294.5 |
| Remarks: | M-709-008 |
