Profile/Photo Observation Report

Street:	BRACKEN PKWY & TANAGER ST	Flow Control:	Not Controlled
City:	Hobart, IN	Year Renewed:	
Location:	Light Highway	Tape/Media #:	
Purpose:	Maintenance Related	Dia/Height:	12"
Use:	Sanitary	Material:	PVC
Drain Area:	NA	Lining:	Cured in Place
Category:	NA		
Comment:			
Location Details:		Direction of Survey:	Downstream
US MH:	M-709-008	DS MH:	M-709-009
		Total Length Surveyed (ft):	178.6

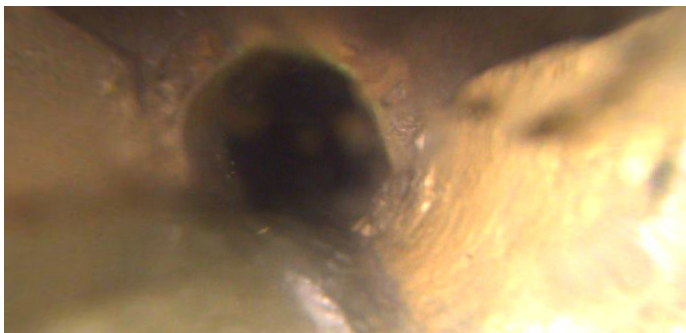
Code: **AMH**
Description: **Manhole**

Distance (ft): **.0**
Structural Grade: **0**
O&M Grade: **0**
Clock Start/From:
Clock To:
1st Value:
2nd Value:
Value Percent:
Continuous Index:
Within 8" of Joint: **NO**
Remarks: **M-709-008**

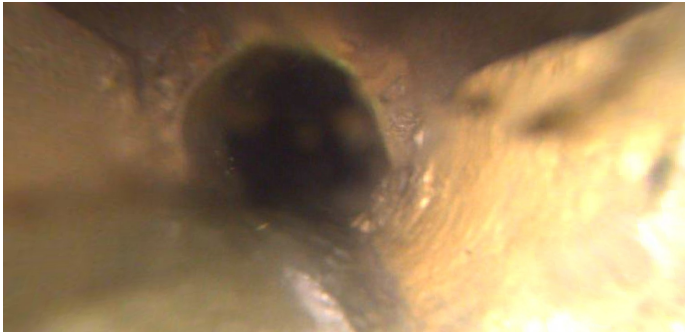
Code:	MWL
Description:	Water Level

Distance (ft):	.0
Structural Grade:	0
O&M Grade:	0
Clock Start/From:	
Clock To:	
1st Value:	
2nd Value:	
Value Percent:	10.000
Continuous Index:	
Within 8" of Joint:	NO
Remarks:

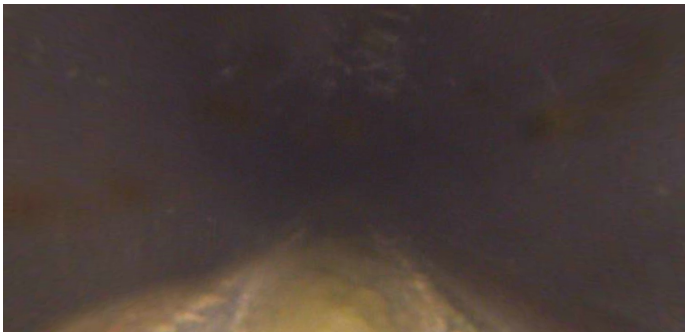
Code:	DAZ
Description:	Deposits Attached Other

Distance (ft):	2.8
Structural Grade:	0
O&M Grade:	2
Clock Start/From:	8
Clock To:	4
1st Value:	
2nd Value:	
Value Percent:	5.000
Continuous Index:	S01
Within 8" of Joint:	NO
Remarks:

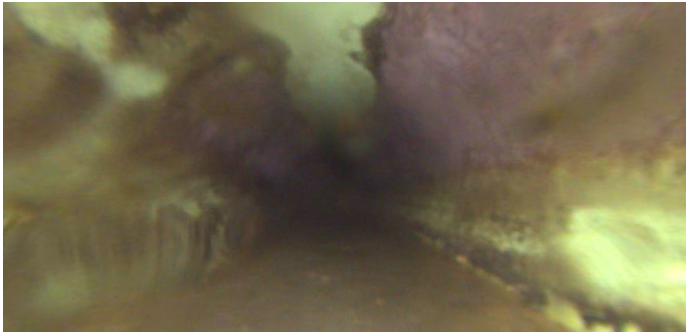
Code: **MWL**
Description: **Water Level**

Distance (ft): **105.0**
Structural Grade: **0**
O&M Grade: **0**
Clock Start/From:
Clock To:
1st Value:
2nd Value:
Value Percent: **30.000**
Continuous Index:
Within 8" of Joint: **NO**
Remarks:

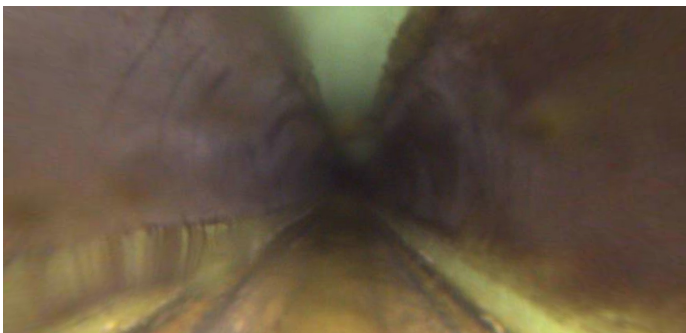
Code: **MWL**
Description: **Water Level**

Distance (ft): **154.5**
Structural Grade: **0**
O&M Grade: **0**
Clock Start/From:
Clock To:
1st Value:
2nd Value:
Value Percent: **5.000**
Continuous Index:
Within 8" of Joint: **NO**
Remarks:

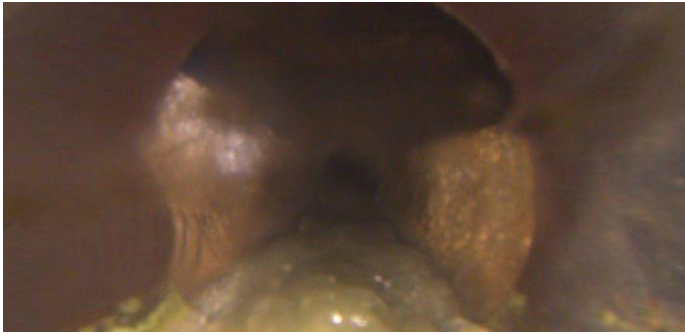
Code: **DAZ**
Description: **Deposits Attached Other**

Distance (ft): **176.1**
Structural Grade: **0**
O&M Grade: **2**
Clock Start/From: **8**
Clock To: **4**
1st Value:
2nd Value:
Value Percent: **5.000**
Continuous Index: **F01**
Within 8" of Joint: **NO**
Remarks:

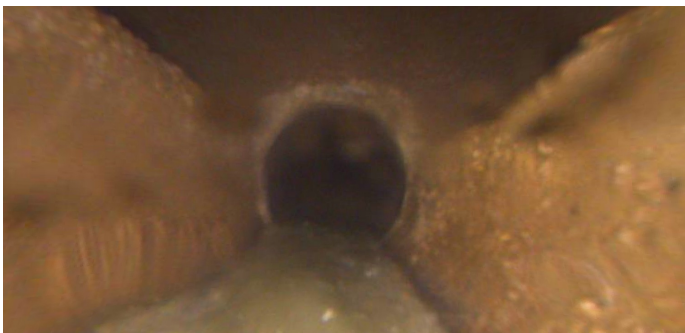
Code: **AMH**
Description: **Manhole**

Distance (ft): **178.6**
Structural Grade: **0**
O&M Grade: **0**
Clock Start/From:
Clock To:
1st Value:
2nd Value:
Value Percent:
Continuous Index:
Within 8" of Joint: **NO**
Remarks: **M-709-009**
