Profile/Photo Observation Report

Date:	04/01/2018	Weather:		Coding:	PACP 6.0
Pipe Length (ft):	183.0	Owner:	NA	Pre Clean:	Not Known
P.O.#:		Surveyor:	Jen Costello	PSR:	P-709-008-009
Customer:		Clean Date:	01/01/1900	Shape:	C

Street:	Bracken	Flow Control:	Not Controlled
City:	Hobart, IN	Year Renewed:	
Location:	Light Highway	Tape/Media #:	
Purpose:	Maintenance Related	Dia/Height:	12"
Use:	Sanitary	Material:	PVC
Drain Area:	NA	Lining:	Cured in Place
Category:	NA		
Comment:

Location Details:		Direction of Survey:	Downstream
US MH:	M-709-008	DS MH:	M-709-009
		Total Length Surveyed (ft):	178.6

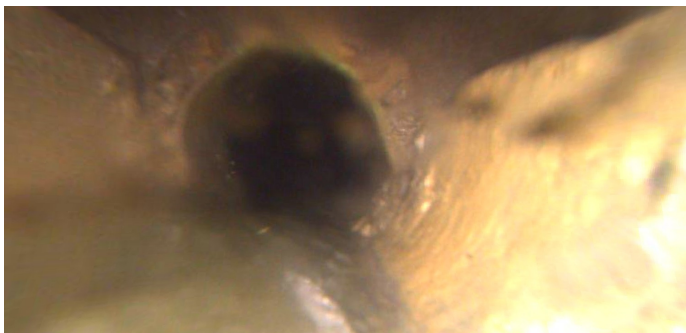
Code: **AMH**
Description: **Manhole**

Distance (ft): **.0**
Structural Grade: **0**
O&M Grade: **0**
Clock Start/From:
Clock To:
1st Value:
2nd Value:
Value Percent:
Continuous Index:
Within 8" of Joint: **NO**
Remarks: **M-709-008**

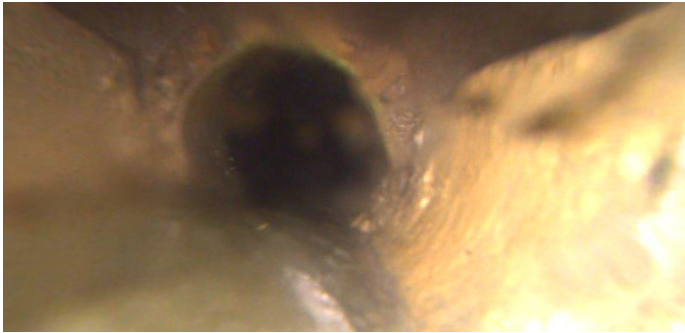
Code:	MWL
Description:	Water Level

Distance (ft):	.0
Structural Grade:	0
O&M Grade:	0
Clock Start/From:	
Clock To:	
1st Value:	
2nd Value:	
Value Percent:	10.000
Continuous Index:	
Within 8" of Joint:	NO
Remarks:

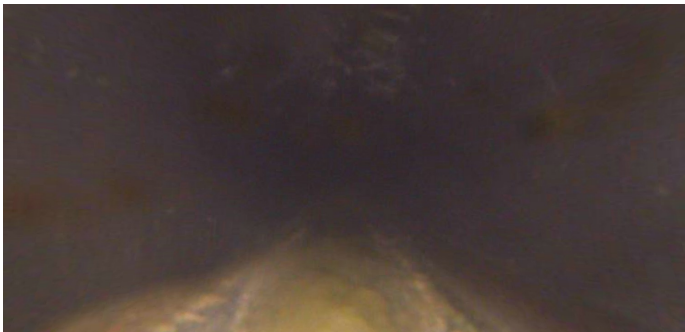
Code:	DAZ
Description:	Deposits Attached Other

Distance (ft):	2.8
Structural Grade:	0
O&M Grade:	2
Clock Start/From:	8
Clock To:	4
1st Value:	
2nd Value:	
Value Percent:	5.000
Continuous Index:	S01
Within 8" of Joint:	NO
Remarks:

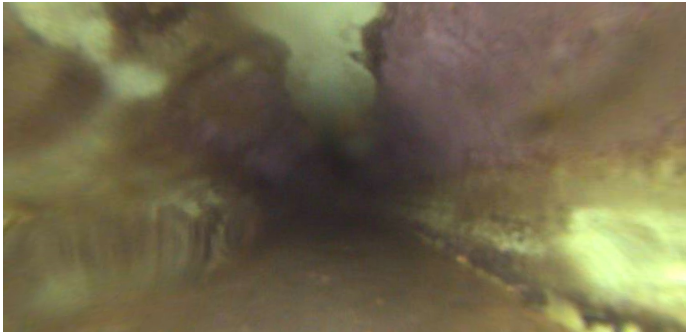
Code: **MWL**
Description: **Water Level**

Distance (ft): **105.0**
Structural Grade: **0**
O&M Grade: **0**
Clock Start/From:
Clock To:
1st Value:
2nd Value:
Value Percent: **30.000**
Continuous Index:
Within 8" of Joint: **NO**
Remarks:

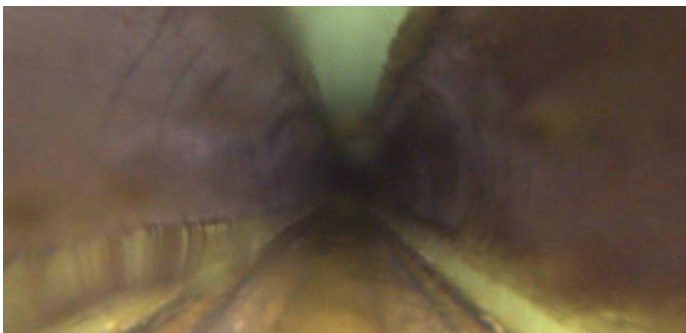
Code: **MWL**
Description: **Water Level**

Distance (ft): **154.5**
Structural Grade: **0**
O&M Grade: **0**
Clock Start/From:
Clock To:
1st Value:
2nd Value:
Value Percent: **5.000**
Continuous Index:
Within 8" of Joint: **NO**
Remarks:

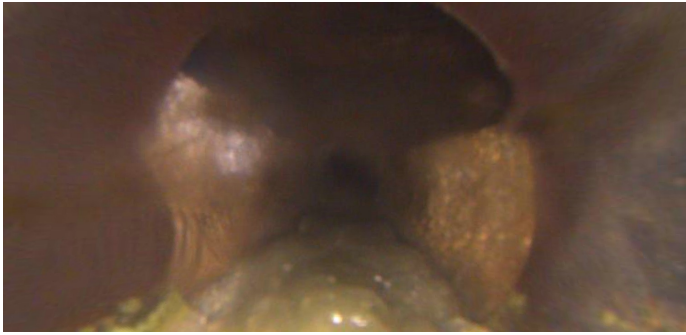
Code: **DAZ**
Description: **Deposits Attached Other**

Distance (ft): **176.1**
Structural Grade: **0**
O&M Grade: **2**
Clock Start/From: **8**
Clock To: **4**
1st Value:
2nd Value:
Value Percent: **5.000**
Continuous Index: **F01**
Within 8" of Joint: **NO**
Remarks:

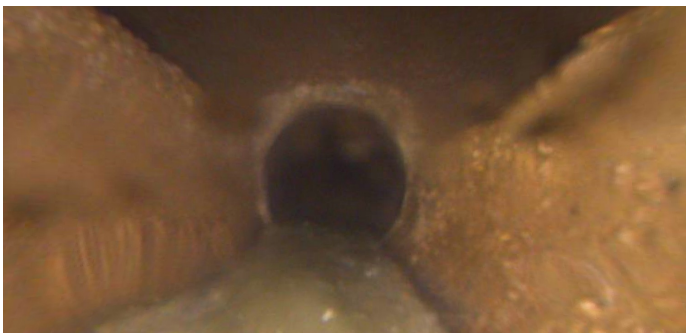
Code: **AMH**
Description: **Manhole**

Distance (ft): **178.6**
Structural Grade: **0**
O&M Grade: **0**
Clock Start/From:
Clock To:
1st Value:
2nd Value:
Value Percent:
Continuous Index:
Within 8" of Joint: **NO**
Remarks: **M-709-009**
