Profile/Photo Observation Report

Street:	BRACKEN PKWY & TANAGER ST	Flow Control:	Not Controlled
City:	Hobart, IN	Year Renewed:	
Location:	Light Highway	Tape/Media #:	
Purpose:	Maintenance Related	Dia/Height:	8"
Use:	Sanitary	Material:	PVC
Drain Area:	NA	Lining:	Cured in Place
Category:	NA		
Comment:

Location Details:		Direction of Survey:	Upstream
US MH:	M-709-008	DS MH:	M-709-035
		Total Length Surveyed (ft):	305.8

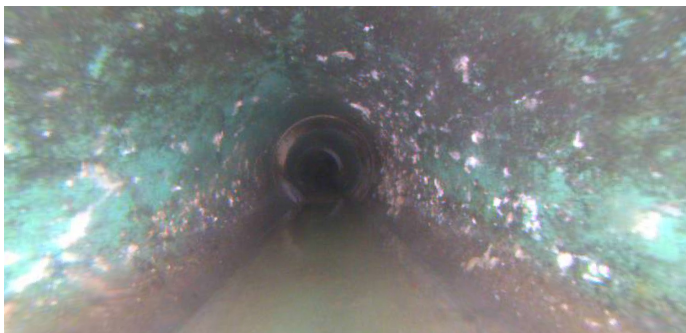
Code: **AMH**
Description: **Manhole**

Distance (ft): **.0**
Structural Grade: **0**
O&M Grade: **0**
Clock Start/From:
Clock To:
1st Value:
2nd Value:
Value Percent:
Continuous Index:
Within 8" of Joint: **NO**
Remarks: **M-709-035**

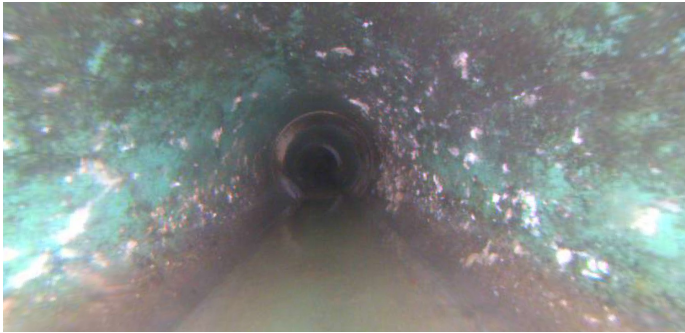
Code:	MWL
Description:	Water Level

Distance (ft):	.0
Structural Grade:	0
O&M Grade:	0
Clock Start/From:	
Clock To:	
1st Value:	
2nd Value:	
Value Percent:	20.000
Continuous Index:	
Within 8" of Joint:	NO
Remarks:

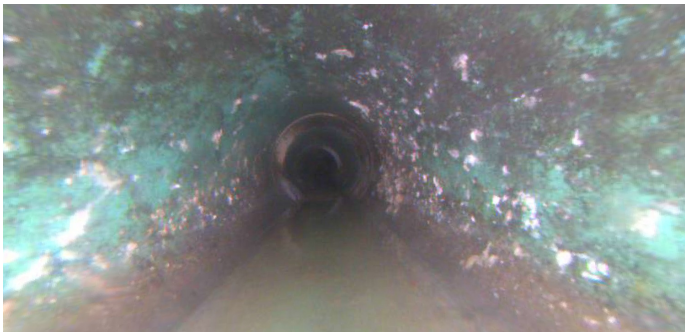
Code:	DAGS
Description:	Deposits Attached Grease

Distance (ft):	.0
Structural Grade:	0
O&M Grade:	2
Clock Start/From:	8
Clock To:	4
1st Value:	
2nd Value:	
Value Percent:	5.000
Continuous Index:	S01
Within 8" of Joint:	NO
Remarks:

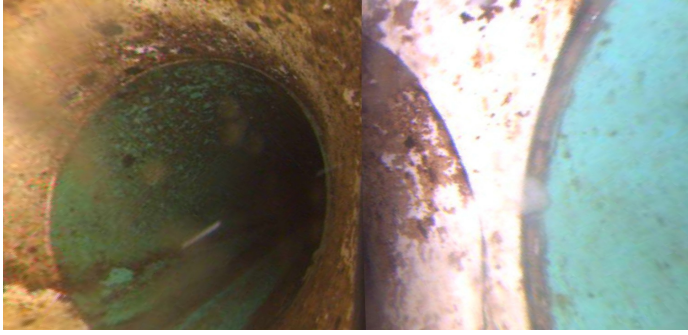
Code: **TFA**
Description: **Tap Factory Active**

Distance (ft): **3.1**
Structural Grade: **0**
O&M Grade: **0**
Clock Start/From: **9**
Clock To:
1st Value: **4.000**
2nd Value:
Value Percent:
Continuous Index:
Within 8" of Joint:
Remarks:

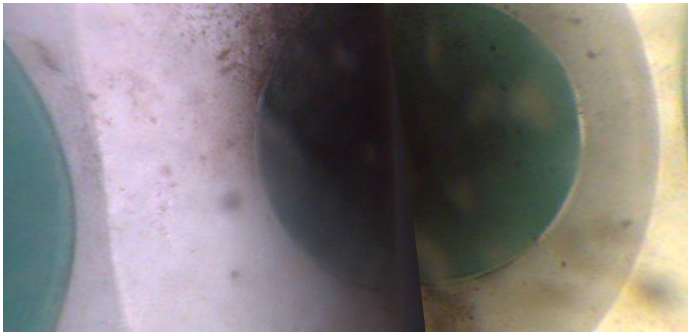
Code: **TF**
Description: **Tap Factory**

Distance (ft): **5.2**
Structural Grade: **0**
O&M Grade: **0**
Clock Start/From: **2**
Clock To:
1st Value: **4.000**
2nd Value:
Value Percent:
Continuous Index:
Within 8" of Joint:
Remarks:

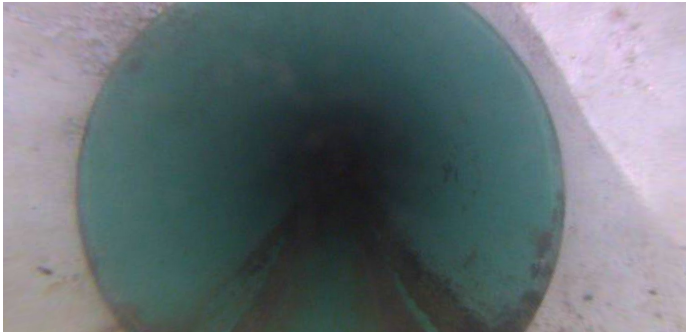
Code: **DAGS**
Description: **Deposits Attached Grease**

Distance (ft): **5.2**
Structural Grade: **0**
O&M Grade: **2**
Clock Start/From: **8**
Clock To: **4**
1st Value:
2nd Value:
Value Percent: **5.000**
Continuous Index: **F01**
Within 8" of Joint: **NO**
Remarks:

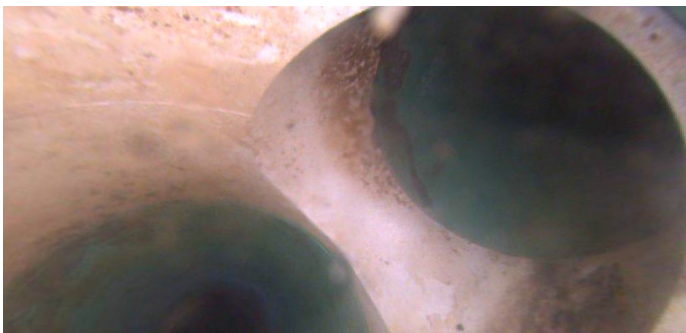
Code: **TF**
Description: **Tap Factory**

Distance (ft): **56.4**
Structural Grade: **0**
O&M Grade: **0**
Clock Start/From: **2**
Clock To:
1st Value: **4.000**
2nd Value:
Value Percent:
Continuous Index:
Within 8" of Joint:
Remarks:

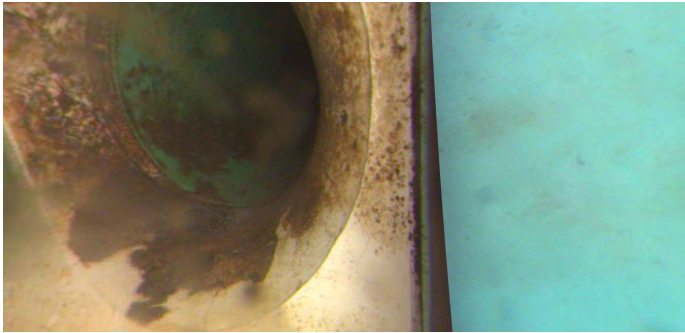
Code: **TF**
Description: **Tap Factory**

Distance (ft): **59.2**
Structural Grade: **0**
O&M Grade: **0**
Clock Start/From: **10**
Clock To:
1st Value: **4.000**
2nd Value:
Value Percent:
Continuous Index:
Within 8" of Joint:
Remarks:

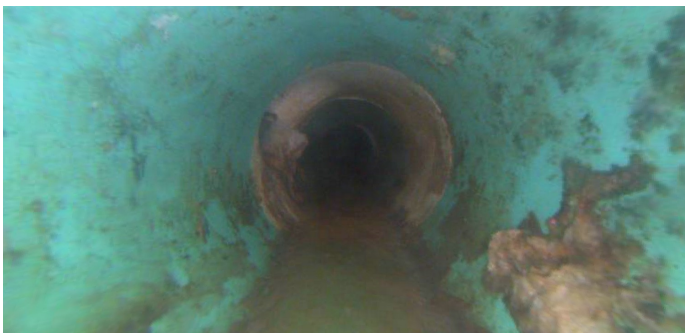
Code: **DAGS**
Description: **Deposits Attached Grease**

Distance (ft): **129.9**
Structural Grade: **0**
O&M Grade: **2**
Clock Start/From: **4**
Clock To:
1st Value:
2nd Value:
Value Percent: **5.000**
Continuous Index:
Within 8" of Joint: **NO**
Remarks:

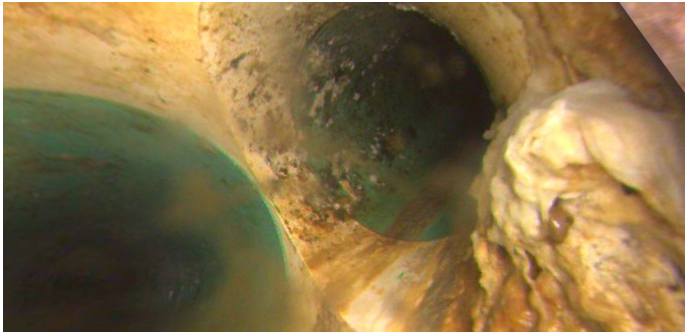
Code: **TFD**
Description: **Tap Factory Defective**

Distance (ft): **131.5**
Structural Grade: **0**
O&M Grade: **2**
Clock Start/From: **10**
Clock To:
1st Value: **4.000**
2nd Value:
Value Percent:
Continuous Index:
Within 8" of Joint:
Remarks: **dags**

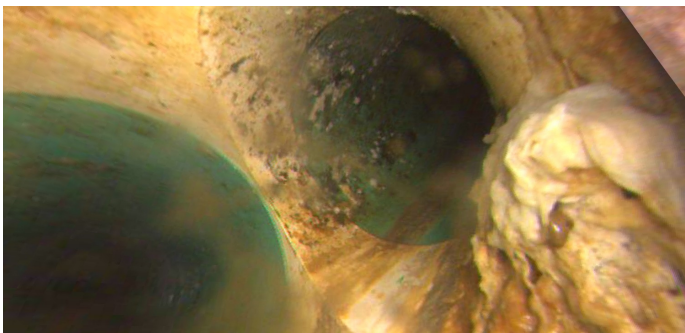
Code: **DAGS**
Description: **Deposits Attached Grease**

Distance (ft): **131.5**
Structural Grade: **0**
O&M Grade: **2**
Clock Start/From: **10**
Clock To:
1st Value:
2nd Value:
Value Percent: **5.000**
Continuous Index:
Within 8" of Joint: **NO**
Remarks:

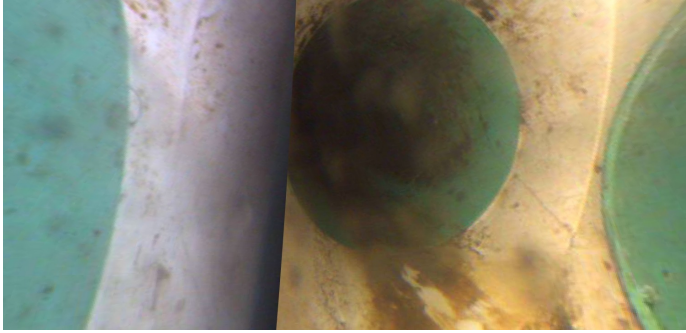
Code: **TF**
Description: **Tap Factory**

Distance (ft): **133.6**
Structural Grade: **0**
O&M Grade: **0**
Clock Start/From: **2**
Clock To:
1st Value: **4.000**
2nd Value:
Value Percent:
Continuous Index:
Within 8" of Joint:
Remarks:

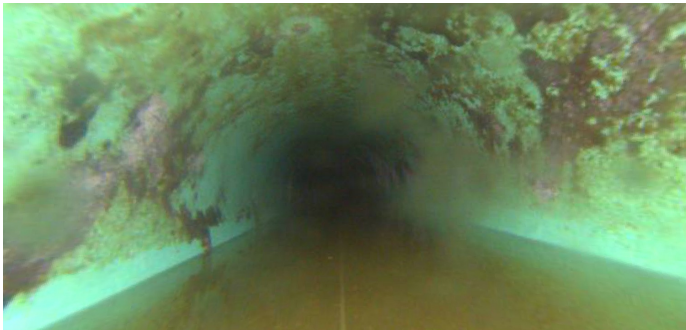
Code: **MGO**
Description: **General Observation**

Distance (ft): **189.8**
Structural Grade: **0**
O&M Grade: **0**
Clock Start/From:
Clock To:
1st Value:
2nd Value:
Value Percent:
Continuous Index:
Within 8" of Joint: **NO**
Remarks: **rear camera**

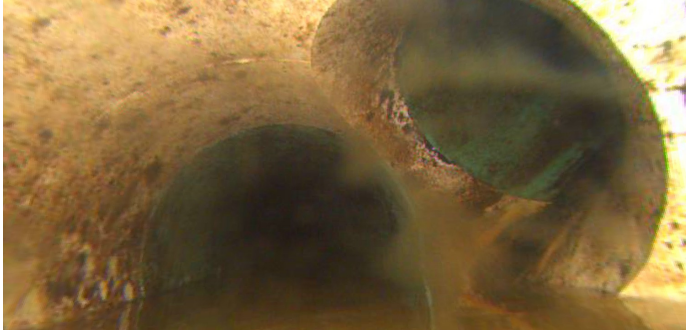
Code: **TF**
Description: **Tap Factory**

Distance (ft): **206.4**
Structural Grade: **0**
O&M Grade: **0**
Clock Start/From: **10**
Clock To:
1st Value: **4.000**
2nd Value:
Value Percent:
Continuous Index:
Within 8" of Joint:
Remarks:

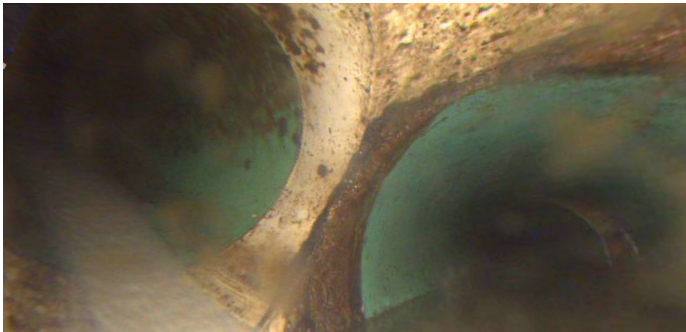
Code: **TFA**
Description: **Tap Factory Active**

Distance (ft): **208.2**
Structural Grade: **0**
O&M Grade: **0**
Clock Start/From: **2**
Clock To:
1st Value: **4.000**
2nd Value:
Value Percent:
Continuous Index:
Within 8" of Joint:
Remarks:

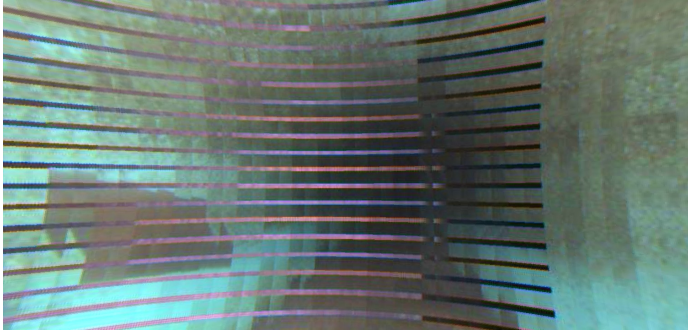
Code: **MSA**
Description: **Abandoned Survey**

Distance (ft): **305.8**
Structural Grade: **0**
O&M Grade: **0**
Clock Start/From:
Clock To:
1st Value:
2nd Value:
Value Percent:
Continuous Index:
Within 8" of Joint: **NO**
Remarks: **unknown**
