Profile/Photo Observation Report

Street:	Tanager	Flow Control:	Not Controlled
City:	Hobart, IN	Year Renewed:	
Location:	Light Highway	Tape/Media #:	
Purpose:	Maintenance Related	Dia/Height:	8"
Use:	Sanitary	Material:	PVC
Drain Area:	NA	Lining:	Cured in Place
Category:	NA		
Comment:

Location Details:		Direction of Survey:	Upstream
US MH:	M-709-008	DS MH:	M-709-035
		Total Length Surveyed (ft):	305.8

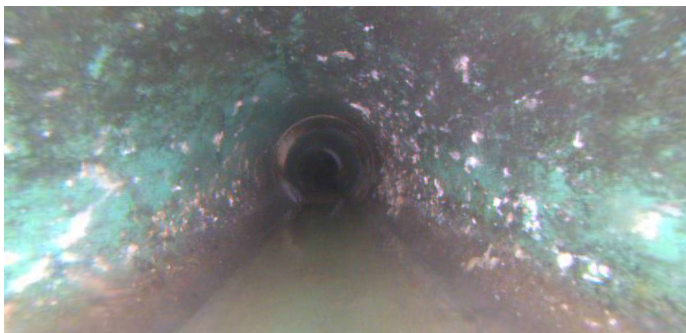
Code: **AMH**
Description: **Manhole**

Distance (ft): **.0**
Structural Grade: **0**
O&M Grade: **0**
Clock Start/From:
Clock To:
1st Value:
2nd Value:
Value Percent:
Continuous Index:
Within 8" of Joint: **NO**
Remarks: **M-709-035**

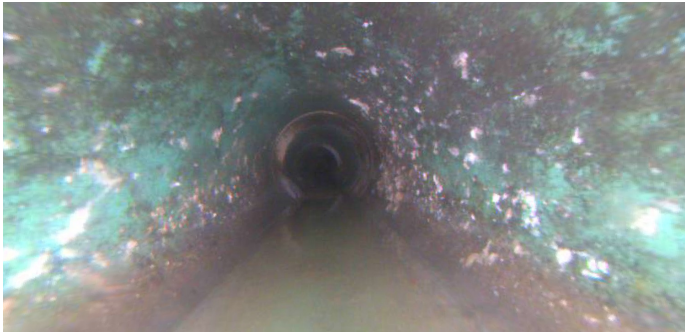
Code:	MWL
Description:	Water Level

Distance (ft):	.0
Structural Grade:	0
O&M Grade:	0
Clock Start/From:	
Clock To:	
1st Value:	
2nd Value:	
Value Percent:	20.000
Continuous Index:	
Within 8" of Joint:	NO
Remarks:

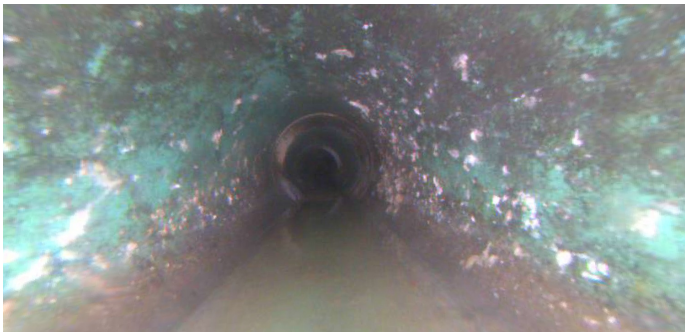
Code:	DAGS
Description:	Deposits Attached Grease

Distance (ft):	.0
Structural Grade:	0
O&M Grade:	2
Clock Start/From:	8
Clock To:	4
1st Value:	
2nd Value:	
Value Percent:	5.000
Continuous Index:	S01
Within 8" of Joint:	NO
Remarks:

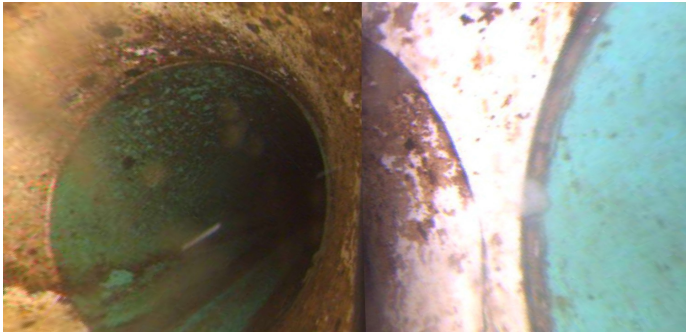
Code: **TFA**
Description: **Tap Factory Active**

Distance (ft): **3.1**
Structural Grade: **0**
O&M Grade: **0**
Clock Start/From: **9**
Clock To:
1st Value: **4.000**
2nd Value:
Value Percent:
Continuous Index:
Within 8" of Joint:
Remarks:

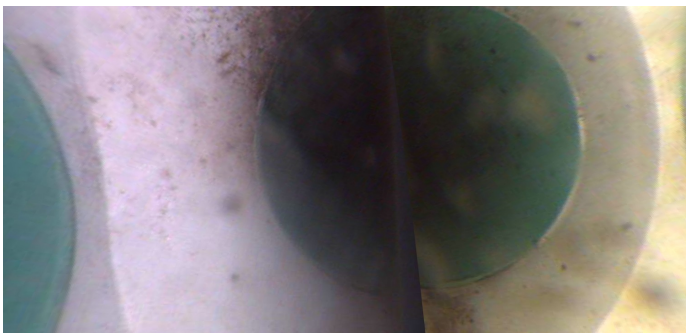
Code: **TF**
Description: **Tap Factory**

Distance (ft): **5.2**
Structural Grade: **0**
O&M Grade: **0**
Clock Start/From: **2**
Clock To:
1st Value: **4.000**
2nd Value:
Value Percent:
Continuous Index:
Within 8" of Joint:
Remarks:

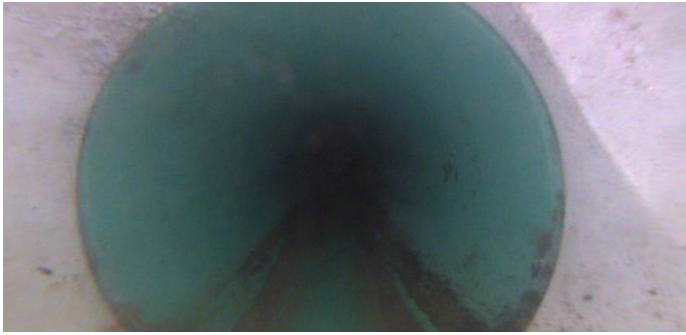
Code: **DAGS**
Description: **Deposits Attached Grease**

Distance (ft): **5.2**
Structural Grade: **0**
O&M Grade: **2**
Clock Start/From: **8**
Clock To: **4**
1st Value:
2nd Value:
Value Percent: **5.000**
Continuous Index: **F01**
Within 8" of Joint: **NO**
Remarks:

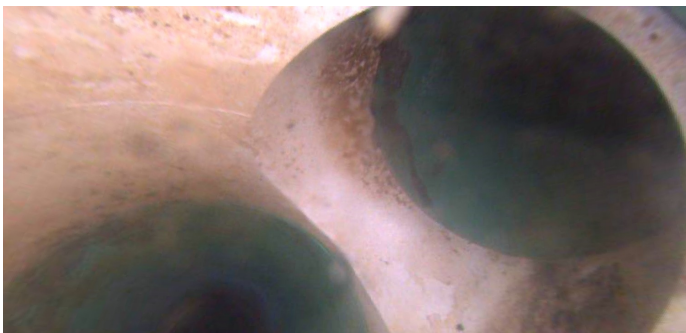
Code: **TF**
Description: **Tap Factory**

Distance (ft): **56.4**
Structural Grade: **0**
O&M Grade: **0**
Clock Start/From: **2**
Clock To:
1st Value: **4.000**
2nd Value:
Value Percent:
Continuous Index:
Within 8" of Joint:
Remarks:

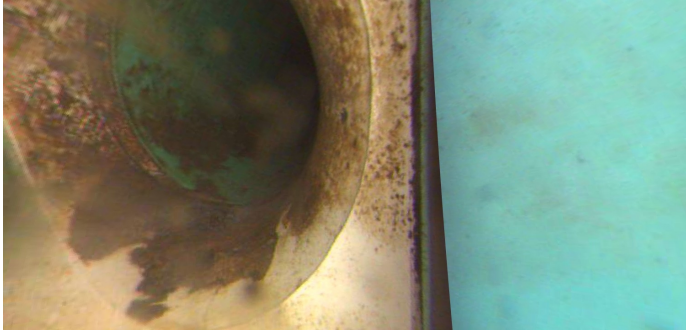
Code: **TF**
Description: **Tap Factory**

Distance (ft): **59.2**
Structural Grade: **0**
O&M Grade: **0**
Clock Start/From: **10**
Clock To:
1st Value: **4.000**
2nd Value:
Value Percent:
Continuous Index:
Within 8" of Joint:
Remarks:

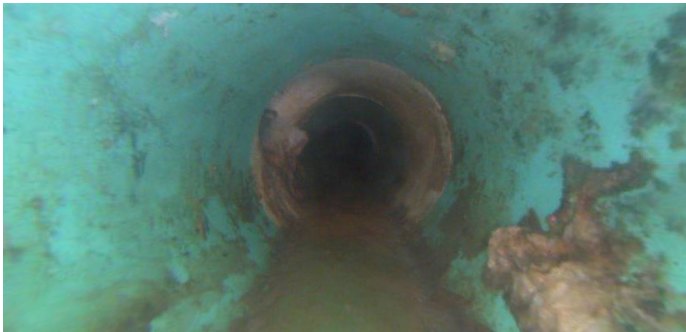
Code: **DAGS**
Description: **Deposits Attached Grease**

Distance (ft): **129.9**
Structural Grade: **0**
O&M Grade: **2**
Clock Start/From: **4**
Clock To:
1st Value:
2nd Value:
Value Percent: **5.000**
Continuous Index:
Within 8" of Joint: **NO**
Remarks:

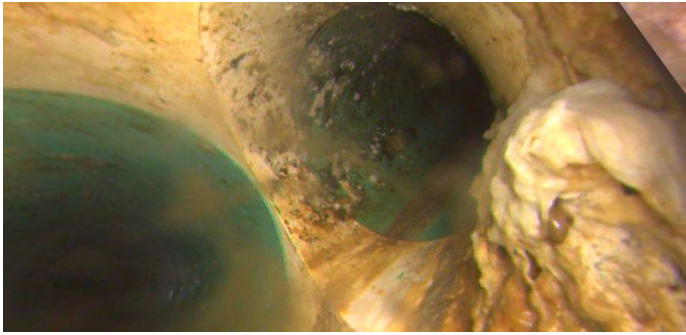
Code: **TFD**
Description: **Tap Factory Defective**

Distance (ft): **131.5**
Structural Grade: **0**
O&M Grade: **2**
Clock Start/From: **10**
Clock To:
1st Value: **4.000**
2nd Value:
Value Percent:
Continuous Index:
Within 8" of Joint:
Remarks: **dags**

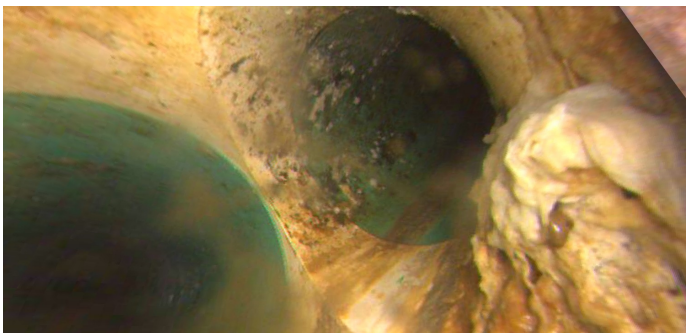
Code: **DAGS**
Description: **Deposits Attached Grease**

Distance (ft): **131.5**
Structural Grade: **0**
O&M Grade: **2**
Clock Start/From: **10**
Clock To:
1st Value:
2nd Value:
Value Percent: **5.000**
Continuous Index:
Within 8" of Joint: **NO**
Remarks:

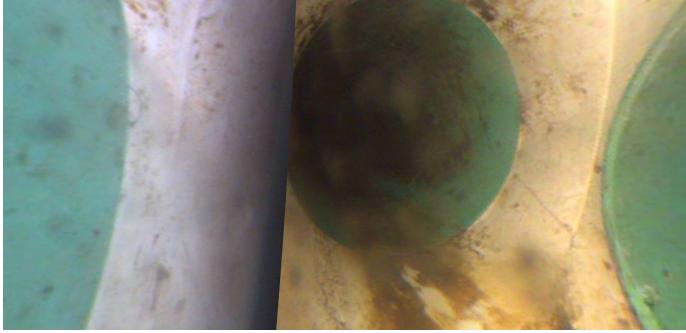
Code: **TF**
Description: **Tap Factory**

Distance (ft): **133.6**
Structural Grade: **0**
O&M Grade: **0**
Clock Start/From: **2**
Clock To:
1st Value: **4.000**
2nd Value:
Value Percent:
Continuous Index:
Within 8" of Joint:
Remarks:

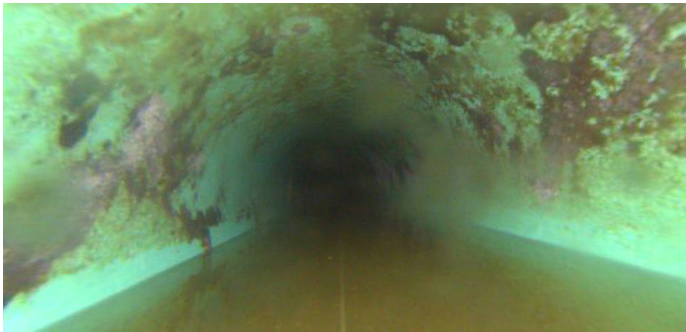
Code: **MGO**
Description: **General Observation**

Distance (ft): **189.8**
Structural Grade: **0**
O&M Grade: **0**
Clock Start/From:
Clock To:
1st Value:
2nd Value:
Value Percent:
Continuous Index:
Within 8" of Joint: **NO**
Remarks: **rear camera**

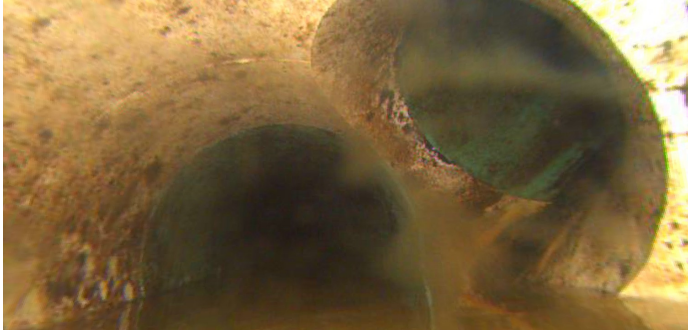
Code: **TF**
Description: **Tap Factory**

Distance (ft): **206.4**
Structural Grade: **0**
O&M Grade: **0**
Clock Start/From: **10**
Clock To:
1st Value: **4.000**
2nd Value:
Value Percent:
Continuous Index:
Within 8" of Joint:
Remarks:

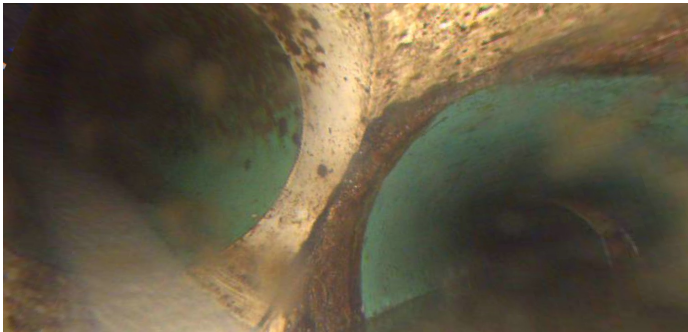
Code: **TFA**
Description: **Tap Factory Active**

Distance (ft): **208.2**
Structural Grade: **0**
O&M Grade: **0**
Clock Start/From: **2**
Clock To:
1st Value: **4.000**
2nd Value:
Value Percent:
Continuous Index:
Within 8" of Joint:
Remarks:

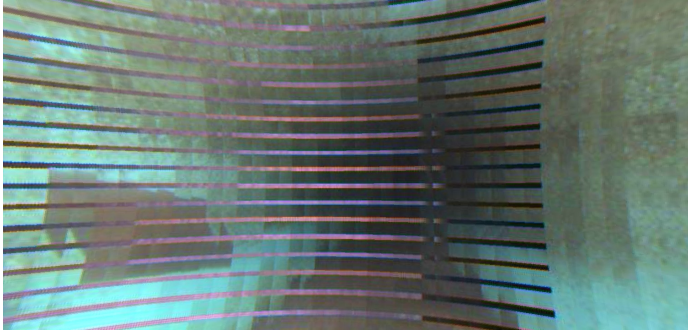
Code: **MSA**
Description: **Abandoned Survey**

Distance (ft): **305.8**
Structural Grade: **0**
O&M Grade: **0**
Clock Start/From:
Clock To:
1st Value:
2nd Value:
Value Percent:
Continuous Index:
Within 8" of Joint: **NO**
Remarks: **unknown**
