## Profile/Photo Observation Report

Street:	<b>BRACKEN PKWY &amp; TANAGER ST</b>	Flow Control:	<b>Not Controlled</b>
City:	<b>Hobart, IN</b>	Year Renewed:	
Location:	<b>Light Highway</b>	Tape/Media #:	
Purpose:	<b>Maintenance Related</b>	Dia/Height:	<b>12"</b>
Use:	<b>Sanitary</b>	Material:	<b>PVC</b>
Drain Area:	<b>NA</b>	Lining:	<b>Cured in Place</b>
Category:	<b>NA</b>		
Comment:	<b>Flow direction wrong.</b>

Location Details:		Direction of Survey:	<b>Downstream</b>
US MH:	<b>M-709-008</b>	DS MH:	<b>M-709-035</b>
		Total Length Surveyed (ft):	<b>302.1</b>

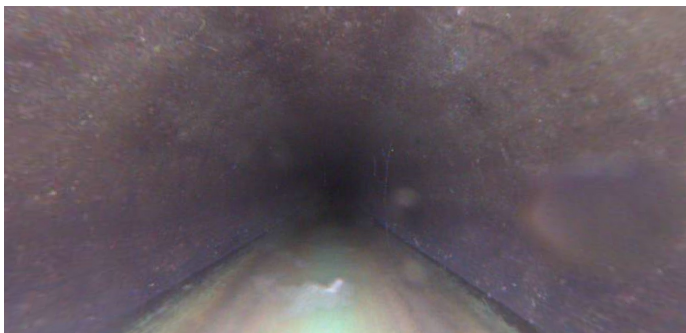
Code: **AMH**  
Description: **Manhole**

Distance (ft): **.0**  
Structural Grade: **0**  
O&M Grade: **0**  
Clock Start/From:  
Clock To:  
1st Value:  
2nd Value:  
Value Percent:  
Continuous Index:  
Within 8" of Joint: **NO**  
Remarks: **M-709-008**

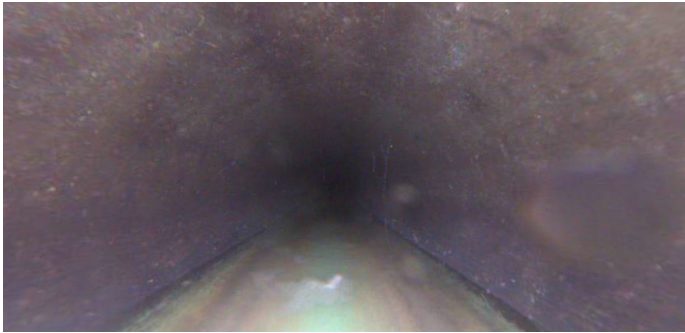
Code:	<b>MWL</b>
Description:	<b>Water Level</b>

Distance (ft):	<b>.0</b>
Structural Grade:	<b>0</b>
O&M Grade:	<b>0</b>
Clock Start/From:	
Clock To:	
1st Value:	
2nd Value:	
Value Percent:	<b>10.000</b>
Continuous Index:	
Within 8" of Joint:	<b>NO</b>
Remarks:

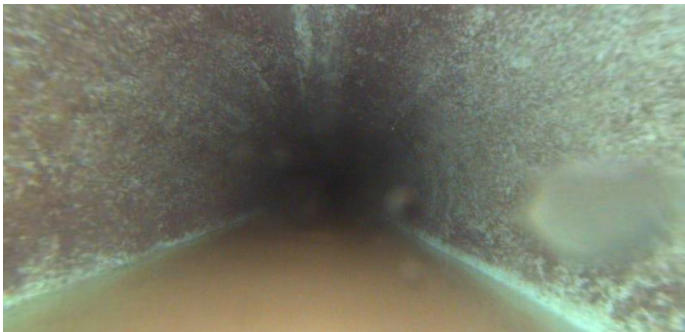
Code:	<b>MWL</b>
Description:	<b>Water Level</b>

Distance (ft):	<b>12.2</b>
Structural Grade:	<b>0</b>
O&M Grade:	<b>0</b>
Clock Start/From:	
Clock To:	
1st Value:	
2nd Value:	
Value Percent:	<b>30.000</b>
Continuous Index:	
Within 8" of Joint:	<b>NO</b>
Remarks:

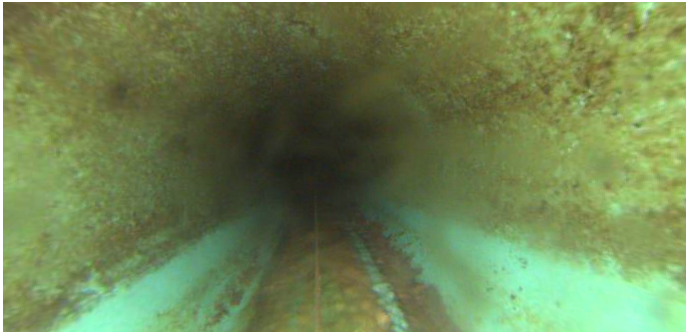
Code: **MGO**  
Description: **General Observation**

Distance (ft): **25.4**  
Structural Grade: **0**  
O&M Grade: **0**  
Clock Start/From:  
Clock To:  
1st Value:  
2nd Value:  
Value Percent:  
Continuous Index:  
Within 8" of Joint: **NO**  
Remarks: **rear camera**

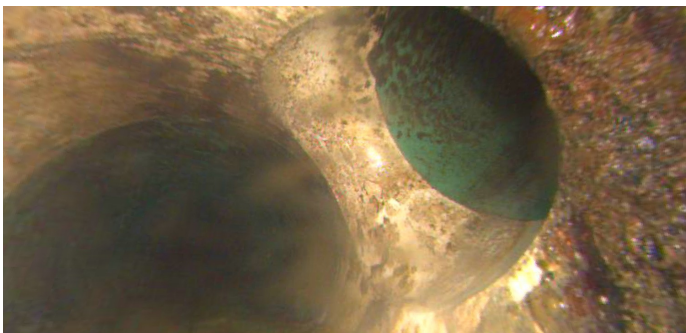
Code: **TF**  
Description: **Tap Factory**

Distance (ft): **131.4**  
Structural Grade: **0**  
O&M Grade: **0**  
Clock Start/From: **10**  
Clock To:  
1st Value: **4.000**  
2nd Value:  
Value Percent:  
Continuous Index:  
Within 8" of Joint:  
Remarks:

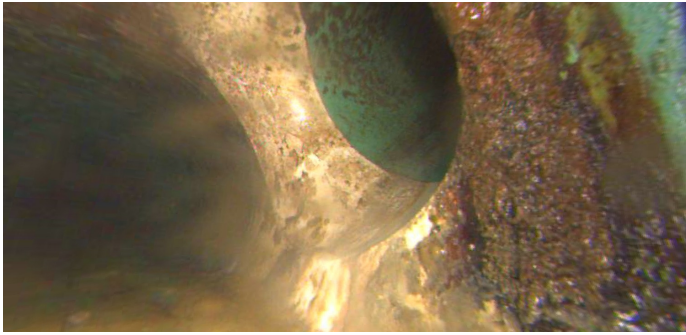
Code: **DAE**  
Description: **Deposits Attached Encrustation**

Distance (ft): **131.4**  
Structural Grade: **0**  
O&M Grade: **2**  
Clock Start/From: **8**  
Clock To: **10**  
1st Value:  
2nd Value:  
Value Percent: **5.000**  
Continuous Index:  
Within 8" of Joint: **YES**  
Remarks:

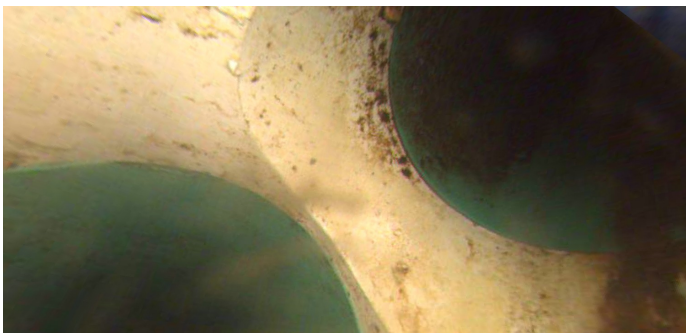
Code: **TF**  
Description: **Tap Factory**

Distance (ft): **205.9**  
Structural Grade: **0**  
O&M Grade: **0**  
Clock Start/From: **10**  
Clock To:  
1st Value: **4.000**  
2nd Value:  
Value Percent:  
Continuous Index:  
Within 8" of Joint:  
Remarks:

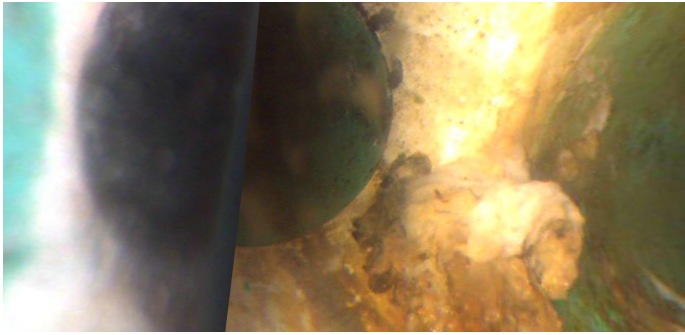
Code: **TF**  
Description: **Tap Factory**

Distance (ft): **208.1**  
Structural Grade: **0**  
O&M Grade: **0**  
Clock Start/From: **2**  
Clock To:  
1st Value: **4.000**  
2nd Value:  
Value Percent:  
Continuous Index:  
Within 8" of Joint:  
Remarks:

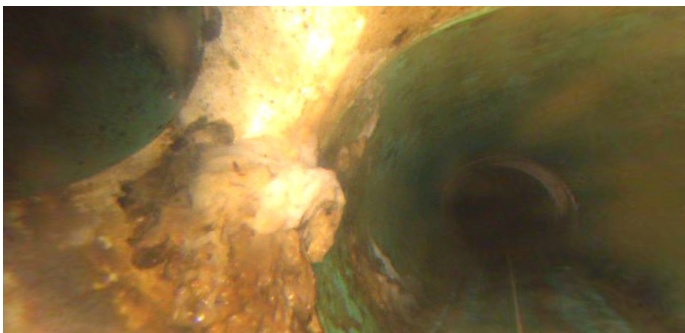
Code: **DAGS**  
Description: **Deposits Attached Grease**

Distance (ft): **208.1**  
Structural Grade: **0**  
O&M Grade: **2**  
Clock Start/From: **3**  
Clock To:  
1st Value:  
2nd Value:  
Value Percent: **5.000**  
Continuous Index:  
Within 8" of Joint: **NO**  
Remarks:

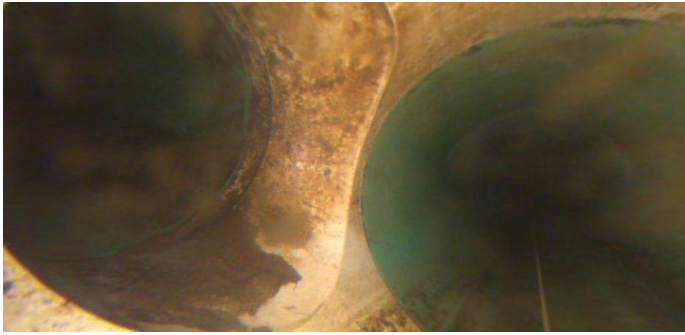
Code: **TF**  
Description: **Tap Factory**

Distance (ft): **280.6**  
Structural Grade: **0**  
O&M Grade: **0**  
Clock Start/From: **3**  
Clock To:  
1st Value: **4.000**  
2nd Value:  
Value Percent:  
Continuous Index:  
Within 8" of Joint:  
Remarks:

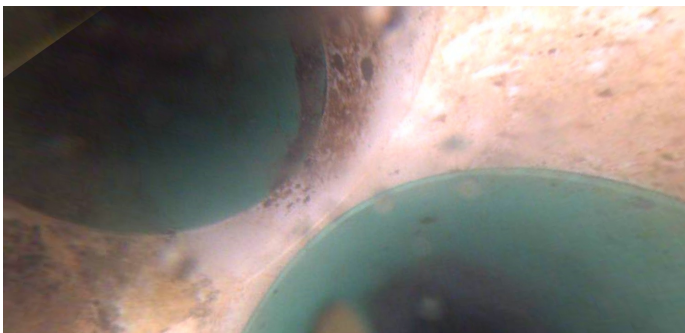
Code: **TF**  
Description: **Tap Factory**

Distance (ft): **282.4**  
Structural Grade: **0**  
O&M Grade: **0**  
Clock Start/From: **11**  
Clock To:  
1st Value: **4.000**  
2nd Value:  
Value Percent:  
Continuous Index:  
Within 8" of Joint:  
Remarks:

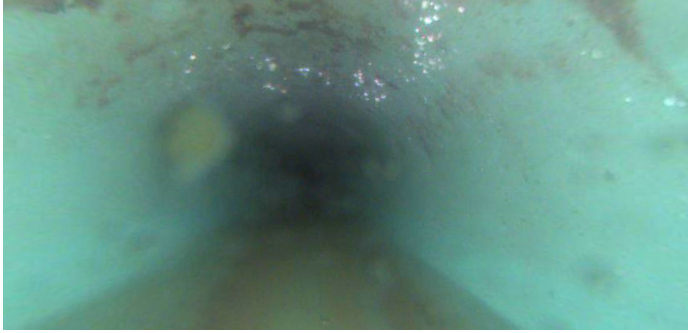
Code:	<b>MSA</b>
Description:	<b>Abandoned Survey</b>
Distance (ft):	<b>302.1</b>
Structural Grade:	<b>0</b>
O&M Grade:	<b>0</b>
Clock Start/From:	
Clock To:	
1st Value:	
2nd Value:	
Value Percent:	
Continuous Index:	
Within 8" of Joint:	<b>NO</b>
Remarks:	<b>unknown</b>
