## Profile/Photo Observation Report

Date:	<b>04/01/2018</b>	Weather:		Coding:	<b>PACP 6.0</b>
Pipe Length (ft):	<b>341.6</b>	Owner:	<b>NA</b>	Pre Clean:	<b>Not Known</b>
P.O.#:		Surveyor:	<b>Jen Costello</b>	PSR:	<b>P-709-035-008</b>
Customer:		Clean Date:	<b>01/01/1900</b>	Shape:	<b>C</b>

Street:	<b>Tanager</b>	Flow Control:	<b>Not Controlled</b>
City:	<b>Hobart, IN</b>	Year Renewed:	
Location:	<b>Light Highway</b>	Tape/Media #:	
Purpose:	<b>Maintenance Related</b>	Dia/Height:	<b>12"</b>
Use:	<b>Sanitary</b>	Material:	<b>PVC</b>
Drain Area:	<b>NA</b>	Lining:	<b>Cured in Place</b>
Category:	<b>NA</b>		
Comment:	<b>Flow direction wrong.</b>

Location Details:		Direction of Survey:	<b>Downstream</b>
US MH:	<b>M-709-008</b>	DS MH:	<b>M-709-035</b>
		Total Length Surveyed (ft):	<b>302.1</b>

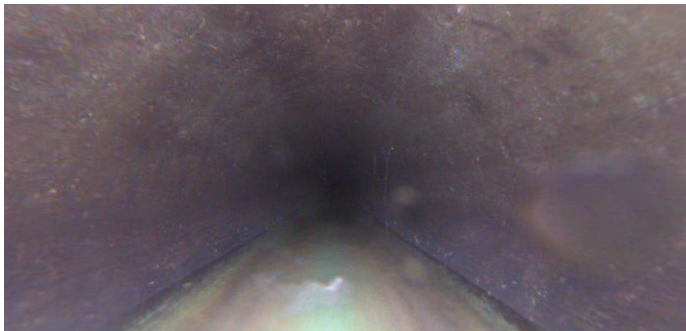
Code: **AMH**  
Description: **Manhole**

Distance (ft): **.0**  
Structural Grade: **0**  
O&M Grade: **0**  
Clock Start/From:  
Clock To:  
1st Value:  
2nd Value:  
Value Percent:  
Continuous Index:  
Within 8" of Joint: **NO**  
Remarks: **M-709-008**

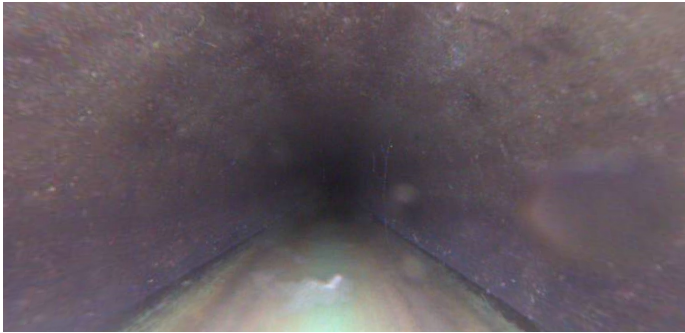
Code:	<b>MWL</b>
Description:	<b>Water Level</b>

Distance (ft):	<b>.0</b>
Structural Grade:	<b>0</b>
O&M Grade:	<b>0</b>
Clock Start/From:	
Clock To:	
1st Value:	
2nd Value:	
Value Percent:	<b>10.000</b>
Continuous Index:	
Within 8" of Joint:	<b>NO</b>
Remarks:

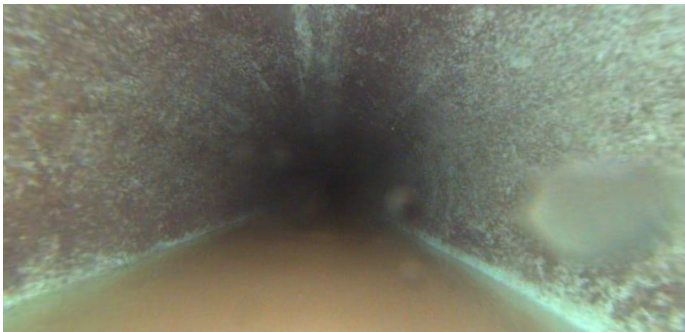
Code:	<b>MWL</b>
Description:	<b>Water Level</b>

Distance (ft):	<b>12.2</b>
Structural Grade:	<b>0</b>
O&M Grade:	<b>0</b>
Clock Start/From:	
Clock To:	
1st Value:	
2nd Value:	
Value Percent:	<b>30.000</b>
Continuous Index:	
Within 8" of Joint:	<b>NO</b>
Remarks:

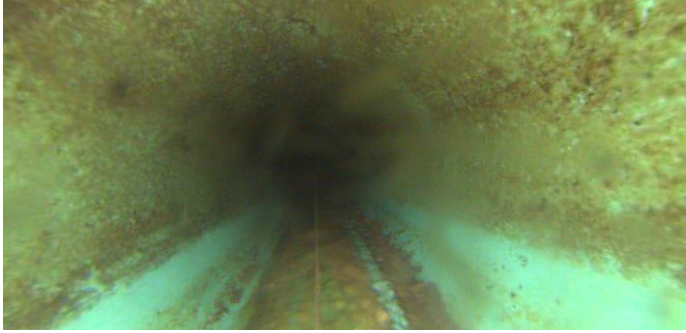
Code: **MGO**  
Description: **General Observation**

Distance (ft): **25.4**  
Structural Grade: **0**  
O&M Grade: **0**  
Clock Start/From:  
Clock To:  
1st Value:  
2nd Value:  
Value Percent:  
Continuous Index:  
Within 8" of Joint: **NO**  
Remarks: **rear camera**

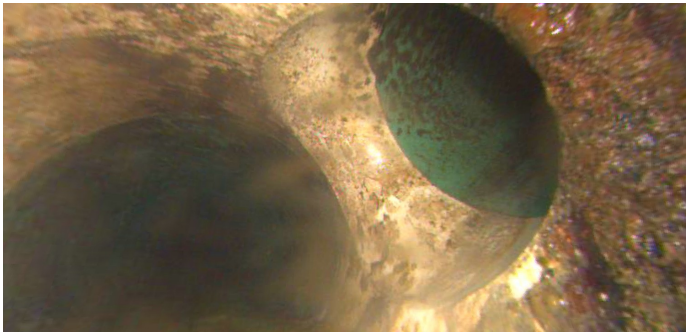
Code: **TF**  
Description: **Tap Factory**

Distance (ft): **131.4**  
Structural Grade: **0**  
O&M Grade: **0**  
Clock Start/From: **10**  
Clock To:  
1st Value: **4.000**  
2nd Value:  
Value Percent:  
Continuous Index:  
Within 8" of Joint:  
Remarks:

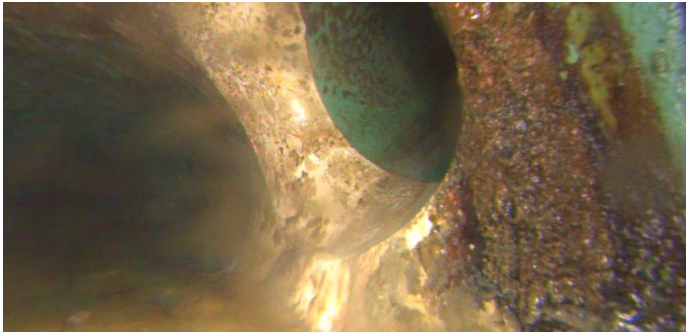
Code: **DAE**  
Description: **Deposits Attached Encrustation**

Distance (ft): **131.4**  
Structural Grade: **0**  
O&M Grade: **2**  
Clock Start/From: **8**  
Clock To: **10**  
1st Value:  
2nd Value:  
Value Percent: **5.000**  
Continuous Index:  
Within 8" of Joint: **YES**  
Remarks:

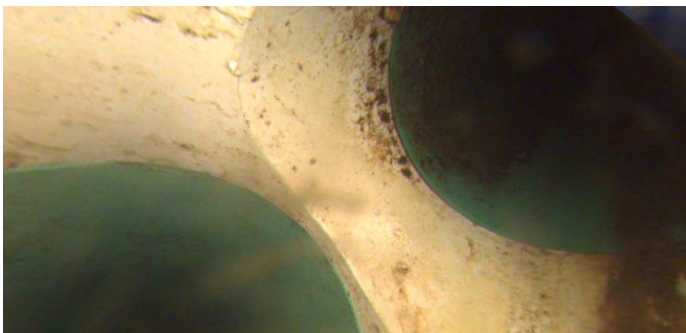
Code: **TF**  
Description: **Tap Factory**

Distance (ft): **205.9**  
Structural Grade: **0**  
O&M Grade: **0**  
Clock Start/From: **10**  
Clock To:  
1st Value: **4.000**  
2nd Value:  
Value Percent:  
Continuous Index:  
Within 8" of Joint:  
Remarks:

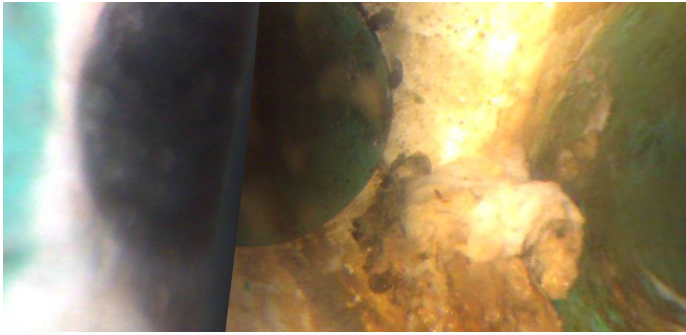
Code: **TF**  
Description: **Tap Factory**

Distance (ft): **208.1**  
Structural Grade: **0**  
O&M Grade: **0**  
Clock Start/From: **2**  
Clock To:  
1st Value: **4.000**  
2nd Value:  
Value Percent:  
Continuous Index:  
Within 8" of Joint:  
Remarks:

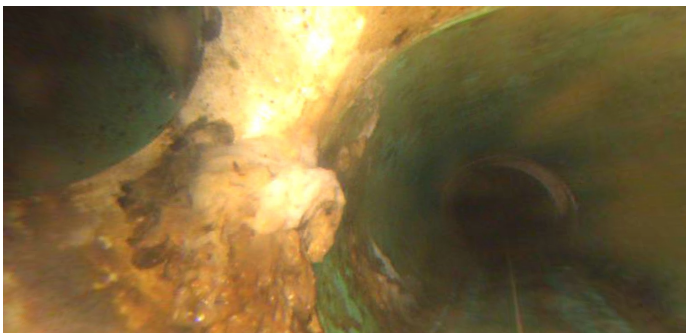
Code: **DAGS**  
Description: **Deposits Attached Grease**

Distance (ft): **208.1**  
Structural Grade: **0**  
O&M Grade: **2**  
Clock Start/From: **3**  
Clock To:  
1st Value:  
2nd Value:  
Value Percent: **5.000**  
Continuous Index:  
Within 8" of Joint: **NO**  
Remarks:

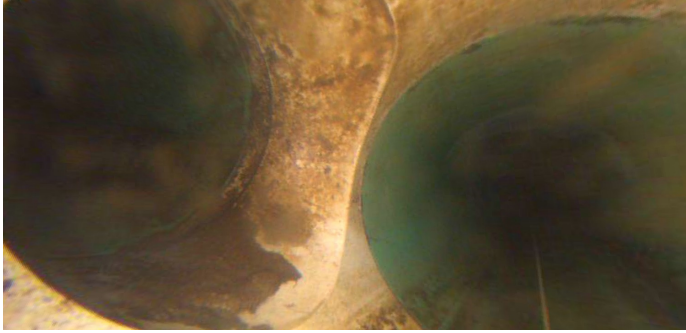
Code: **TF**  
Description: **Tap Factory**

Distance (ft): **280.6**  
Structural Grade: **0**  
O&M Grade: **0**  
Clock Start/From: **3**  
Clock To:  
1st Value: **4.000**  
2nd Value:  
Value Percent:  
Continuous Index:  
Within 8" of Joint:  
Remarks:

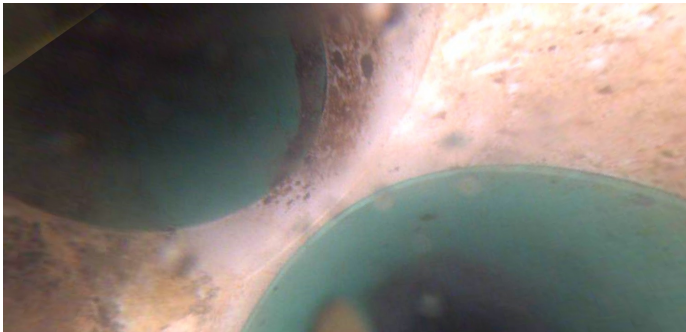
Code: **TF**  
Description: **Tap Factory**

Distance (ft): **282.4**  
Structural Grade: **0**  
O&M Grade: **0**  
Clock Start/From: **11**  
Clock To:  
1st Value: **4.000**  
2nd Value:  
Value Percent:  
Continuous Index:  
Within 8" of Joint:  
Remarks:

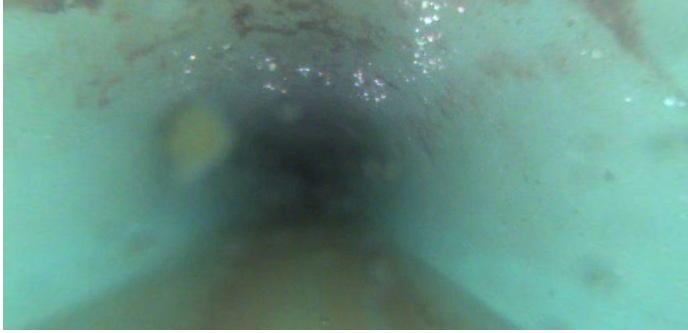
Code:	<b>MSA</b>
Description:	<b>Abandoned Survey</b>
Distance (ft):	<b>302.1</b>
Structural Grade:	<b>0</b>
O&M Grade:	<b>0</b>
Clock Start/From:	
Clock To:	
1st Value:	
2nd Value:	
Value Percent:	
Continuous Index:	
Within 8" of Joint:	<b>NO</b>
Remarks:	<b>unknown</b>
