Profile/Photo Observation Report

| Street: | BRACKEN PKWY & LINCOLN ST | Flow Control: | Not Controlled |
| City: | Hobart, IN | Year Renewed: | |

| US MH: | M-708-201 | DS MH: | M-709-009 |

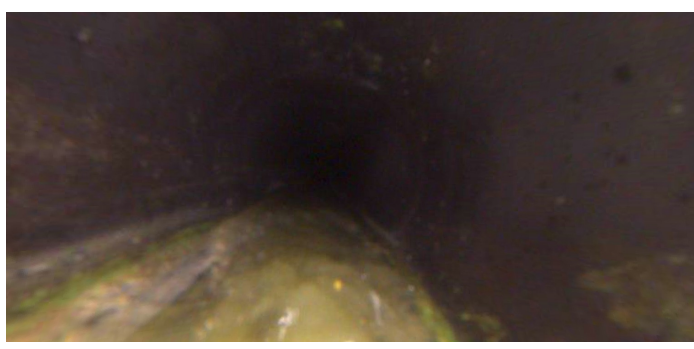
Code: **AMH**
Description: **Manhole**

Distance (ft): **.0**
Structural Grade: **0**
O&M Grade: **0**
Clock Start/From:
Clock To:
1st Value:
2nd Value:
Value Percent:
Continuous Index:
Within 8" of Joint: **NO**
Remarks: **M-709-009**

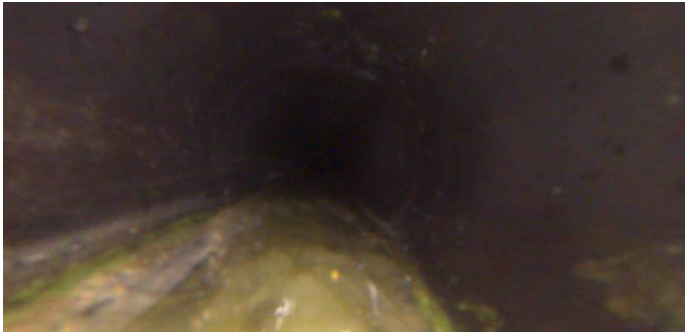
| Code: | MWL |
| Description: | Water Level |

| Distance (ft): | .0 |
| Value Percent: | 10.000 |

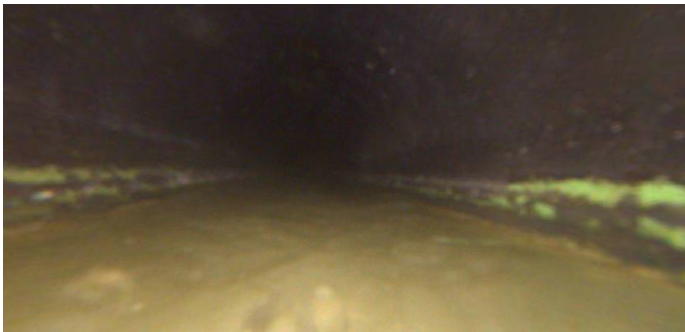
| Code: | MWL |
| Description: | Water Level |

| Distance (ft): | 16.9 |
| Value Percent: | 30.000 |

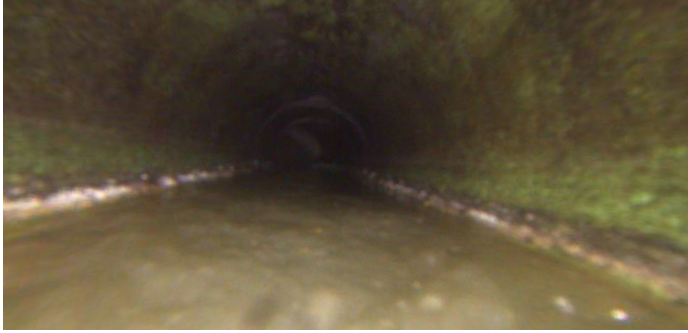
| Code: | MSA |
| Description: | Abandoned Survey |
| Distance (ft): | 124.8 |
| Remarks: | debris under water |
