Profile/Photo Observation Report

Date:	04/01/2018	Weather:		Coding:	PACP 6.0
Pipe Length (ft):	519.3	Owner:	NA	Pre Clean:	Not Known
P.O.#:		Surveyor:	Jen Costello	PSR:	P-709-009-LS011
Customer:		Clean Date:	01/01/1900	Shape:	C

Street:	Bracken	Flow Control:	Not Controlled
City:	Hobart, IN	Year Renewed:	
Location:	Sidewalk	Tape/Media #:	
Purpose:	Maintenance Related	Dia/Height:	12"
Use:	Sanitary	Material:	PVC
Drain Area:	NA	Lining:	Cured in Place
Category:	NA		
Comment:	Flow direction wrong.

Location Details:		Direction of Survey:	Upstream
US MH:	M-708-201	DS MH:	M-709-009
		Total Length Surveyed (ft):	124.8

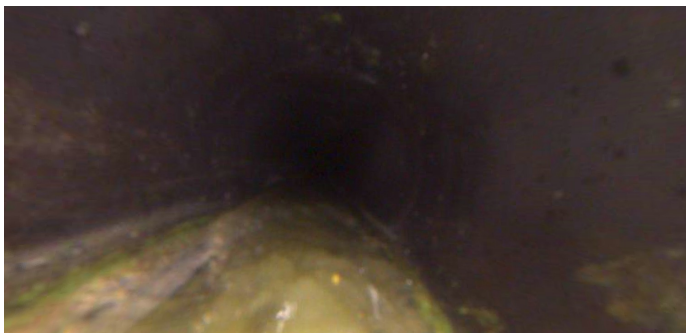
Code: **AMH**
Description: **Manhole**

Distance (ft): **.0**
Structural Grade: **0**
O&M Grade: **0**
Clock Start/From:
Clock To:
1st Value:
2nd Value:
Value Percent:
Continuous Index:
Within 8" of Joint: **NO**
Remarks: **M-709-009**

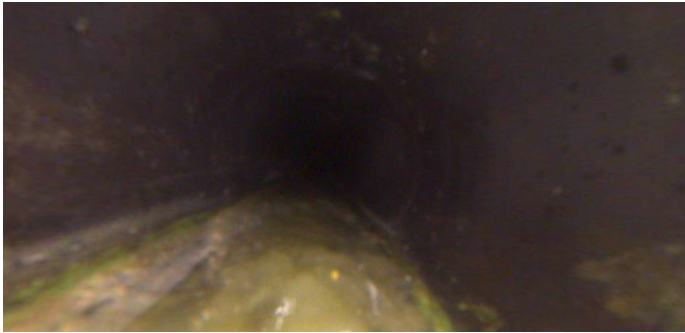
Code:	MWL
Description:	Water Level

Distance (ft):	.0
Structural Grade:	0
O&M Grade:	0
Clock Start/From:	
Clock To:	
1st Value:	
2nd Value:	
Value Percent:	10.000
Continuous Index:	
Within 8" of Joint:	NO
Remarks:

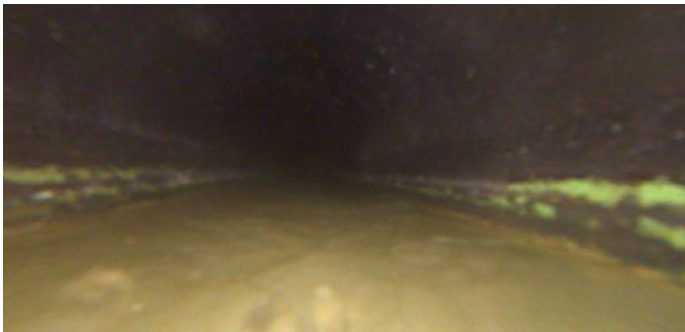
Code:	MWL
Description:	Water Level

Distance (ft):	16.9
Structural Grade:	0
O&M Grade:	0
Clock Start/From:	
Clock To:	
1st Value:	
2nd Value:	
Value Percent:	30.000
Continuous Index:	
Within 8" of Joint:	NO
Remarks:

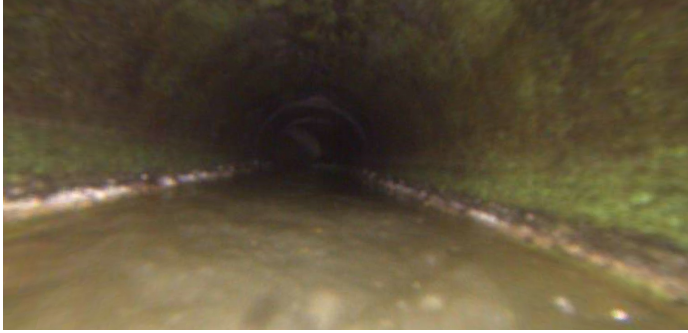
Code:	MSA
Description:	Abandoned Survey
Distance (ft):	124.8
Structural Grade:	0
O&M Grade:	0
Clock Start/From:	
Clock To:	
1st Value:	
2nd Value:	
Value Percent:	
Continuous Index:	
Within 8" of Joint:	NO
Remarks:	debris under water
