Profile/Photo Observation Report

Date:	03/19/2018	Weather:		Coding:	PACP 6.0
Pipe Length (ft):	80.9	Owner:	NA	Pre Clean:	Not Known
P.O.#:		Surveyor:	John Kuglmaier	PSR:	P-709-011-010
Customer:		Clean Date:	01/01/1900	Shape:	C

Street:	Oak	Flow Control:	Not Controlled
City:	Hobart, IN	Year Renewed:	
Location:	Yard	Tape/Media #:	
Purpose:	Maintenance Related	Dia/Height:	8"
Use:	Sanitary	Material:	PVC
Drain Area:	NA	Lining:	
Category:	NA		
Comment:	full of heavy blk silt at 9'.

Location Details:		Direction of Survey:	Downstream
US MH:	M-709-010	DS MH:	M-709-011
		Total Length Surveyed (ft):	10.1

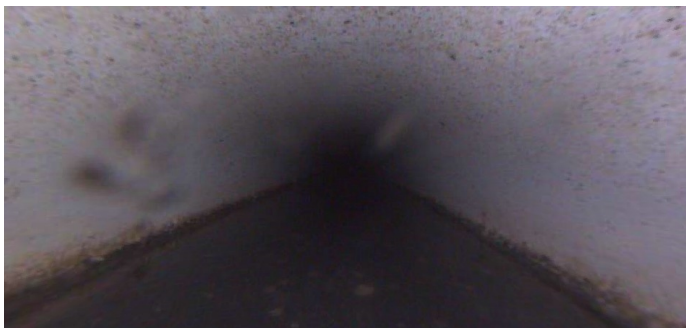
Code: **AMH**
Description: **Manhole**

Distance (ft): **.0**
Structural Grade: **0**
O&M Grade: **0**
Clock Start/From:
Clock To:
1st Value:
2nd Value:
Value Percent:
Continuous Index:
Within 8" of Joint: **NO**
Remarks: **M-709-010**

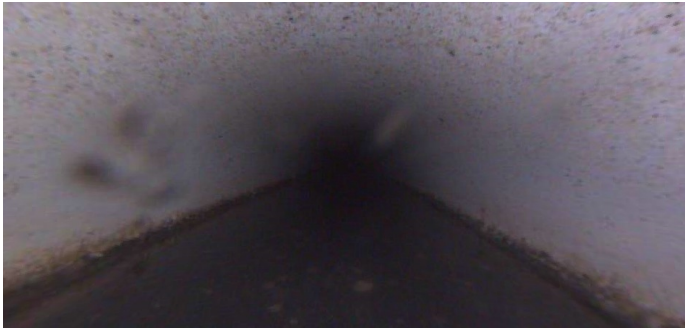
Code:	MWL
Description:	Water Level

Distance (ft):	.0
Structural Grade:	0
O&M Grade:	0
Clock Start/From:	
Clock To:	
1st Value:	
2nd Value:	
Value Percent:	30.000
Continuous Index:	
Within 8" of Joint:	NO
Remarks:

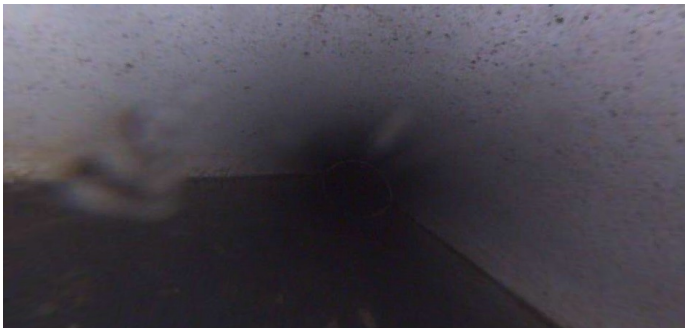
Code:	MWL
Description:	Water Level

Distance (ft):	10.1
Structural Grade:	0
O&M Grade:	0
Clock Start/From:	
Clock To:	
1st Value:	
2nd Value:	
Value Percent:	50.000
Continuous Index:	
Within 8" of Joint:	NO
Remarks:

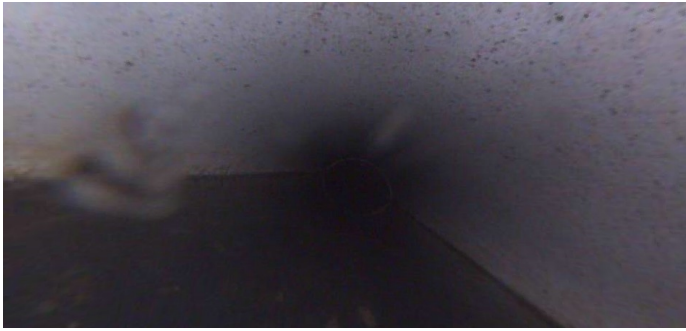
Code:	MSA
Description:	Abandoned Survey
Distance (ft):	10.1
Structural Grade:	0
O&M Grade:	0
Clock Start/From:	
Clock To:	
1st Value:	
2nd Value:	
Value Percent:	
Continuous Index:	
Within 8" of Joint:	NO
Remarks:	Unknown
