## Profile/Photo Observation Report

Street:	<b>DUNLIN CT</b>	Flow Control:	<b>Not Controlled</b>
City:	<b>Hobart, IN</b>	Year Renewed:	
Location:	<b>Yard</b>	Tape/Media #:	
Purpose:	<b>Maintenance Related</b>	Dia/Height:	<b>8"</b>
Use:	<b>Sanitary</b>	Material:	<b>PVC</b>
Drain Area:	<b>NA</b>	Lining:	
Category:	<b>NA</b>		
Comment:	<b>Reverse setup. heavy gravel and sludge at 69'.</b>		
Location Details:		Direction of Survey:	<b>Upstream</b>
US MH:	<b>M-709-010</b>	DS MH:	<b>M-709-011</b>
		Total Length Surveyed (ft):	<b>70.3</b>

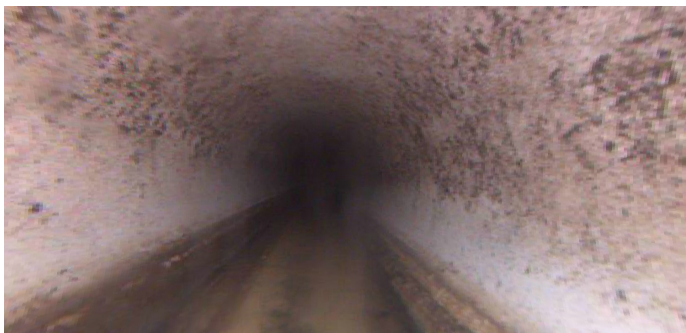
Code: **AMH**  
Description: **Manhole**

Distance (ft): **.0**  
Structural Grade: **0**  
O&M Grade: **0**  
Clock Start/From:  
Clock To:  
1st Value:  
2nd Value:  
Value Percent:  
Continuous Index:  
Within 8" of Joint: **NO**  
Remarks: **M-709-011**

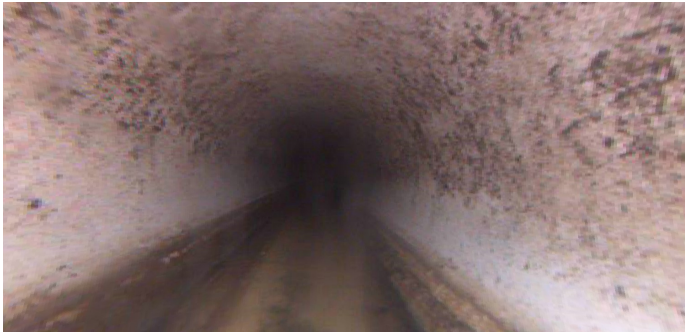
Code:	<b>MWL</b>
Description:	<b>Water Level</b>

Distance (ft):	<b>.0</b>
Structural Grade:	<b>0</b>
O&M Grade:	<b>0</b>
Clock Start/From:	
Clock To:	
1st Value:	
2nd Value:	
Value Percent:	<b>5.000</b>
Continuous Index:	
Within 8" of Joint:	<b>NO</b>
Remarks:

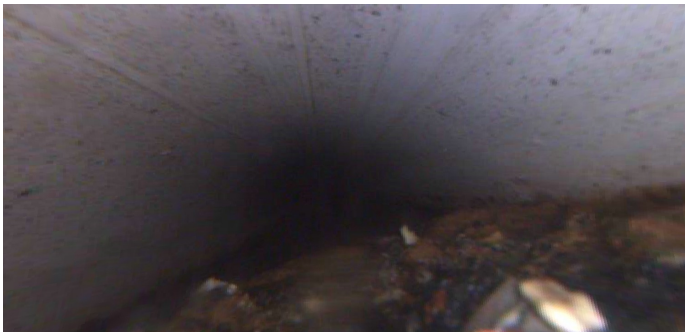
Code:	<b>DSZ</b>
Description:	<b>Deposits Settled Other</b>

Distance (ft):	<b>70.3</b>
Structural Grade:	<b>0</b>
O&M Grade:	<b>2</b>
Clock Start/From:	<b>6</b>
Clock To:	
1st Value:	
2nd Value:	
Value Percent:	<b>5.000</b>
Continuous Index:	
Within 8" of Joint:	<b>NO</b>
Remarks:	<b>mixed material</b>

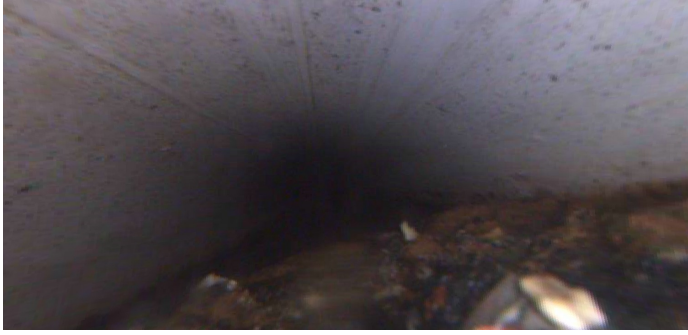
Code:	<b>MSA</b>
Description:	<b>Abandoned Survey</b>
Distance (ft):	<b>70.3</b>
Structural Grade:	<b>0</b>
O&M Grade:	<b>0</b>
Clock Start/From:	
Clock To:	
1st Value:	
2nd Value:	
Value Percent:	
Continuous Index:	
Within 8" of Joint:	<b>NO</b>
Remarks:	<b>mixed material blocking passage</b>
