Profile/Photo Observation Report

Date:	03/21/2018	Weather:		Coding:	PACP 6.0
Pipe Length (ft):	80.9	Owner:	NA	Pre Clean:	Not Known
P.O.#:		Surveyor:	Selasie Honu	PSR:	P-709-011-010
Customer:		Clean Date:	01/01/1900	Shape:	C

Street:	Oak	Flow Control:	Not Controlled
City:	Hobart, IN	Year Renewed:	
Location:	Yard	Tape/Media #:	
Purpose:	Maintenance Related	Dia/Height:	8"
Use:	Sanitary	Material:	PVC
Drain Area:	NA	Lining:	
Category:	NA		
Comment:	Reverse setup. heavy gravel and sludge at 69'.		
Location Details:		Direction of Survey:	Upstream
US MH:	M-709-010	DS MH:	M-709-011
		Total Length Surveyed (ft):	70.3

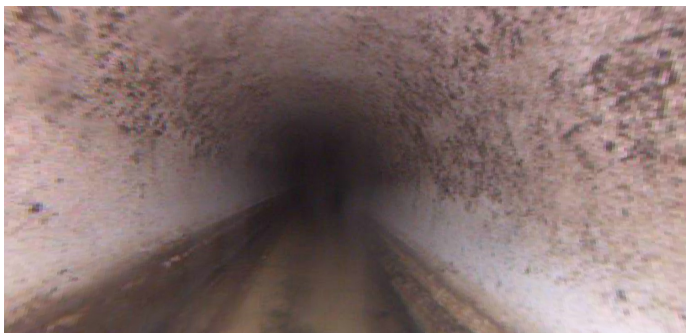
Code: **AMH**
Description: **Manhole**

Distance (ft): **.0**
Structural Grade: **0**
O&M Grade: **0**
Clock Start/From:
Clock To:
1st Value:
2nd Value:
Value Percent:
Continuous Index:
Within 8" of Joint: **NO**
Remarks: **M-709-011**

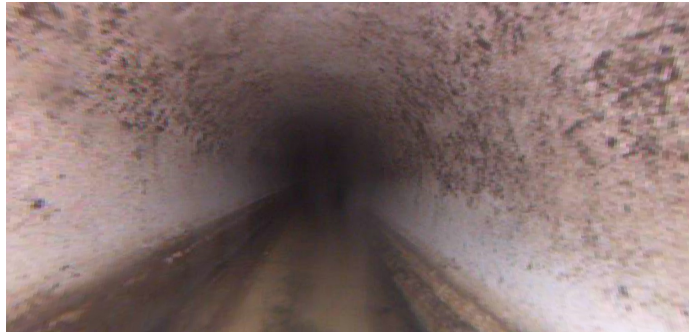
Code: **MWL**
Description: **Water Level**

Distance (ft): **.0**
Structural Grade: **0**
O&M Grade: **0**
Clock Start/From:
Clock To:
1st Value:
2nd Value:
Value Percent: **5.000**
Continuous Index:
Within 8" of Joint: **NO**
Remarks:

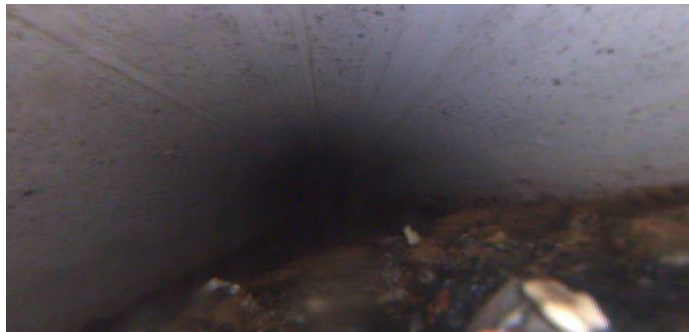
Code: **DSZ**
Description: **Deposits Settled Other**

Distance (ft): **70.3**
Structural Grade: **0**
O&M Grade: **2**
Clock Start/From: **6**
Clock To:
1st Value:
2nd Value:
Value Percent: **5.000**
Continuous Index:
Within 8" of Joint: **NO**
Remarks: **mixed material**

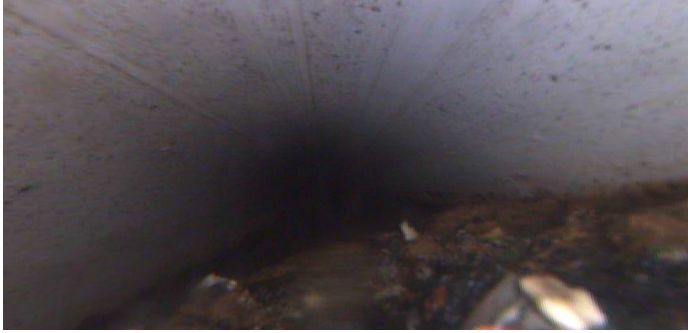
Code:	MSA
Description:	Abandoned Survey
Distance (ft):	70.3
Structural Grade:	0
O&M Grade:	0
Clock Start/From:	
Clock To:	
1st Value:	
2nd Value:	
Value Percent:	
Continuous Index:	
Within 8" of Joint:	NO
Remarks:	mixed material blocking passage
