## Profile/Photo Observation Report

Date:	<b>03/19/2018</b>	Weather:		Coding:	<b>PACP 6.0</b>
Pipe Length (ft):	<b>170.8</b>	Owner:	<b>NA</b>	Pre Clean:	<b>Not Known</b>
P.O.#:		Surveyor:	<b>John Kuglmaier</b>	PSR:	<b>P-709-029-012</b>
Customer:		Clean Date:	<b>01/01/1900</b>	Shape:	<b>C</b>

Street:	<b>AVOCET CIR &amp; DUNLIN CT</b>	Flow Control:	<b>Not Controlled</b>
City:	<b>Hobart, IN</b>	Year Renewed:	
Location:	<b>Light Highway</b>	Tape/Media #:	
Purpose:	<b>Maintenance Related</b>	Dia/Height:	<b>8"</b>
Use:	<b>Sanitary</b>	Material:	<b>PVC</b>
Drain Area:	<b>NA</b>	Lining:	
Category:	<b>NA</b>		
Comment:	<b>Reverse setup. large clay/mud blockage at 97'.</b>		
Location Details:		Direction of Survey:	<b>Downstream</b>
US MH:	<b>M-709-012</b>	DS MH:	<b>M-709-029</b>
		Total Length Surveyed (ft):	<b>98.2</b>

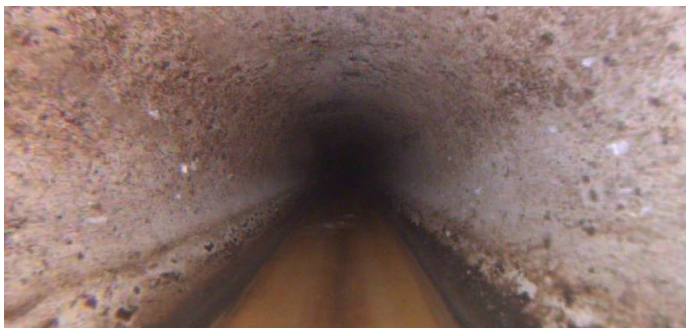
Code: **AMH**  
Description: **Manhole**

Distance (ft): **.0**  
Structural Grade: **0**  
O&M Grade: **0**  
Clock Start/From:  
Clock To:  
1st Value:  
2nd Value:  
Value Percent:  
Continuous Index:  
Within 8" of Joint: **NO**  
Remarks: **M-709-012**

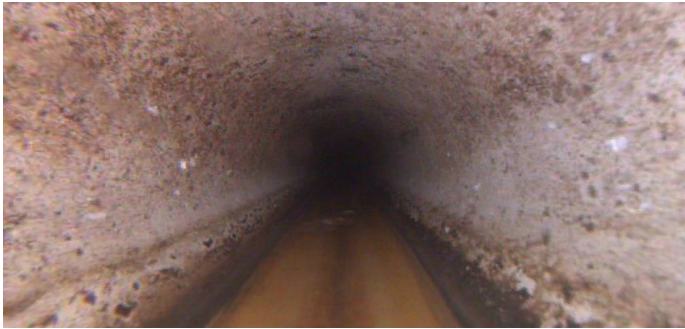
Code:	<b>MWL</b>
Description:	<b>Water Level</b>

Distance (ft):	<b>.0</b>
Structural Grade:	<b>0</b>
O&M Grade:	<b>0</b>
Clock Start/From:	
Clock To:	
1st Value:	
2nd Value:	
Value Percent:	<b>15.000</b>
Continuous Index:	
Within 8" of Joint:	<b>NO</b>
Remarks:

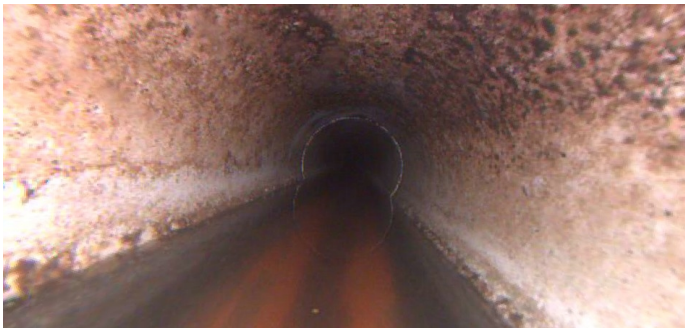
Code:	<b>MWL</b>
Description:	<b>Water Level</b>

Distance (ft):	<b>10.7</b>
Structural Grade:	<b>0</b>
O&M Grade:	<b>0</b>
Clock Start/From:	
Clock To:	
1st Value:	
2nd Value:	
Value Percent:	<b>25.000</b>
Continuous Index:	
Within 8" of Joint:	<b>NO</b>
Remarks:

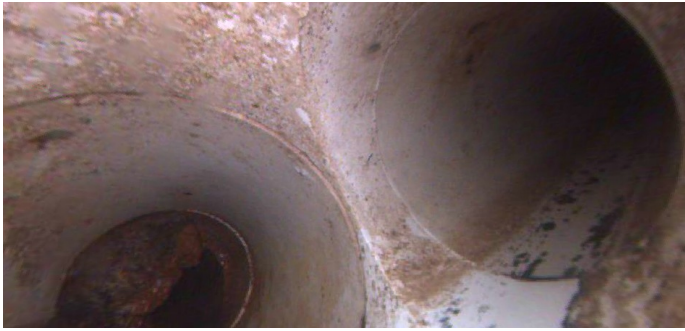
Code: **TF**  
Description: **Tap Factory**

Distance (ft): **96.4**  
Structural Grade: **0**  
O&M Grade: **0**  
Clock Start/From: **2**  
Clock To:  
1st Value: **4.000**  
2nd Value:  
Value Percent:  
Continuous Index:  
Within 8" of Joint:  
Remarks:

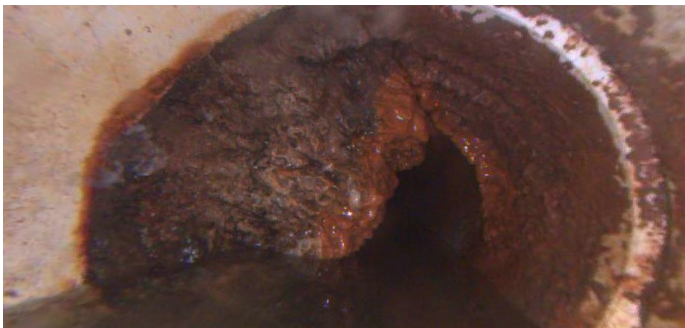
Code: **TFD**  
Description: **Tap Factory Defective**

Distance (ft): **97.5**  
Structural Grade: **0**  
O&M Grade: **2**  
Clock Start/From: **10**  
Clock To:  
1st Value: **4.000**  
2nd Value:  
Value Percent:  
Continuous Index:  
Within 8" of Joint:  
Remarks: **Blockage**

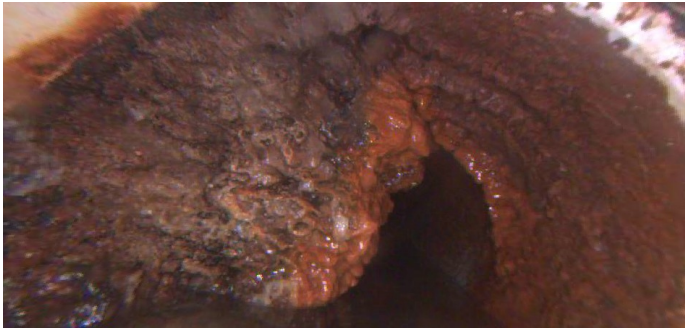
Code: **DAE**  
Description: **Deposits Attached Encrustation**

Distance (ft): **97.6**  
Structural Grade: **0**  
O&M Grade: **5**  
Clock Start/From: **9**  
Clock To: **3**  
1st Value:  
2nd Value:  
Value Percent: **35.000**  
Continuous Index:  
Within 8" of Joint: **YES**  
Remarks:

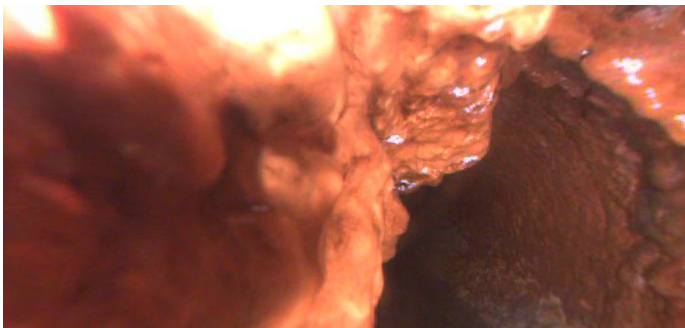
Code: **MSA**  
Description: **Abandoned Survey**

Distance (ft): **98.2**  
Structural Grade: **0**  
O&M Grade: **0**  
Clock Start/From:  
Clock To:  
1st Value:  
2nd Value:  
Value Percent:  
Continuous Index:  
Within 8" of Joint: **NO**  
Remarks: **DAE**
