Profile/Photo Observation Report

Date:	03/19/2018	Weather:		Coding:	PACP 6.0
Pipe Length (ft):	170.8	Owner:	NA	Pre Clean:	Not Known
P.O.#:		Surveyor:	John Kuglmaier	PSR:	P-709-029-012
Customer:		Clean Date:	01/01/1900	Shape:	C

Street:	Oak	Flow Control:	Not Controlled
City:	Hobart, IN	Year Renewed:	
Location:	Light Highway	Tape/Media #:	
Purpose:	Maintenance Related	Dia/Height:	8"
Use:	Sanitary	Material:	PVC
Drain Area:	NA	Lining:	
Category:	NA		
Comment:	Reverse setup. large clay/mud blockage at 97'.		
Location Details:		Direction of Survey:	Downstream
US MH:	M-709-012	DS MH:	M-709-029
		Total Length Surveyed (ft):	98.2

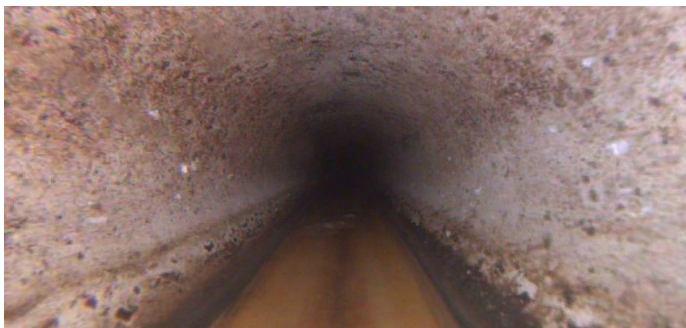
Code: **AMH**
Description: **Manhole**

Distance (ft): **.0**
Structural Grade: **0**
O&M Grade: **0**
Clock Start/From:
Clock To:
1st Value:
2nd Value:
Value Percent:
Continuous Index:
Within 8" of Joint: **NO**
Remarks: **M-709-012**

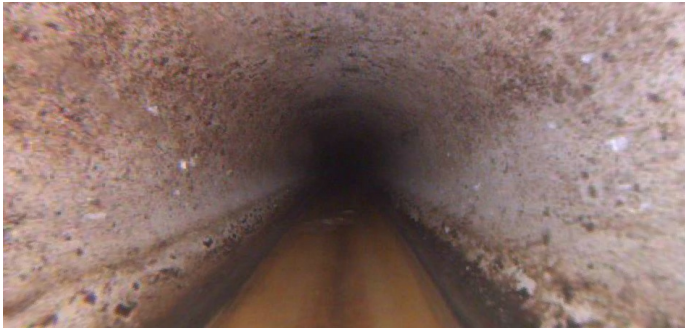
Code:	MWL
Description:	Water Level

Distance (ft):	.0
Structural Grade:	0
O&M Grade:	0
Clock Start/From:	
Clock To:	
1st Value:	
2nd Value:	
Value Percent:	15.000
Continuous Index:	
Within 8" of Joint:	NO
Remarks:

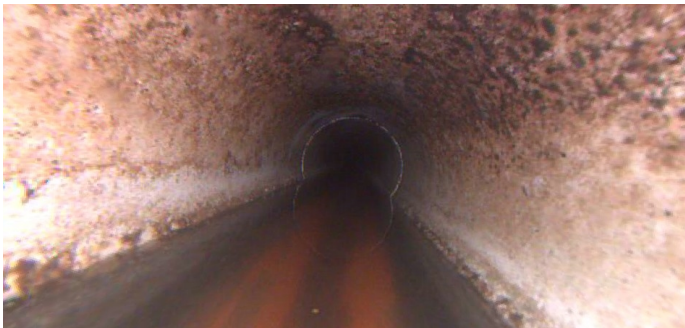
Code:	MWL
Description:	Water Level

Distance (ft):	10.7
Structural Grade:	0
O&M Grade:	0
Clock Start/From:	
Clock To:	
1st Value:	
2nd Value:	
Value Percent:	25.000
Continuous Index:	
Within 8" of Joint:	NO
Remarks:

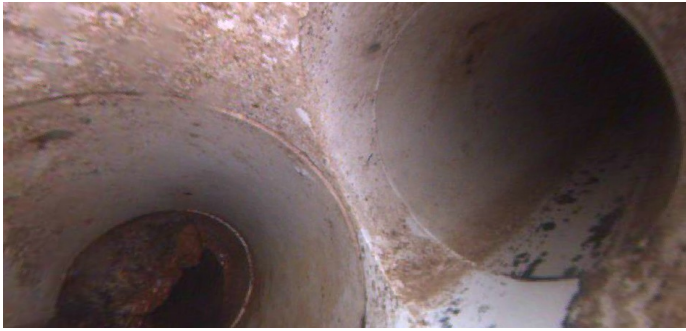
Code: **TF**
Description: **Tap Factory**

Distance (ft): **96.4**
Structural Grade: **0**
O&M Grade: **0**
Clock Start/From: **2**
Clock To:
1st Value: **4.000**
2nd Value:
Value Percent:
Continuous Index:
Within 8" of Joint:
Remarks:

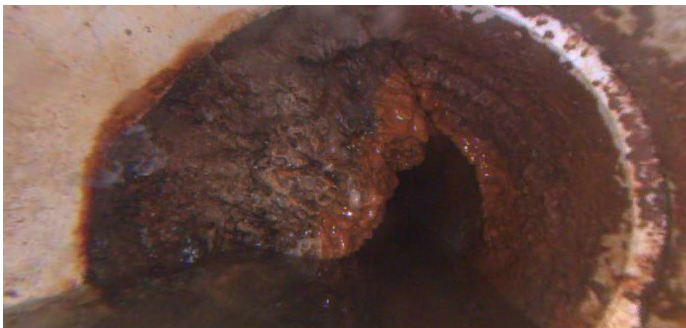
Code: **TFD**
Description: **Tap Factory Defective**

Distance (ft): **97.5**
Structural Grade: **0**
O&M Grade: **2**
Clock Start/From: **10**
Clock To:
1st Value: **4.000**
2nd Value:
Value Percent:
Continuous Index:
Within 8" of Joint:
Remarks: **Blockage**

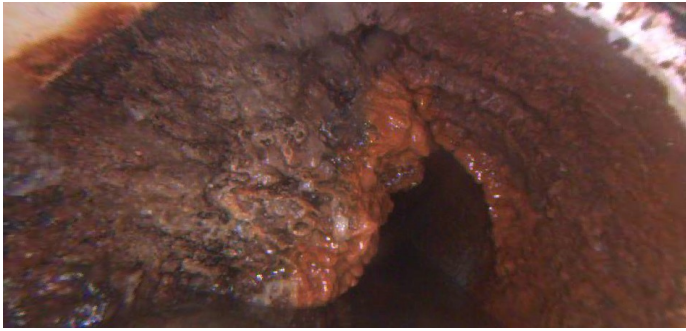
Code: **DAE**
Description: **Deposits Attached Encrustation**

Distance (ft): **97.6**
Structural Grade: **0**
O&M Grade: **5**
Clock Start/From: **9**
Clock To: **3**
1st Value:
2nd Value:
Value Percent: **35.000**
Continuous Index:
Within 8" of Joint: **YES**
Remarks:

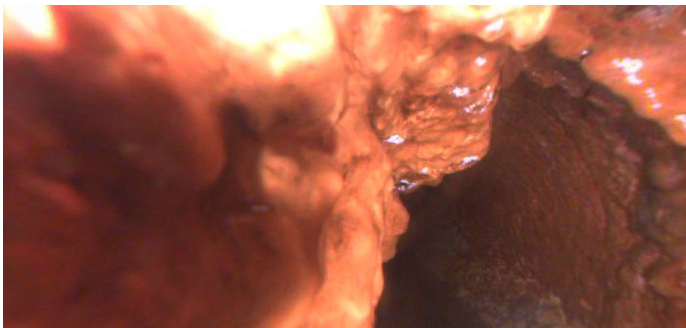
Code: **MSA**
Description: **Abandoned Survey**

Distance (ft): **98.2**
Structural Grade: **0**
O&M Grade: **0**
Clock Start/From:
Clock To:
1st Value:
2nd Value:
Value Percent:
Continuous Index:
Within 8" of Joint: **NO**
Remarks: **DAE**
