Profile/Photo Observation Report

Date:	03/20/2018	Weather:		Coding:	PACP 6.0
Pipe Length (ft):	170.8	Owner:	NA	Pre Clean:	Not Known
P.O.#:		Surveyor:	John Kuglmaier	PSR:	P-709-029-012
Customer:		Clean Date:	01/01/1900	Shape:	C

Street:	AVOCET CIR & DUNLIN CT	Flow Control:	Not Controlled
City:	Hobart, IN	Year Renewed:	
Location:	Yard	Tape/Media #:	
Purpose:	Maintenance Related	Dia/Height:	8"
Use:	Sanitary	Material:	PVC
Drain Area:	NA	Lining:	
Category:	NA		
Comment:	2nd attempt. mh at 168', broke up clay mound.		
Location Details:		Direction of Survey:	Upstream
US MH:	M-709-012	DS MH:	M-709-029
		Total Length Surveyed (ft):	169.7

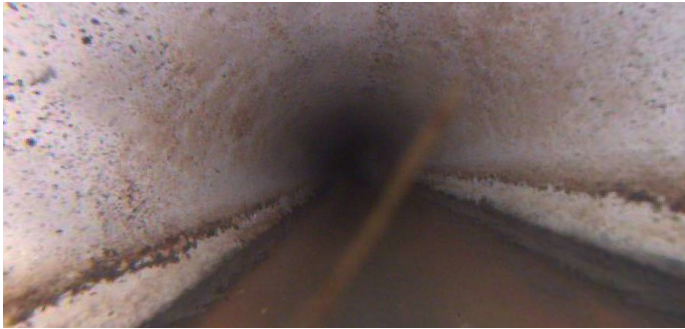
Code:	MWL
Description:	Water Level

Distance (ft):	.0
Structural Grade:	0
O&M Grade:	0
Clock Start/From:	
Clock To:	
1st Value:	
2nd Value:	
Value Percent:	20.000
Continuous Index:	
Within 8" of Joint:	NO
Remarks:

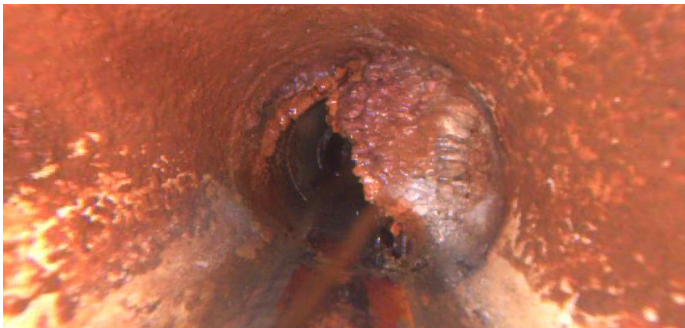
Code:	DAE
Description:	Deposits Attached Encrustation

Distance (ft):	68.3
Structural Grade:	0
O&M Grade:	5
Clock Start/From:	9
Clock To:	5
1st Value:	
2nd Value:	
Value Percent:	50.000
Continuous Index:	
Within 8" of Joint:	YES
Remarks:

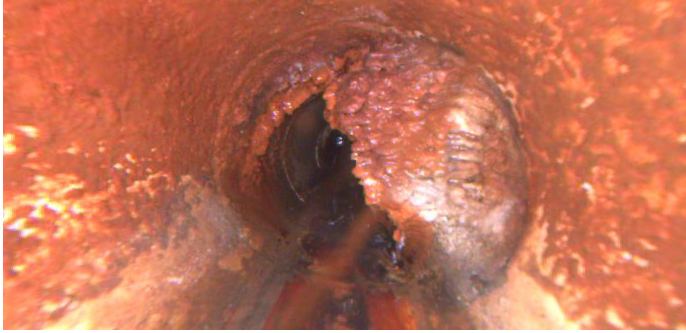
Code: **IR**
Description: **Infil Runner**

Distance (ft): **68.3**
Structural Grade: **0**
O&M Grade: **4**
Clock Start/From: **11**
Clock To: **12**
1st Value:
2nd Value:
Value Percent:
Continuous Index:
Within 8" of Joint: **YES**
Remarks:

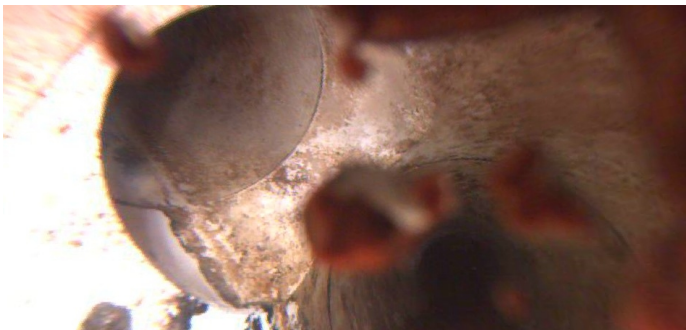
Code: **TF**
Description: **Tap Factory**

Distance (ft): **70.4**
Structural Grade: **0**
O&M Grade: **0**
Clock Start/From: **10**
Clock To:
1st Value: **4.000**
2nd Value:
Value Percent:
Continuous Index:
Within 8" of Joint:
Remarks:

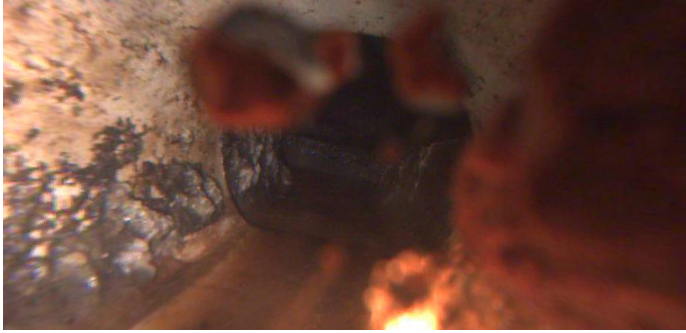
Code: **DAGS**
Description: **Deposits Attached Grease**

Distance (ft): **167.0**
Structural Grade: **0**
O&M Grade: **2**
Clock Start/From: **8**
Clock To: **4**
1st Value:
2nd Value:
Value Percent: **5.000**
Continuous Index:
Within 8" of Joint: **NO**
Remarks:
