# Profile/Photo Observation Report

Date:	<b>03/19/2018</b>	Weather:		Coding:	<b>PACP 6.0</b>
Pipe Length (ft):	<b>166.8</b>	Owner:	<b>NA</b>	Pre Clean:	<b>Not Known</b>
P.O.#:		Surveyor:	<b>John Kuglmaier</b>	PSR:	<b>P-709-014-013</b>
Customer:		Clean Date:	<b>01/01/1900</b>	Shape:	<b>C</b>

Street:	<b>Oak</b>	Flow Control:	<b>Not Controlled</b>
City:	<b>Hobart, IN</b>	Year Renewed:	
Location:	<b>Yard</b>	Tape/Media #:	
Purpose:	<b>Maintenance Related</b>	Dia/Height:	<b>8"</b>
Use:	<b>Sanitary</b>	Material:	<b>PVC</b>
Drain Area:	<b>NA</b>	Lining:	
Category:	<b>NA</b>		
Comment:	<b>blk silt rollover at 127'.</b>		
Location Details:		Direction of Survey:	<b>Upstream</b>
US MH:	<b>M-709-013</b>	DS MH:	<b>M-709-014</b>
		Total Length Surveyed (ft):	<b>128.5</b>

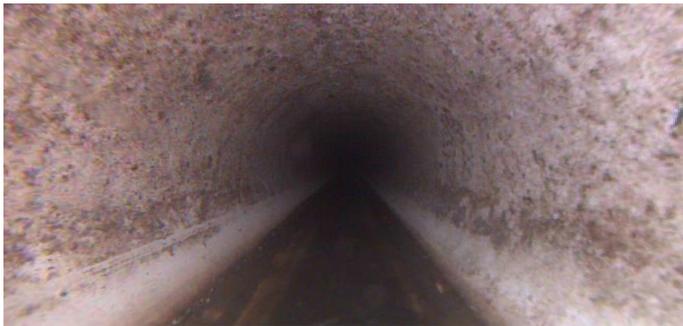
Code: **AMH**  
Description: **Manhole**

Distance (ft): **.0**  
Structural Grade: **0**  
O&M Grade: **0**  
Clock Start/From:  
Clock To:  
1st Value:  
2nd Value:  
Value Percent:  
Continuous Index:  
Within 8" of Joint: **NO**  
Remarks: **M-709-014**

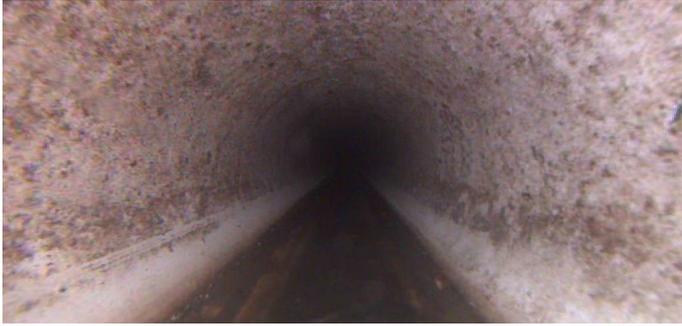
Code: **MWL**  
Description: **Water Level**

Distance (ft): **.0**  
Structural Grade: **0**  
O&M Grade: **0**  
Clock Start/From:  
Clock To:  
1st Value:  
2nd Value:  
Value Percent: **10.000**  
Continuous Index:  
Within 8" of Joint: **NO**  
Remarks:

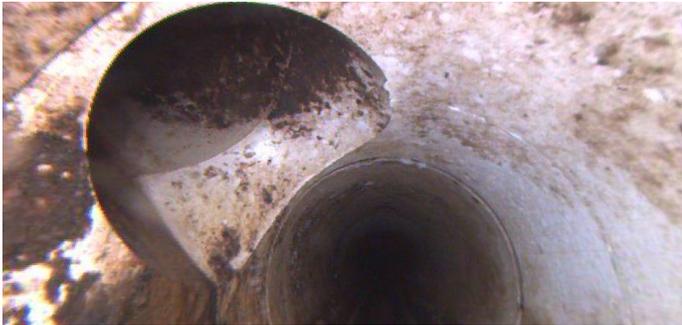
Code: **TF**  
Description: **Tap Factory**

Distance (ft): **67.5**  
Structural Grade: **0**  
O&M Grade: **0**  
Clock Start/From: **10**  
Clock To:  
1st Value: **4.000**  
2nd Value:  
Value Percent:  
Continuous Index:  
Within 8" of Joint:  
Remarks:

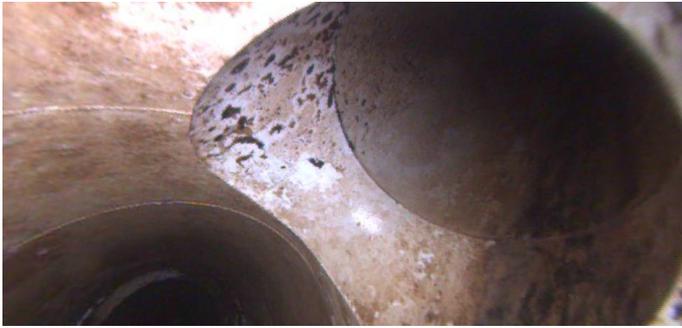
Code: **TF**  
Description: **Tap Factory**

Distance (ft): **125.1**  
Structural Grade: **0**  
O&M Grade: **0**  
Clock Start/From: **2**  
Clock To:  
1st Value: **4.000**  
2nd Value:  
Value Percent:  
Continuous Index:  
Within 8" of Joint:  
Remarks:

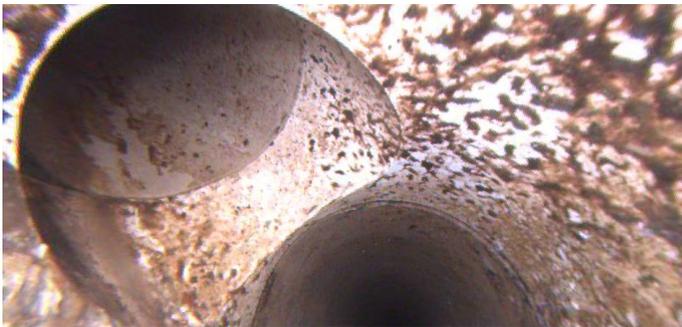
Code: **TF**  
Description: **Tap Factory**

Distance (ft): **126.7**  
Structural Grade: **0**  
O&M Grade: **0**  
Clock Start/From: **10**  
Clock To:  
1st Value: **4.000**  
2nd Value:  
Value Percent:  
Continuous Index:  
Within 8" of Joint:  
Remarks:

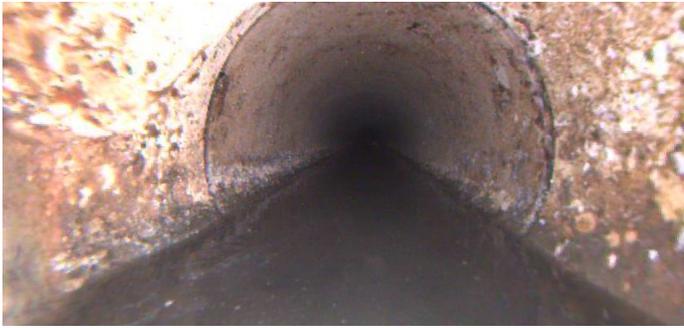
Code: **MWL**  
Description: **Water Level**

Distance (ft): **126.9**  
Structural Grade: **0**  
O&M Grade: **0**  
Clock Start/From:  
Clock To:  
1st Value:  
2nd Value:  
Value Percent: **20.000**  
Continuous Index:  
Within 8" of Joint: **NO**  
Remarks:

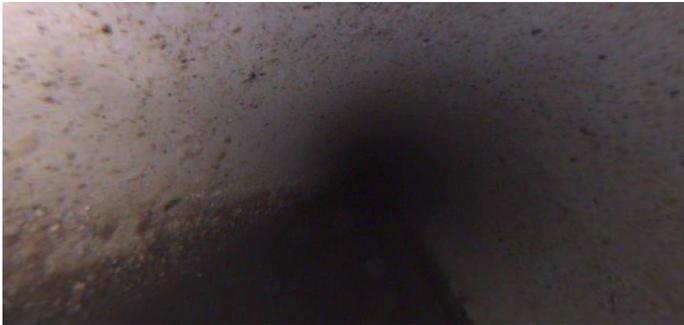
Code: **MSA**  
Description: **Abandoned Survey**

Distance (ft): **128.5**  
Structural Grade: **0**  
O&M Grade: **0**  
Clock Start/From:  
Clock To:  
1st Value:  
2nd Value:  
Value Percent:  
Continuous Index:  
Within 8" of Joint: **NO**  
Remarks: **Unknown**
