Profile/Photo Observation Report

| Street: | Oak | Flow Control: | Not Controlled |
| City: | Hobart, IN | Year Renewed: | |

| US MH: | M-709-014 | DS MH: | M-709-015 |

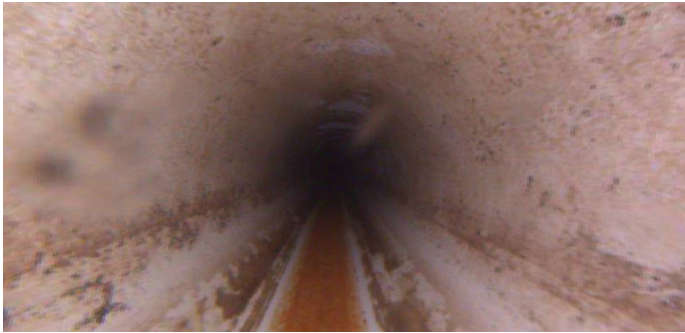
| Code: | MWL |
| Description: | Water Level |

| Distance (ft): | .0 |
| Value Percent: | 5.000 |

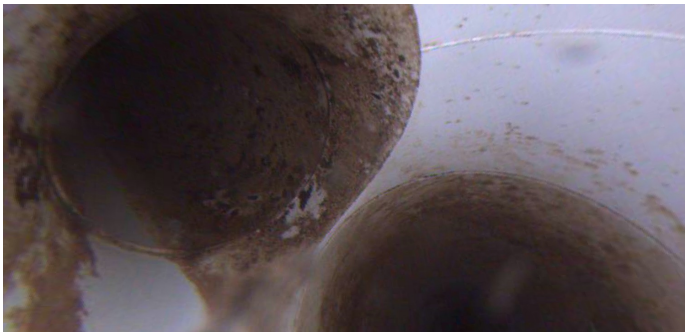
| Code: | TF |
| Description: | Tap Factory |

| Distance (ft): | 52.0 |
| Clock Start/From: | 10 |
| 1st Value: | 4.000 |

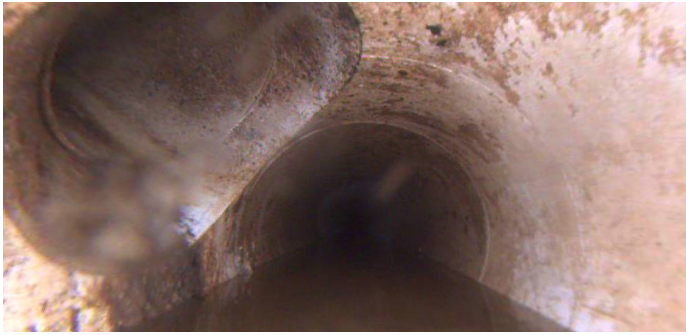
Code: **TF**
Description: **Tap Factory**

Distance (ft): **187.1**
Structural Grade: **0**
O&M Grade: **0**
Clock Start/From: **10**
Clock To:
1st Value: **4.000**
2nd Value:
Value Percent:
Continuous Index:
Within 8" of Joint:
Remarks:

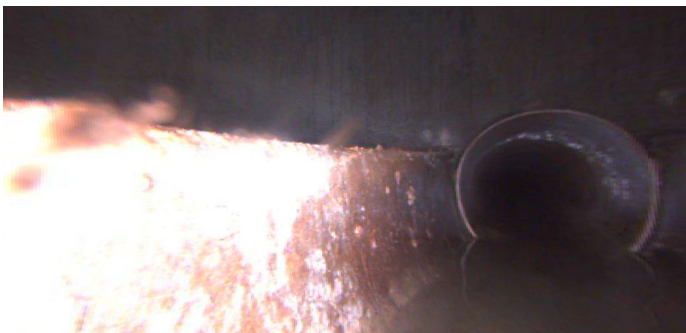
Code: **AMH**
Description: **Manhole**

Distance (ft): **215.0**
Structural Grade: **0**
O&M Grade: **0**
Clock Start/From:
Clock To:
1st Value:
2nd Value:
Value Percent:
Continuous Index:
Within 8" of Joint: **NO**
Remarks: **M-709-015**
